Repair of Damaged Floor Slabs

Yoichi HIGASHI

The crack pattern and deflection of 48 damaged slabs in a 5-story reinforced concrete building with wide cracks and large deflections were measured. Two repair methods proposed were injection of epoxy resin into the cracks, and the casting of a concrete or mortar layer over the damaged slabs, depending on the degree of damage. Loading tests on one-way slab specimens similar to the actual slabs, and vibration tests on the actual slabs were carried out before and after repairing. The results of these tests show that the proposed methods of repair were very effective for the damaged slabs.

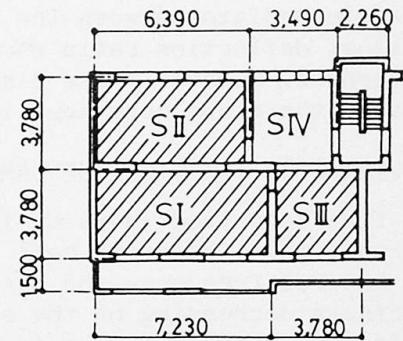
Fig.3 Plan of a flat

Crack patterns and deflection of 48 damaged slabs of 16 flats in a actual 5-story apartment houses of reinforced concrete wall structure were measured.⁵⁾ The plan of a flat is shown in Fig.3. The slabs consisted of three types, namely, SI (center to center span is $3.78 \times 7.23 \text{ m}$), SII ($3.78 \times 6.39 \text{ m}$), SIII ($3.78 \times 3.78 \text{ m}$).

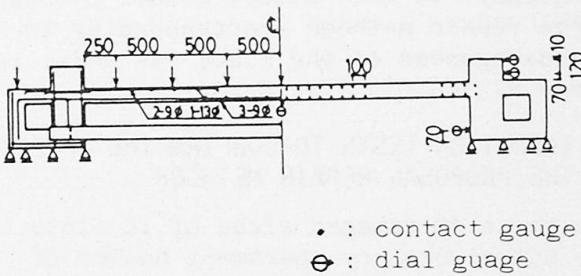
Fig.7 Specimen of short-term loading tests

Each specimen was loaded by many oil jacks as shown Fig.7 until the residual deflection reached the values shown in Table 2, and was unloaded after cracks occurred. And the specimens were reloaded
