**Zeitschrift:** IABSE reports = Rapports AIPC = IVBH Berichte  
**Band:** 46 (1983)

**Artikel:** Repair of damaged floor slabs  
**Autor:** Higashi, Yoichi  
**DOI:** <https://doi.org/10.5169/seals-35874>

## Repair of Damaged Floor Slabs

### Yoichi HIGASHI

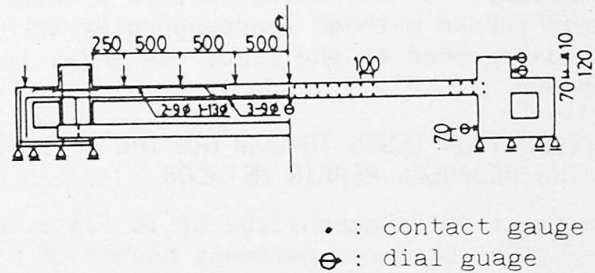
Fig.7 Specimen of short-term loading tests

Each specimen was loaded by many oil jacks as shown Fig.7 until the residual deflection reached the values shown in Table 2, and was unloaded after cracks occurred. And the specimens were reloaded

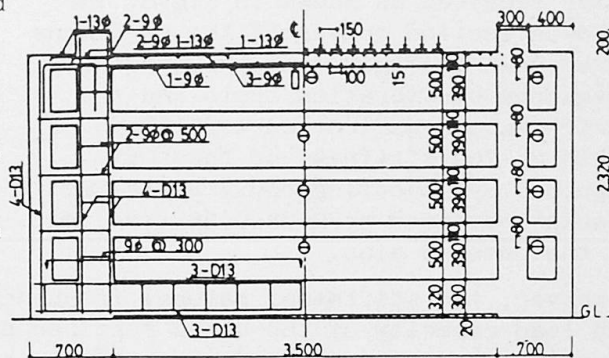
Fig.10 Specimens of long-term loading tests

8 one-way slab specimens of similar section and arrangement as shown in Fig.10 were uniformly loaded steel plates until the residual deflection reached the values shown in Table 3, and they were unloaded after cracks occurred. After repair shown in Fig.8, the specimens were loaded under long-term live load for design ( $W_{LL} = 180 \text{ kg/cm}^2$ ).
