Artikel: Strengthening of a prestressed concrete shell structure

Strengthening of a Prestressed Concrete Shell Structure

Hassan HOSNY

In this paper, strengthening of a prestressed concrete shell in a chemical factory, in Cairo, is presented. The valley beams were strengthened by external prestressing cables anchored outside the building in precast end blocks. The shells were strengthened by casting 4 cm thick resin concrete on top of the existing shell.

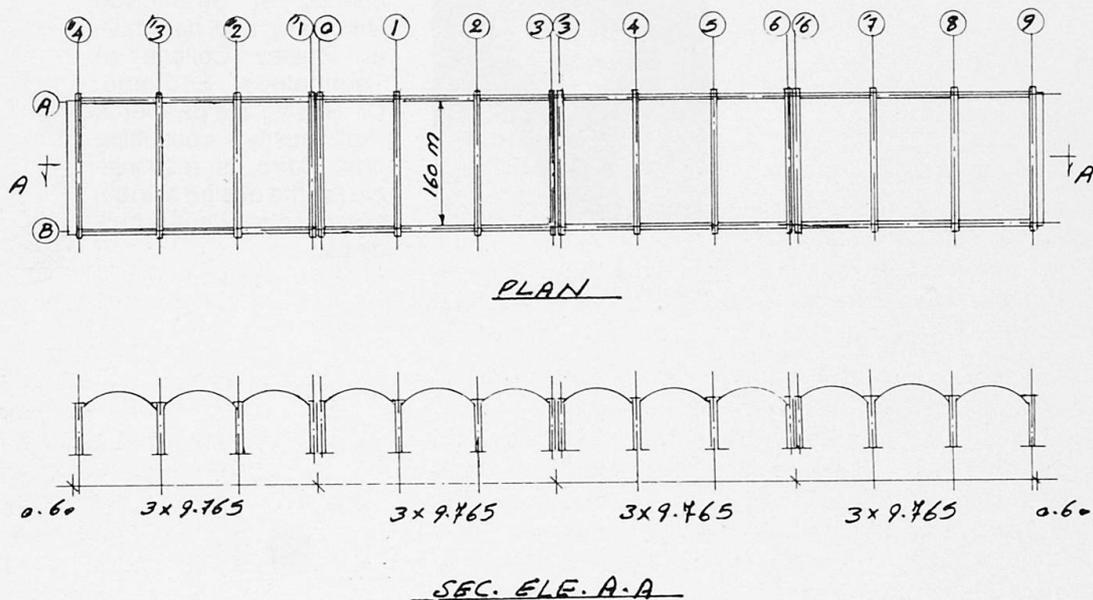
Fig. 1 General Layout

The building is divided into four identical parts separated by three expansion joints as shown in fig.1. Each part is composed of three cylindrical reinforced concrete shells with prestressed edge beams. Each shell is 10ms wide, 16ms long and 6cm thick. The intermediate edge, valley, beams were prestressed with three FREYSSINET cables 12 o 5 mm while the exterior beams were prestressed with only two cables of the same type.
