Additional Insulation of Flat Roofs with Thin-Walled Metal Structures

Ingemar HÖGLUND

Patrick ANDERSSON

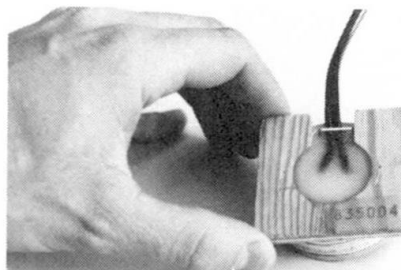
Fig. 2 Moisture-measuring gauge used in the field investigations. The gauge is built into the roof decking. The electrodes, insulated except at the tips, measure the electrical resistance of the plywood. The thermocouple helps to correct resistance measurements for temperature. By using a relation curve of electrical resistance and moisture content in the measuring gauge, it is possible to determine the moisture ratio in the measuring gauge and thereby the moisture ratio in the roof.

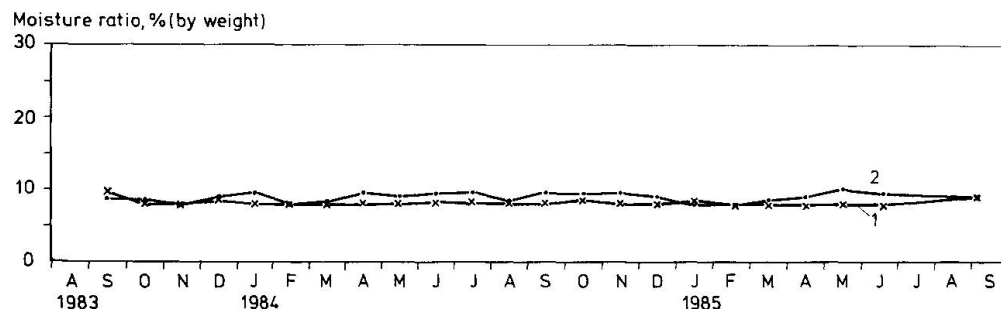
After additional insulation of the roof in spring 1983 dripping from the ceiling stopped and the roof now functions perfectly. Moisture and temperature are measured in the roof to check the moisture content there. See Fig. 8.

Fig. 8 Example of results. Moisture and temperature are measured both in the air space, line 1 and immediately below the new weatherproof layer, line 2. Since additionally insulating the roof the moisture ratio in the roof has remained for the whole period at a low level, c. 8% in the air space and c. 10% under the new weatherproofing. However, the moisture ratio at one of the measurement points immediately below the new weatherproofing was c. 20%, which indicates that moisture has been enclosed. Moisture is measured by means of built-in moisture-measure gauges; figures refer to the moisture ratio in these rounds.
