Additional Insulation of Flat Roofs with Thin-Walled Metal Structures

Ingemar HÖGLUND

Patrick ANDERSSON

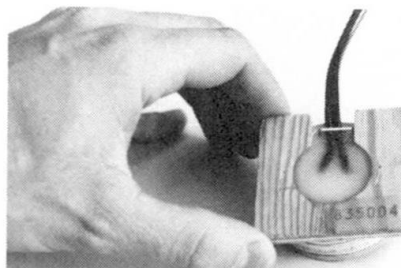
Fig. 2 Moisture-measuring gauge used in the field investigations. The gauge is built into the roof decking. The electrodes, insulated except at the tips, measure the electrical resistance of the plywood. The thermocouple helps to correct resistance measurements for temperature. By using a relation curve of electrical resistance and moisture content in the measuring gauge, it is possible to determine the moisture ratio in the measuring gauge and thereby the moisture ratio in the roof.

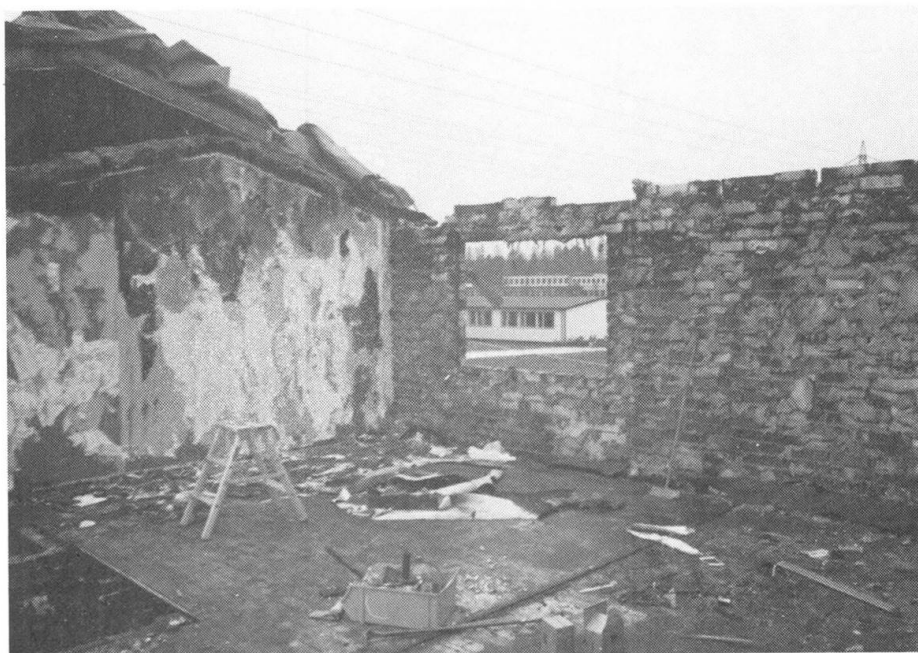
The new method using external additional insulation of flat roofs with the roof ventilation closed off, has also appeared to be efficient in preventing the spread of fire. This was revealed in the autumn of 1984 when there was a fire in one of the investigated housing areas (terraced houses). After the fire, the adjacent houses remained totally intact partially because of the use of this method.
