**Zeitschrift:** IABSE reports = Rapports AIPC = IVBH Berichte  
**Band:** 49 (1986)

**Artikel:** Additional insulation of flat roofs with thin-walled metal structures  
**Autor:** Höglund, Ingemar / Andersson, Patrick  
**DOI:** <https://doi.org/10.5169/seals-38324>

## **Additional Insulation of Flat Roofs with Thin-Walled Metal Structures**

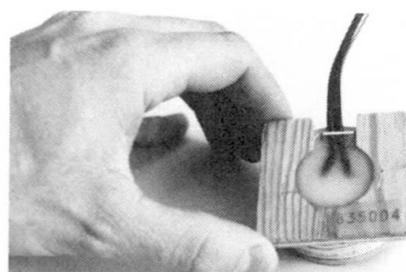
**Fig. 2** Moisture-measuring gauge used in the field investigations. The gauge is built into the roof decking. The electrodes, insulated except at the tips, measure the electrical resistance of the plywood. The thermocouple helps to correct resistance measurements for temperature. By using a relation curve of electrical resistance and moisture content in the measuring gauge, it is possible to determine the moisture ratio in the measuring gauge and thereby the moisture ratio in the roof.

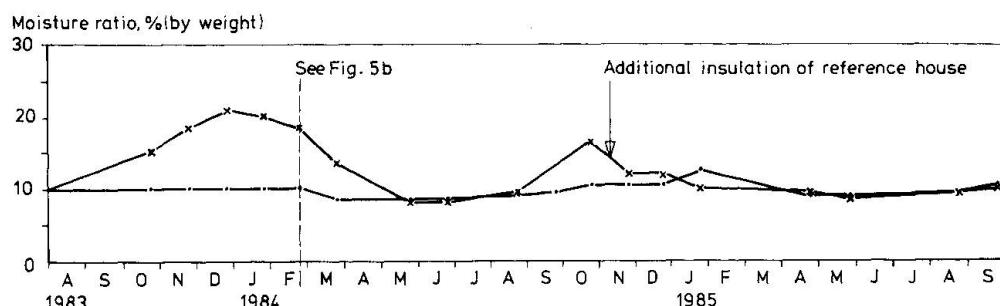
Fig. 5a Example of results. Moisture and temperature measured in three houses at the fibre board. Two houses additionally insulated and instrumented in summer 1983; the third house acted as a reference house and was not insulated until November 1984. During the winter of 1983-84 the effect of these measures could clearly be observed. In the additionally insulated roofs the moisture ratio remained at a low level, c. 10% during the whole period. In the house without additional insulation, however, the moisture ratio rose during the autumn and winter and reached its highest level c. 20% in Dec.-Jan. During the warm spring of -84 the roof dried out and the moisture ratio dropped to about 8%. During the autumn of -84 the moisture ratio rose again, only to drop immediately after the roof was additionally insulated in November -84. Since additional insulation all the roofs have had a low moisture ratio.

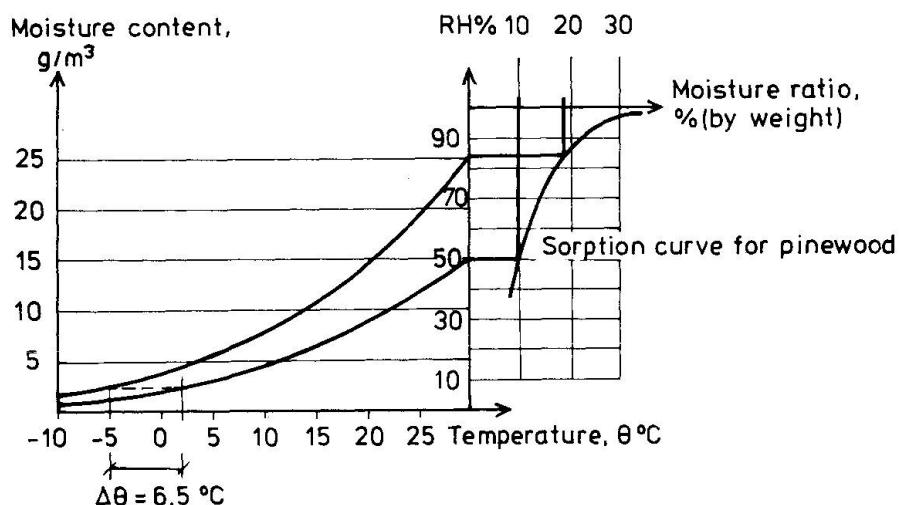
Fig. 5b The measurements in February -84 for the roof without additional insulation showed a moisture ratio of c. 18%, which corresponds to a relative humidity of 85% in the ventilation channel. The temperature in the air space was -5°C. In the additionally insulated roofs the additional insulation resulted in the temperature rising to +1.5°C. With the same vapour content as for the roof without additional insulation this gives a relative humidity of 50% in the air space. This corresponds to a moisture ratio of c. 10%, which agrees with the value obtained (see Fig. 5a). Theory and practice agree nicely.

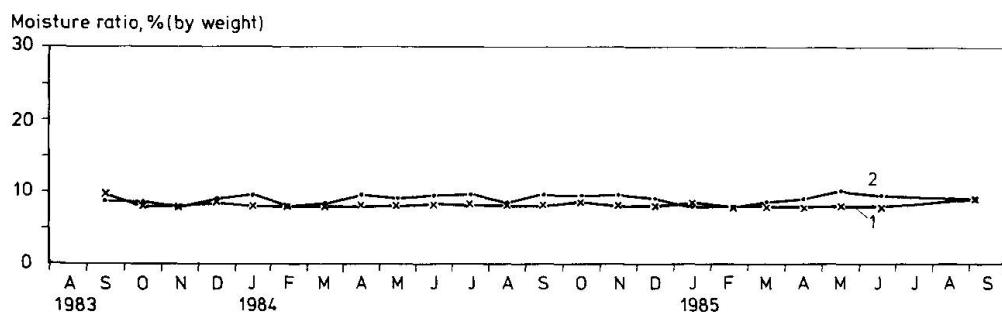
After additional insulation of the roof in spring 1983 dripping from the ceiling stopped and the roof now functions perfectly. Moisture and temperature are measured in the roof to check the moisture content there. See Fig. 8.

**Fig. 8** Example of results. Moisture and temperature are measured both in the air space, line 1 and immediately below the new weatherproof layer, line 2. Since additionally insulating the roof the moisture ratio in the roof has remained for the whole period at a low level, c. 8% in the air space and c. 10% under the new weatherproofing. However, the moisture ratio at one of the measurement points immediately below the new weatherproofing was c. 20%, which indicates that moisture has been enclosed. Moisture is measured by means of built-in moisture-measure gauges; figures refer to the moisture ratio in these rounds.

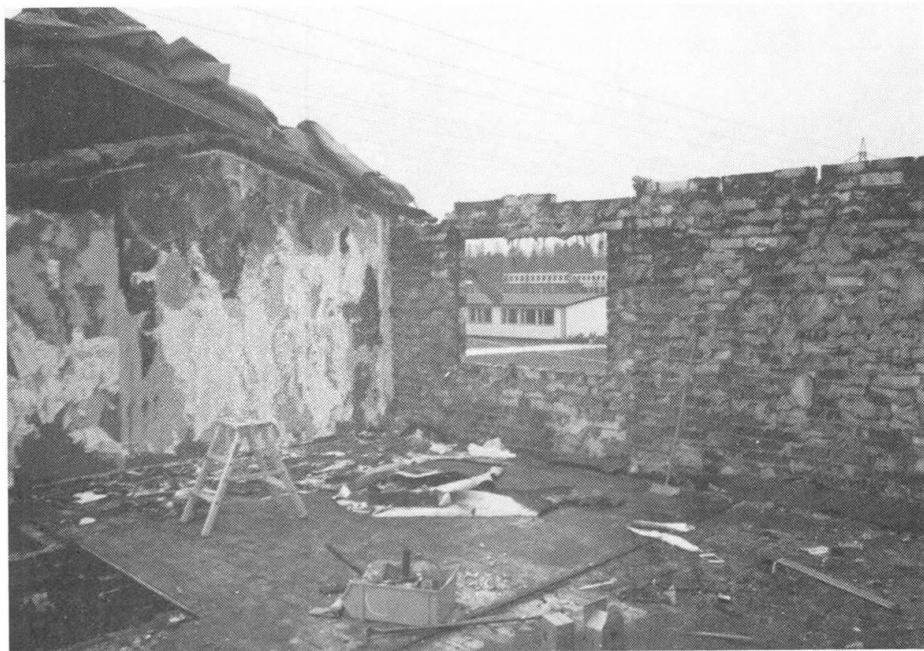
The new method using external additional insulation of flat roofs with the roof ventilation closed off, has also appeared to be efficient in preventing the spread of fire. This was revealed in the autumn of 1984 when there was a fire in one of the investigated housing areas (terraced houses). After the fire, the adjacent houses remained totally intact partially because of the use of this method.
