Zeitschrift: IABSE reports = Rapports AIPC = IVBH Berichte
Band: 57/1/57/2 (1989)

Rubrik: Workshop 3: Durability of suspended structures

Inspection Evaluation, and Rehabilitation of Suspension Bridge Cables

Peter SLUSZKA
Vice President
Steinman
New York, NY, USA

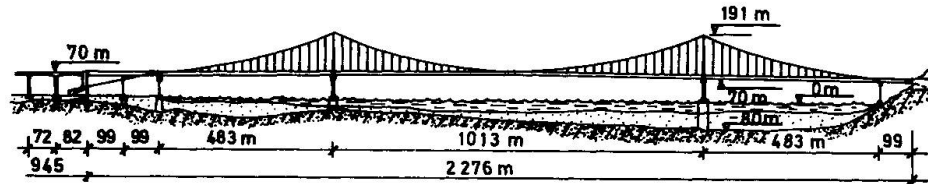
Fig. 1 - LISBON SUSPENSION BRIDGE.

The "25th of April" bridge is a steel structure with a total length of 2276m connected with a concrete approach viaduct (north side) with 945m. The steel structure includes the suspended structure with a 1013m central span and two 483m lateral spans, and a supported continuous stiffened truss with a south end span (99m) and two north end spans (2x99m) (Fig. 1).

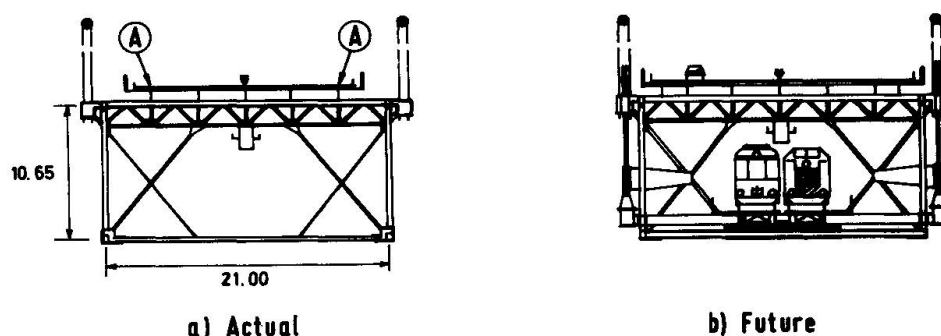
The truss beam is, 10,6m high and 21m wide, suspended from the hangers (23m apart) about 70m above water level. Fig. 2 shows the actual cross section and the future situation with the train. The actual widening design considers the space between the border of the upper deck and the hangers.

Fig. 2 - DECK CROSS SECTION.

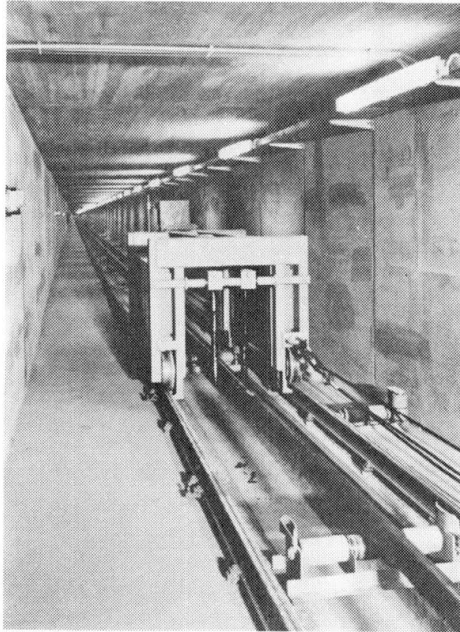
Fig. 4 Seilreckanlage, 400 m lang, mit Einziehwagen, Kuppelwagen im rückwärtigen Teil des Tunnels

Die Seilreckanlage wurde 1970 im Werk Wien als Tunnelreckanlage, vier Meter unter Hüttenflur, errichtet. (Fig.4) Als Besonderheit der Anlage ist hervorzuheben, daß der Reckvorgang zu jeder Zeit bei konstanter Temperatur und unabhängig von den Außenbedingungen erfolgen kann.

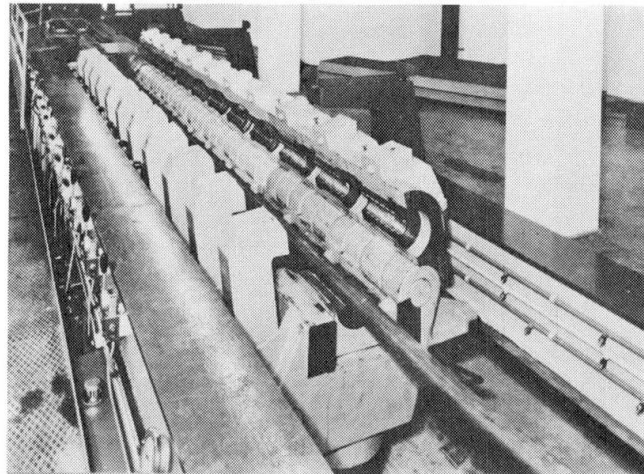
Fig. 5 Klemmenwagen mit elf hydraulisch betätigbaren Klemmbacken

Die Reckkraft wird mittels eines hydraulischen Reckzylinders aufgebracht. Je 12 mit Feinzinklegierung gefutterte Klemmbacken ermöglichen das Recken von Seilen bis zu 100 mm Durchmesser und 40 Tonnen Stückgewicht. Die Krafteinleitung erfolgt über hydraulisch betätigte Klemmbacken. (Fig.5) Dadurch ist es auch möglich, Seile mit einer Länge von mehr als 400 m vorzurecken.

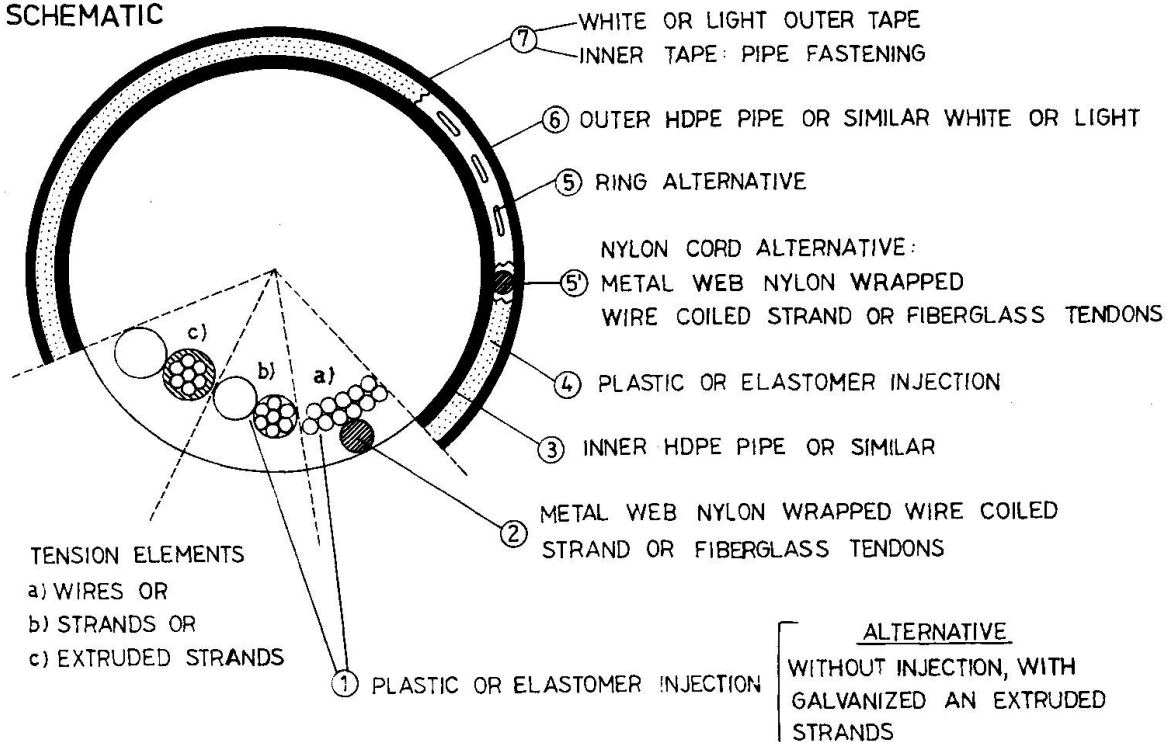
The system proposed (Fig. 1) is composed of a HDPE inner pipe (3) circling the tension elements bundle; another HDPE pipe (6), light or white coloured; an injection between pipes (4) and another injection (1) within the inner pipe (3) both of an elastomeric or plastic material or eventually portland cement with polymers and a two layered wrapping or otherwise only one tape complying with the same purpose. The first helps as a fastener of the whole, and the external one, white or light coloured functions as a protection against UV rays, IR radiation, oxygen and ozone and as a temperature reducer. Also, if vibration produced in the cable by the wind are expected to be significant, it is advisable that external side of the wrapping be corrugated, scarified, ribbed or creased in such a direction that once in place it shows an aerodynamically oriented pattern for dissipating the vibratory energy.

Fig. 1 - Cross section of the proposed cable and alternatives

The spacing between pipes may be obtained with rings (5) perforated for the injection to get through and welded to the inner pipe only but in contact with the outer pipe, without adherence, with the object of allowing the longitudinal movement of the protection top part. The adhesion of the ring, that may be made of any suitable plastic material, can be achieved by the plastic welding update techniques developed nowadays. Though the polyethylene thermal stability makes brief heating possible near the softening point without causing any trouble -provided that it does not occur simultaneously with mechanical loads- if it is desirable to avoid a certain temperature range, a metal web nylon wrapped wire coiled strand (5') may be used over the pipe (or fiberglass tendons as those used for posttensioning concrete bridges), similar to the one used to fasten the wire bundle (2) acting also as spacer. This strand (2) helps -together with rings and the other strands (5')- in keeping the cable circularity the objective of which is to prevent additional interferences in future surveying performed by magnetic induction or similar method. If strands are chosen a tension elements (b) and (c) in Fig. 1, care should be taken that the fasteners and or spacers do not damage the HDPE pipe, the steel or the single tape wrappings.
