Zeitschrift: IABSE reports = Rapports AIPC = IVBH Berichte
Band: 57/1/57/2 (1989)

Rubrik: Workshop 3: Durability of suspended structures

Inspection Evaluation, and Rehabilitation of Suspension Bridge Cables

Inspection Program for the Lisbon Suspension Bridge
Programme d'inspection pour le pont suspendu de Lisbonne
Untersuchungsprogramm für die Hängebrücke in Lissabon

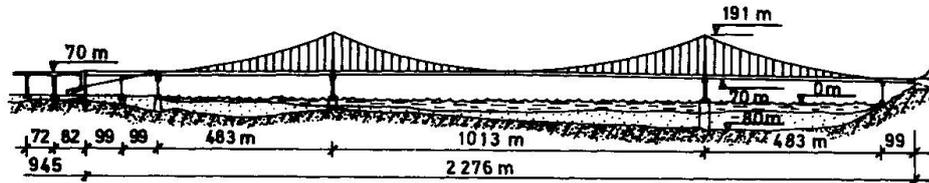
Fig. 1 - LISBON SUSPENSION BRIDGE .

The "25th of April" bridge is a steel structure with a total length of 2276m connected with a concrete approach viaduct (north side) with 945m. The steel structure includes the suspended structure with a 1013m central span and two 483m lateral spans, and a supported continuous stiffened truss with a south end span (99m) and two north end spans (2x99m) (Fig. 1).

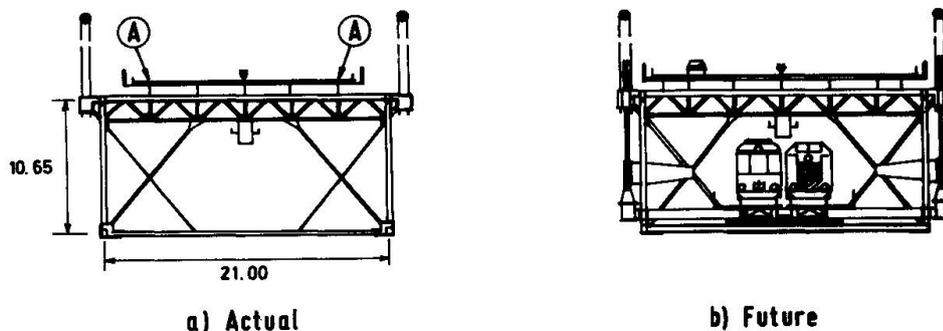
Fig. 2 - DECK CROSS SECTION.

The truss beam is, 10,6m high and 21m wide, suspended from the hangers (23m apart) about 70m above water level. Fig. 2 shows the actual cross section and the future situation with the train. The actual widening design considers the space between the border of the upper deck and the hangers.

At the first stage of the program, the corrosion inspection was implemented. At the columns only superficial corrosion was found, mostly at the interior of the base section. The concrete caissons were also observed and filmed under water to check for concrete degradation, but no relevant findings were obtained. At the cables hangers and cable bands, and with an external observation, only small spots of superficial corrosion were found. Due to the good external condition, an internal observation with electromagnetic techniques was not considered necessary at this stage. All the bars of the deck truss were also inspected and plots of the superficial corrosion along the bridge were drawn for each element (Fig. 3). Structural damage by corrosion was found only in a few nuts of the bolted connections which presented section reductions of more than 20%. It is estimated that about 2% of the deck bolts will need to be replaced shortly. During deck inspection some transversal bars located over the longitudinal girders (shown in Fig. 2 by A). It is estimated that 13% of the total number present this problems.

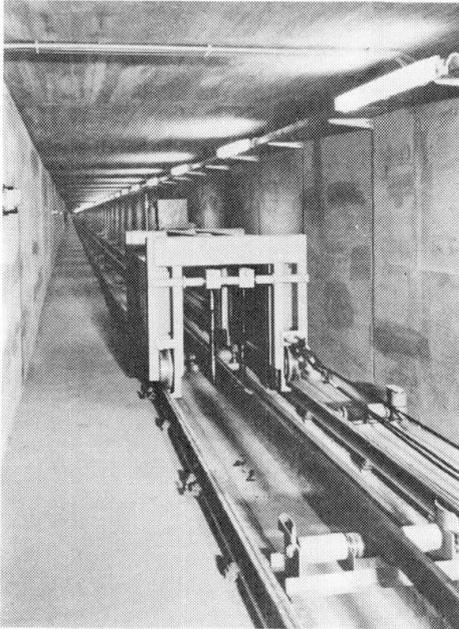
Nach dem Einsetzen der Seilköpfe in den Kuppelwagen (Fig.4) und in den Klemmenwagen (Fig.5) wurde eine Last von 1430 kN, das sind 30 % der rechnerischen Seilbruchlast, aufgebracht. Mittels Einrichtung zur Konstanthaltung konnte die Belastung des Seiles während der Sanierung der beiden Drahtbrüche auf gleichem Niveau gehalten werden.

Fig. 4 Seilreckanlage, 400 m lang, mit Einziehwagen, Kuppelwagen im rückwärtigen Teil des Tunnels

Die Seilreckanlage wurde 1970 im Werk Wien als Tunnelreckanlage, vier Meter unter Hüttenflur, errichtet. (Fig.4) Als Besonderheit der Anlage ist hervorzuheben, daß der Reckvorgang zu jeder Zeit bei konstanter Temperatur und unabhängig von den Außenbedingungen erfolgen kann.

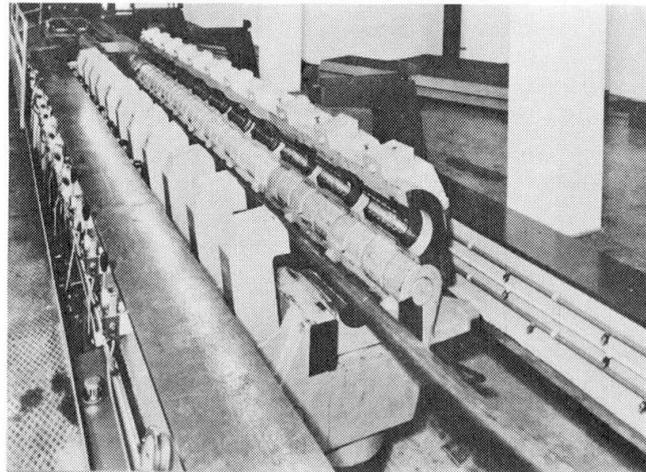
Fig. 5 Klemmenwagen mit elf hydraulisch betätigbaren Klemmbacken

Die Reckkraft wird mittels eines hydraulischen Reckzylinders aufgebracht. Je 12 mit Feinzinklegierung gefutterte Klemmbacken ermöglichen das Recken von Seilen bis zu 100 mm Durchmesser und 40 Tonnen Stückgewicht. Die Krafteinleitung erfolgt über hydraulisch betätigte Klemmbacken. (Fig.5) Dadurch ist es auch möglich, Seile mit einer Länge von mehr als 400 m vorzurecken.

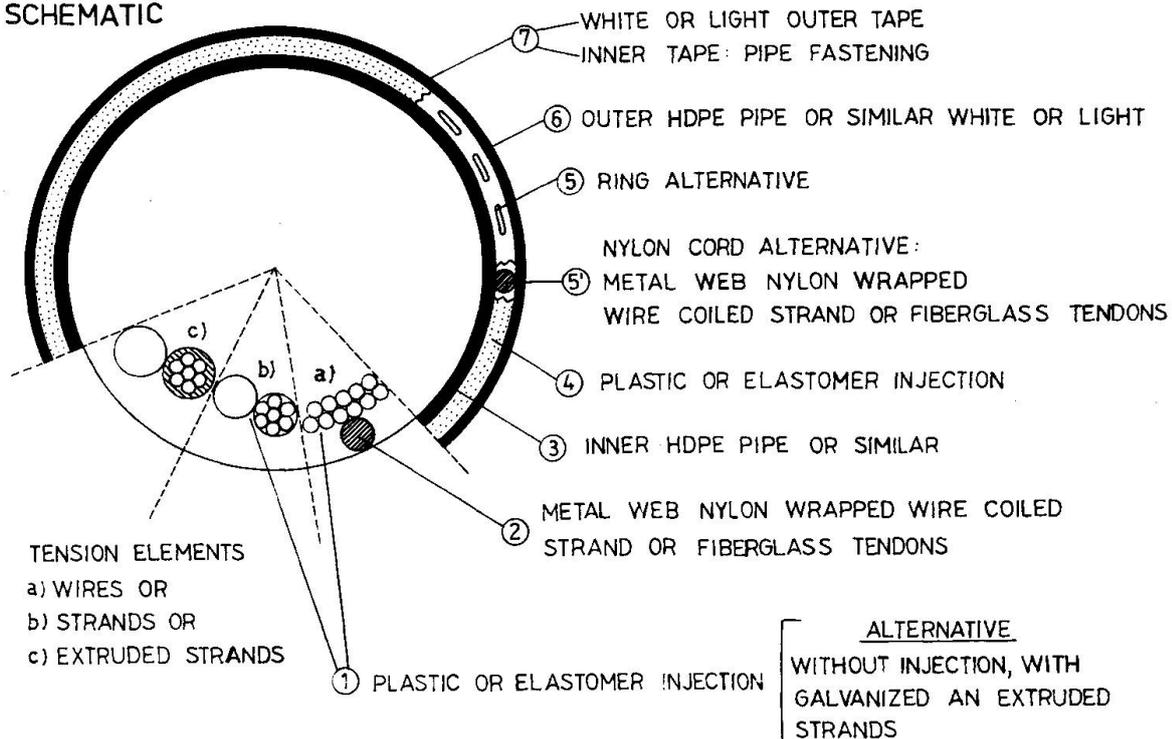
Fig. 1 - Cross section of the proposed cable and alternatives

The system proposed (Fig. 1) is composed of a HDPE inner pipe (3) circling the tension elements bundle; another HDPE pipe (6), light or white coloured; an injection between pipes (4) and another injection (1) within the inner pipe (3) both of an elastomeric or plastic material or eventually portland cement with polymers and a two layered wrapping or otherwise only one tape complying with the same purpose. The first helps as a fastener of the whole, and the external one, white or light coloured functions as a protection against UV rays, IR radiation, oxygen and ozone and as a temperature reducer. Also, if vibration produced in the cable by the wind are expected to be significant, it is advisable that external side of the wrapping be corrugated, scarified, ribbed or creased in such a direction that once in place it shows an aerodynamically oriented pattern for dissipating the vibratory energy.

The spacing between pipes may be obtained with rings (5) perforated for the injection to get through and welded to the inner pipe only but in contact with the outer pipe, without adherence, with the object of allowing the longitudinal movement of the protection top part. The adhesion of the ring, that may be made of any suitable plastic material, can be achieved by the plastic welding update techniques developed nowadays. Though the polyethylene thermal stability makes brief heating possible near the softening point without causing any trouble -provided that it does not occur simultaneously with mechanical loads- if it is desirable to avoid a certain temperature range, a metal web nylon wrapped wire coiled strand (5') may be used over the pipe (or fiberglass tendons as those used for posttensioning concrete bridges), similar to the one used to fasten the wire bundle (2) acting also as spacer. This strand (2) helps -together with rings and the other strands (5')- in keeping the cable circularity the objective of which is to prevent additional interferences in future surveying performed by magnetic induction or similar method. If strands are chosen a tension elements (b) and (c) in Fig. 1, care should be taken that the fasteners and or spacers do not damage the HDPE pipe, the steel or the single tape wrappings.
