Extending the Life of the Williamsburg Bridge

William F. GEYER
Partner
Steinman
New York, NY, USA

The decision to close the Williamsburg Bridge sent shock waves through transportation in New York City and brought the Williamsburg Bridge out from the shadows of the Brooklyn Bridge. The program to determine the present condition and the projected durability of the structure for possible rehabilitation rather than replacement is the subject of this paper.

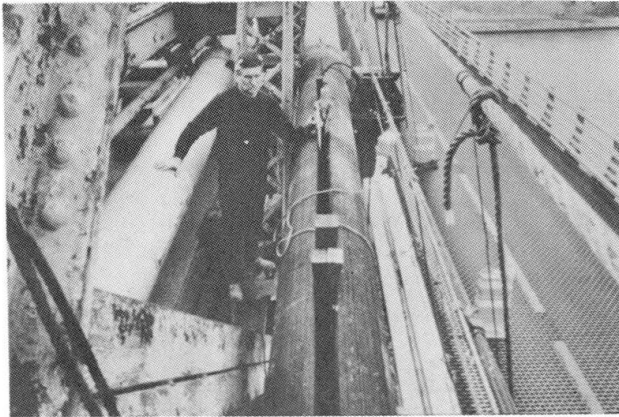
Fig. 6 Hydraulic Jack

The procedure was to open a groove in the cable using wooden wedges and hydraulic jacks, visually inspect and take macro lens photographs, extract, coil and tag the sample for shipment to the laboratory. As the wire was cut the retraction of the wire was measured. The groove opening was then cleaned using a soft wire wheel brush or a cup wire brush. Samples of the corrosion and existing lubricant were then collected and sent to the laboratory for analysis. After cleaning photographs of the wire were taken at five foot intervals. One coat of protective oil (Vitalife 400) was then applied in the groove opening. After this procedure was completed at the eight groove openings, additional protective oil was applied liberally into the cable at that work location. The cable was then wrapped with Herculite and the inspection proceeded to the next work location.
