Artikel: Extending the life of the Williamsburg Bridge
Autor: Geyer, William F.
DOI: <https://doi.org/10.5169/seals-44252>

Extending the Life of the Williamsburg Bridge
Prolongation de la durée de vie du pont de Williamsburg
Verlängerung der Lebensdauer der Williamsburg-Brücke

William F. GEYER
Partner
Steinman
New York, NY, USA

The decision to close the Williamsburg Bridge sent shock waves through transportation in New York City and brought the Williamsburg Bridge out from the shadows of the Brooklyn Bridge. The program to determine the present condition and the projected durability of the structure for possible rehabilitation rather than replacement is the subject of this paper.

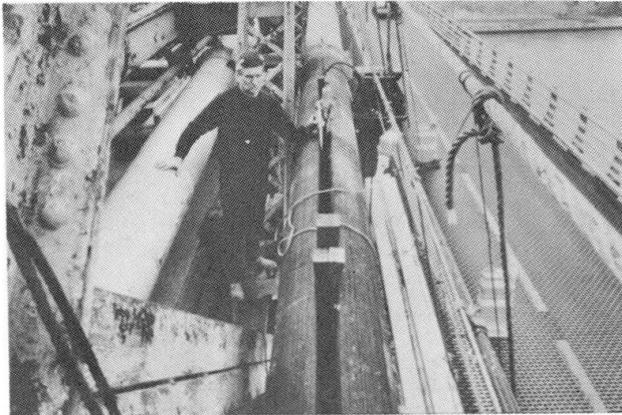
Fig. 6 Hydraulic Jack

The procedure was to open a groove in the cable using wooden wedges and hydraulic jacks, visually inspect and take macro lens photographs, extract, coil and tag the sample for shipment to the laboratory. As the wire was cut the retraction of the wire was measured. The groove opening was then cleaned using a soft wire wheel brush or a cup wire brush. Samples of the corrosion and existing lubricant were then collected and sent to the laboratory for analysis. After cleaning photographs of the wire were taken at five foot intervals. One coat of protective oil (Vitalife 400) was then applied in the groove opening. After this procedure was completed at the eight groove openings, additional protective oil was applied liberally into the cable at that work location. The cable was then wrapped with Herculite and the inspection proceeded to the next work location.
