Zeitschrift: IABSE reports = Rapports AIPC = IVBH Berichte

Band: 57/1/57/2 (1989)

Rubrik: Presentation Session 4a: Case studies

Causes of Damages and Rehabilitation of the Pancevo Bridge

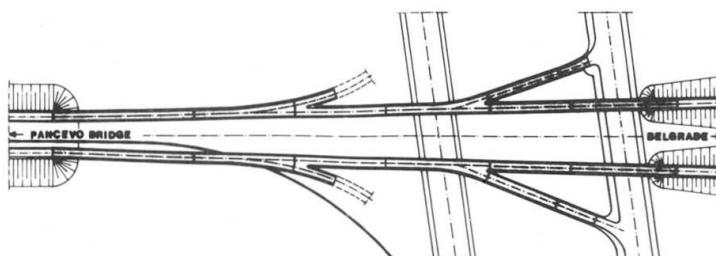
Fig. 1 - The lay-out of the access bridges

Access parts of the Pancevo bridge across the river Danube in Belgrade had been made at the beginning of 1960s. They were among the first prestressed concrete bridge structures in Yugoslavia. The total length of 1.269 m is divided to 16 independent bridge structures interconnected by expansion joints, Fig. 1.

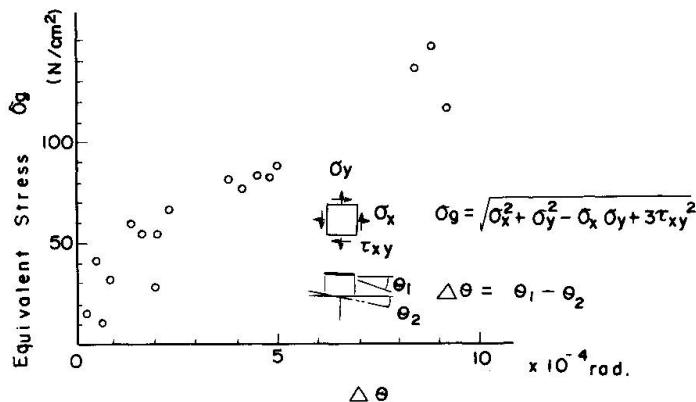
Fig. 4 Relation between σ_g and $\Delta\theta$

From Phase-1 analysis, it was concluded there is a close correlation between the equivalent stress at the connection plate and the rotational difference between the slab and the cross beam as shown in Fig. 4.

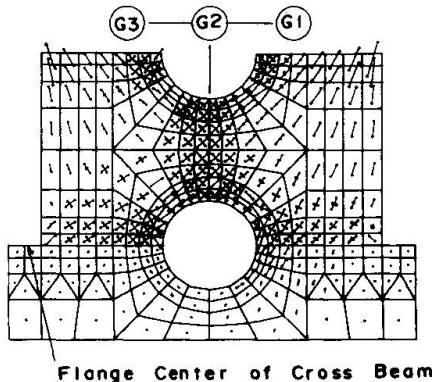
Fig. 5 Principal Stress Diagram

-1) The Principal stress over 200 N/cm² is detected on the connection plate adjacent to the free edge of the top flange of the main girder. Due to shearing stress, the principal stress direction vary significantly as it comes closer to the web as shown in Fig. 5.

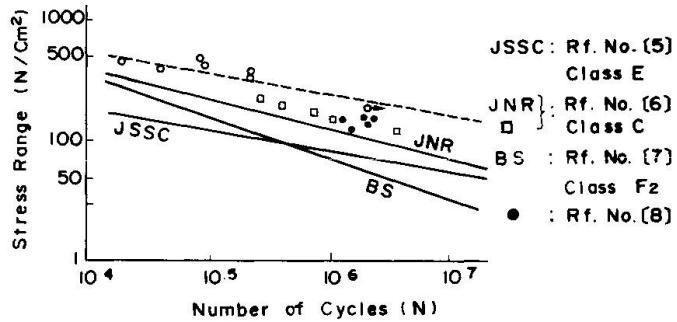
Fig. 10 Fatigue Test Result

A series of the fatigue test was summarized as S-N relation in Fig. 10. The dotted line shows the S-N line given by the least square method. The slope is,

Assuming that the bridges showed the defects are estimated to have experienced stress amplitude of 80 N/cm^2 for the past 14 years, we may conclude that bridges designed by new specification can sustain more than $(80/25)^{5.4}$

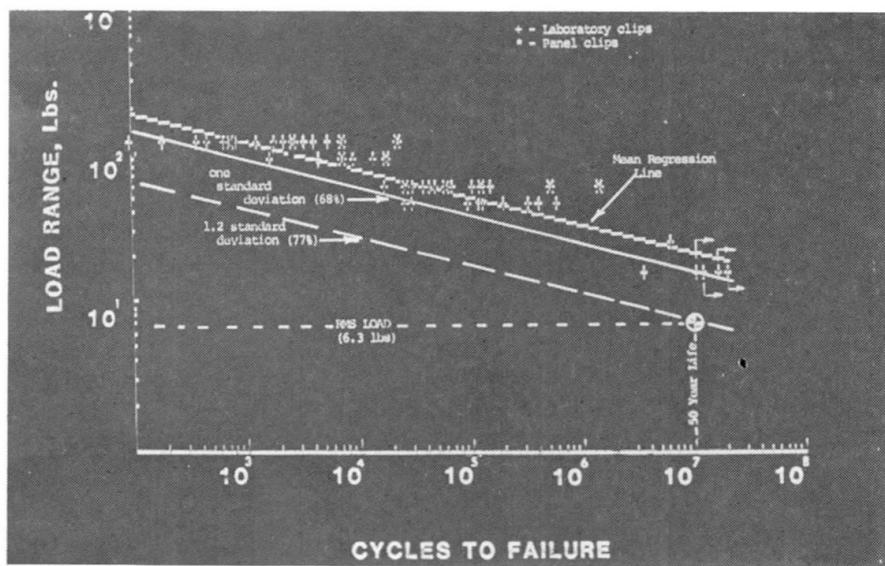
FIG. 2 Load vs. cycles to failure

In order to determine the expected fatigue life of existing panel clips, constant-amplitude cyclic testing of numerous panel clips was performed. These panel clips consisted of existing clips removed from the building, and also new clips fabricated with "imperfect" weldments simulating the existing weldments in the building. The test results were plotted to obtain a "load vs. cycles-to-failure" curve for the clips (Fig. 2).

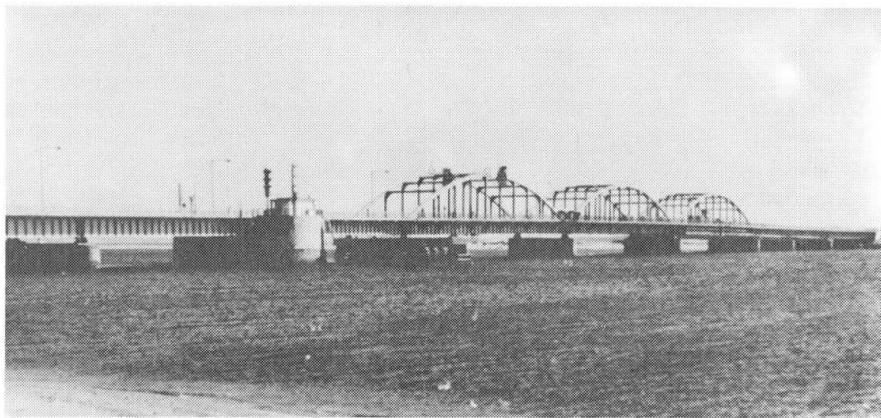
Fig. 1

The combined road and railway bridge over Oddesund was built in the period 1934-37. Fig. 1.

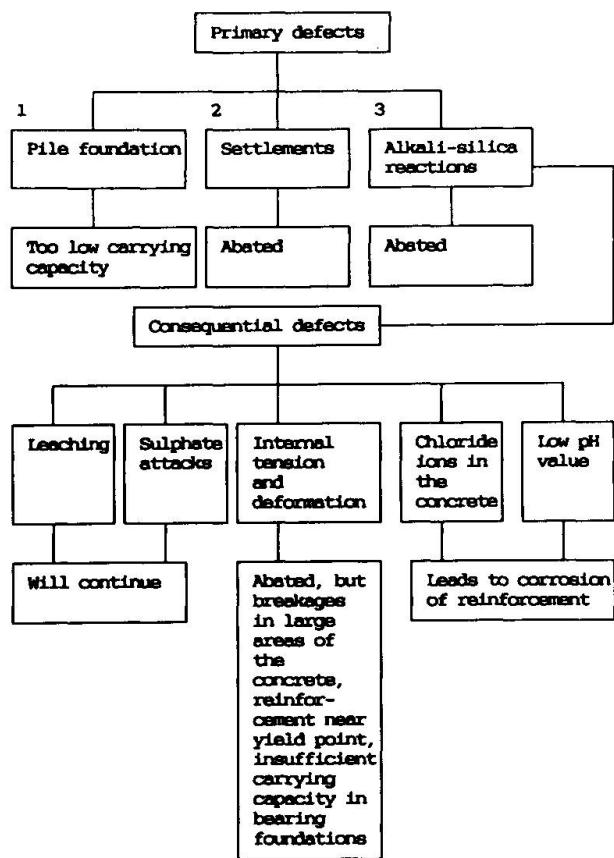
Registration of the condition of the pier was carried out as well as evaluation of its carrying capacity and structure, and the history of the defects was clarified. The history of the defects appears from the outline below.

The defects can be divided into three "primary defects":

1. The carrying capacity of the pile foundation is too low, especially with regard to the ability to absorb impacts from ships and the load of ice.
2. The pier has settled towards the channel and towards the west owing to different foundation conditions and different pile point levels, but the settlements have now abated, and the consequential damage has been repaired.
3. The concrete of the bascule pier structure is heavily affected by alkali-silica reactions resulting in expansion and differential expansions. As a consequence of this the concrete has become severely cracked, and changes in the original geometrical form of the bascule pier have occurred.

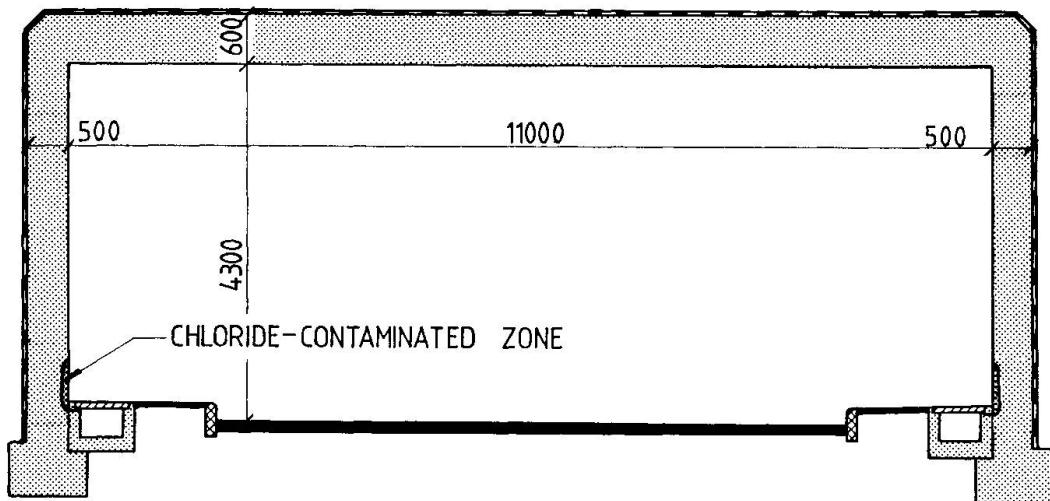
Fig. 1 Cross Section of Tunnel

The tunnel is administered by the Road Directorate and during periodic inspections it was found that the lower parts of the walls showed signs of reinforcement corrosion.
