**Zeitschrift:** IABSE reports = Rapports AIPC = IVBH Berichte  
**Band:** 57/1/57/2 (1989)

**Rubrik:** Presentation Session 4a: Case studies

## Zweckässigkeit und Umfang von Instandsetzungen

## Causes of Damages and Rehabilitation of the Pancevo Bridge

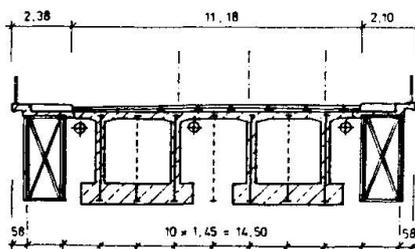
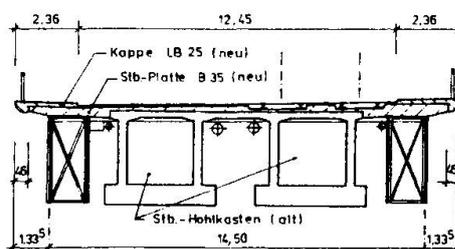
**Bild 3:** Obermainbrücke in Frankfurt a.M.

Diese Brücke über den Main mit 5 Bögen von i.M. 35 m Spannweite war 1878 zunächst als Stahlfachwerkbrücke mit 11 nebeneinanderliegenden Trägern ausgeführt worden. Nach dem Krieg wurde der mittlere Teil im Bereich der Fahrbahn zur Erhöhung der Tragfähigkeit durch eine Stahlbetonkonstruktion ersetzt. Hierbei wurden die Stahlfachwerke z.T. in die Konstruktion integriert. Während der Bauzustände bildeten sie das Traggerüst für die Betonierlast. Im Randbereich unter den Gehwegen blieben die stählernen Fachwerke erhalten (s. Bild 3).

Dieses Bauwerk wies stärkere Schäden im Bereich der Fahrbahnplatte auf, die alle von Undichtigkeiten an den zahlreichen Fugen herrührten. An jedem Pfeiler waren 2 Querfugen und zwischen Massivteil und Stahlfachwerk war jeweils eine Längsfuge über die gesamte Bauwerkslänge vorhanden.

Das Instandsetzungskonzept sollte nicht nur zu einer Behebung der aufgetretenen Schäden, sondern auch zu einer weitgehenden Eliminierung der Schwachpunkte führen. Zusätzlich sollte in der Vorplanung untersucht werden, ob nicht eine Verbreiterung der Fahrbahnplatte um ca. 1,50 m möglich sei, damit drei vollwertige Fahrstreifen gewonnen werden können.

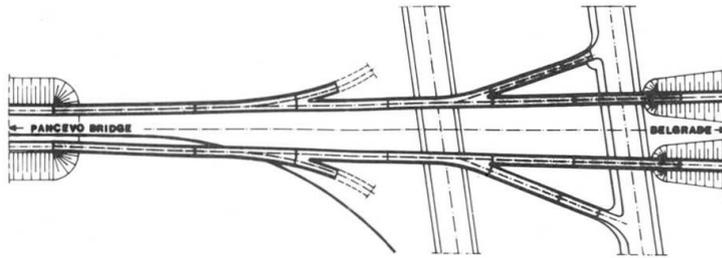
Fig. 1 - The lay-out of the access bridges

Access parts of the Pancevo bridge across the river Danube in Belgrade had been made at the beginning of 1960s. They were among the first prestressed concrete bridge structures in Yugoslavia. The total length of 1.269 m is divided to 16 independent bridge structures interconnected by expansion joints, Fig. 1.

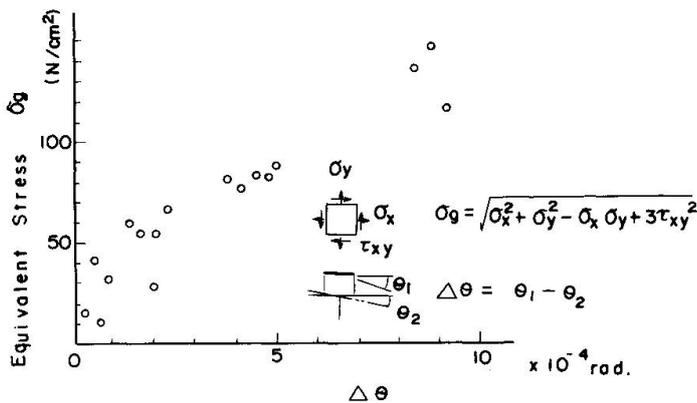
Fig. 4 Relation between  $\sigma_g$  and  $\Delta\theta$

From Phase-1 analysis, it was concluded there is a close correlation between the equivalent stress at the connection plate and the rotational difference between the slab and the cross beam as shown in Fig. 4.

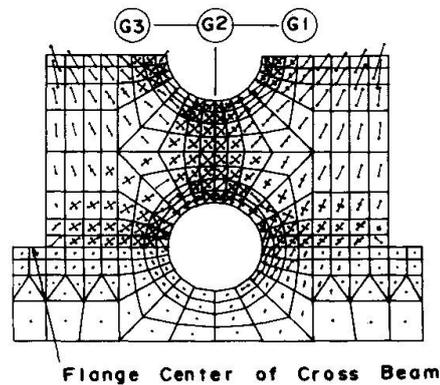
Fig. 5 Principal Stress Diagram

- 1) The Principal stress over 200 N/cm<sup>2</sup> is detected on the connection plate adjacent to the free edge of the top flange of the main girder. Due to shearing stress, the principal stress direction vary significantly as it comes closer to the web as shown in Fig. 5.
- 2) There is a stress turbulence due to scallop.

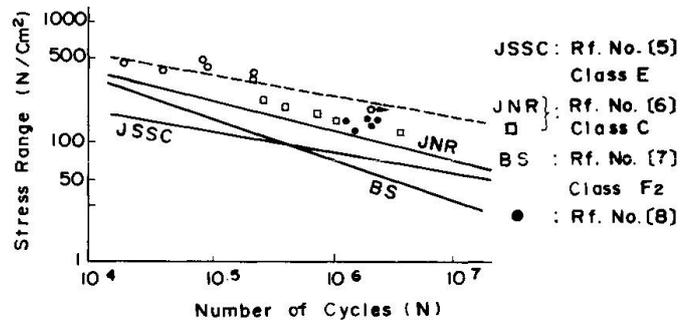
Fig. 10 Fatigue Test Result

The similar fatigue test as 3.3 was also performed for the structure designed by applying new specification. No cracks were detected. A series of the fatigue test was summarized as S-N relation in Fig. 10. The dotted line shows the S-N line given by the least square method. The slope is,

Assuming that the bridges showed the defects are estimated to have experienced stress amplitude of 80 N/cm<sup>2</sup> for the past 14 years, we may conclude that bridges designed by new specification can sustain more than  $(80/25)^{5.4} \times 14$  years.

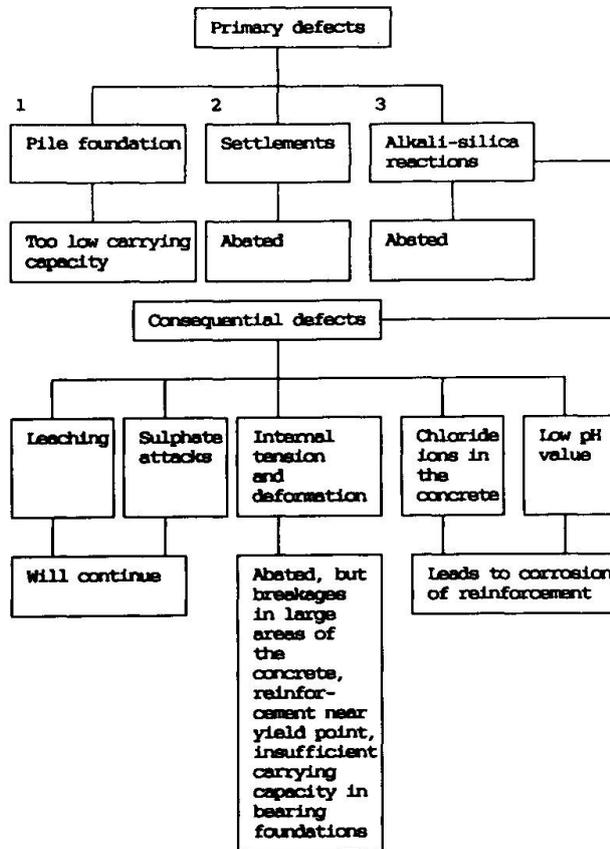
Registration of the condition of the pier was carried out as well as evaluation of its carrying capacity and structure, and the history of the defects was clarified. The history of the defects appears from the outline below.

The defects can be divided into three "primary defects":

1. The carrying capacity of the pile foundation is too low, especially with regard to the ability to absorb impacts from ships and the load of ice.
2. The pier has settled towards the channel and towards the west owing to different foundation conditions and different pile point levels, but the settlements have now abated, and the consequential damage has been repaired.
3. The concrete of the bascule pier structure is heavily affected by alkali-silica reactions resulting in expansion and differential expansions. As a consequence of this the concrete has become severely cracked, and changes in the original geometrical form of the bascule pier have occurred.

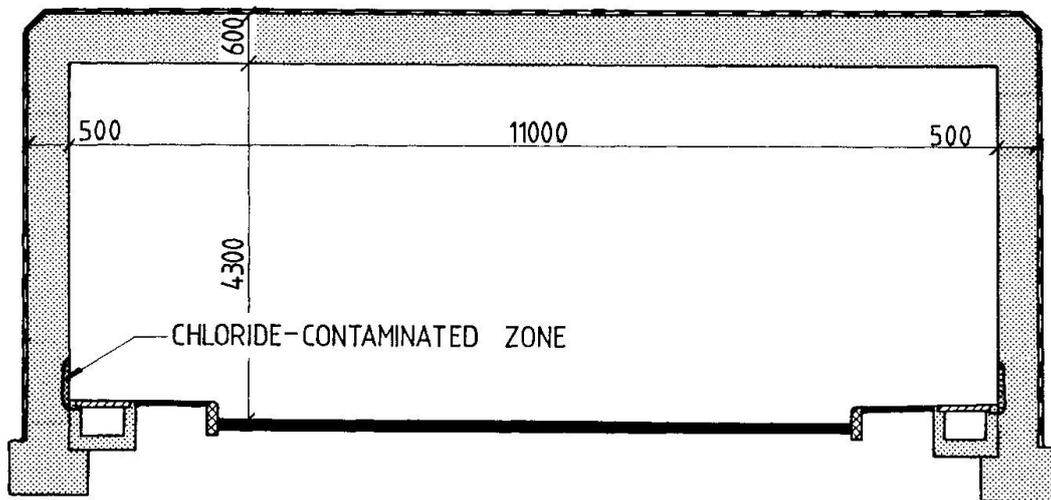
Fig. 1 Cross Section of Tunnel

The tunnel is administered by the Road Directorate and during periodic inspections it was found that the lower parts of the walls showed signs of reinforcement corrosion.

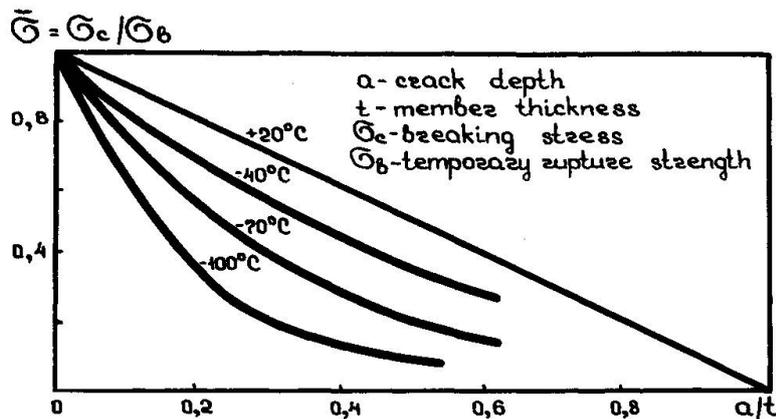
**Fig. 1** Fracture curves for the specimens with surface cracks in the near-weld zone of the welded joint

out using a critical stress intensity factor  $K_c$  as a strength criterion for the weld metal. The above-mentioned margins of the critical stress intensity factors and crack lengths are ensured at max. working internal pressure up to 1,2 MPa and climate temperatures up to  $-25^\circ\text{C}$ . At lowering the temperature to  $-40^\circ\text{C}$  the working pressure in the gas-holder should also be lowered to 0.8 MPa in order to ensure the corresponding crack resistance margins.

The results obtained were used at the evaluation of the gas-holder useful life, considering cracks dimensions in the shell.

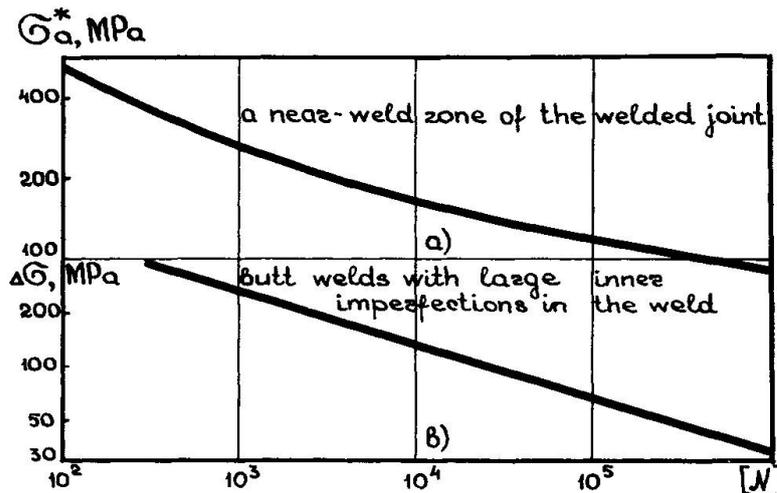
At the evaluation of the useful life based on the criterion of surface cracks development the design fatigue curve found on the basis of the experimental data was used, which connected the amplitude of local stresses  $\sigma_a^*$  in the zones of structural and the admissible number of stresses  $[N]$ ; the safety factors for stresses  $n_\sigma$  and durability  $n_N$  being equal to 1.25 and 3.0, respectively (Fig. 2a).

At calculation of the useful life according to the criteria of a shell depressurization the fatigue curve was used (Fig. 2b), which characterized the relationship of the admissible number of the loading cycles to the range of nominal stresses in the structure  $\Delta\sigma$  and corresponding to the lower envelope of the experimental data according to the moment of through cracks development in ball gas-holders, as well as models of welded joints with the similar weld imperfections at the above-mentioned safety factors according to stresses and durability.

**Fig. 2** Fatigue curves for the evaluation of the useful life: a) according to the criterion of surface cracks development, b) according to the criterion of the shell depressurization

The calculation of the useful life was also carried out on the basis of the rule of linear summation of damages without taking into account those amplitudes of nominal stresses at which fatigue cracks had no growth; the largest imperfection found at a random ultrasonic non-destructive testing in one of the gas-holders (lack of penetration of 450x8 mm size) being taken as an initial imperfection. As a result, it was found out that the useful life of a battery of ball gas-holders according to the criterion of the shell depressurization caused by fatigue cracks development from long inner defects in butt field welded joints was 34 years.

In such a way, the factor limiting the structure useful life was the presence of long inner defects in butt welded joints, the elimination of these defects would increase the durability of ball gas-holders up to 44 years.
