**Artikel:** Causes of damages and rehabilitation of the Pancevo Bridge

**Autor:** Pakvor, Aleksandar / Djurdjevi, Mihajlo

## Causes of Damages and Rehabilitation of the Pancevo Bridge

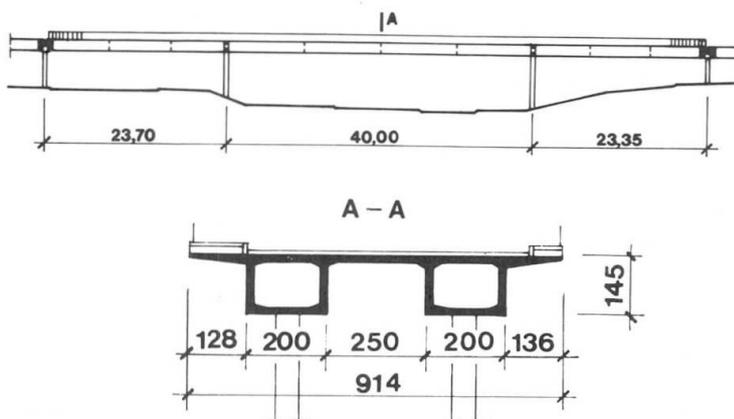
Fig. 2 - Disposition of a bridge

The structures are continuous frames with two, three or five fields, of the span ranging between 20 and 40 m, with slender posts. The width of the bridges is  $(1.50+7.00+0.80)$  m with two carriage-ways to the same direction. The cross section is the constant height box of 1.45 m, Fig. 2.
