Zeitschrift:	IABSE reports = Rapports AIPC = IVBH Berichte
Band:	57/1/57/2 (1989)
Artikel:	Causes of damages and rehabilitation of the Pancevo Bridge
Autor:	Pakvor, Aleksandar / Djurdjevi, Mihajlo
DOI:	https://doi.org/10.5169/seals-44282

Causes of Damages and Rehabilitation of the Pancevo Bridge

Aleksandar PAKVOR Professor, Dr. Sc.

Mihajlo DJURDJEVIĆ Research Assist., Mr. Sc. University of Belgrade Belgrade, Yugoslavia

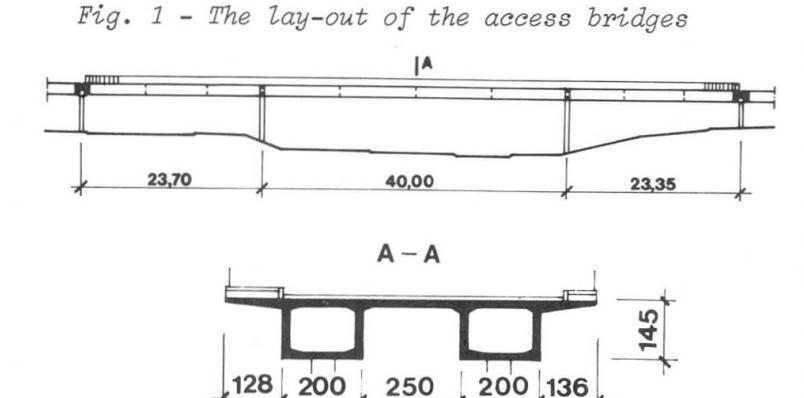
Fig. 2 - Disposition of a bridge

The structures are continuous frames with two, three of five fields, of the span ranging between 20 and 40 m, with slender posts. The width of the bridges is (1.50+7.00+ 0.80) m with two carriageways to the same direction. The cross section is the constant height box of 1.45 m, Fig. 2.
