**Artikel:** Repair of fatigue-cracked plate girders in highway bridges  
**Autor:** Nishimura, Akira / Horikawa, Kohsuke / Takayama, Hiromi  
**DOI:** <https://doi.org/10.5169/seals-44284>

**Repair of Fatigue-Cracked Plate Girders in Highway Bridges**  
**Réparation de poutres métalliques de ponts ayant des fissures de fatigue**  
**Reparatur von Blechträgern mit Ermüdungsrissen in Brücken**

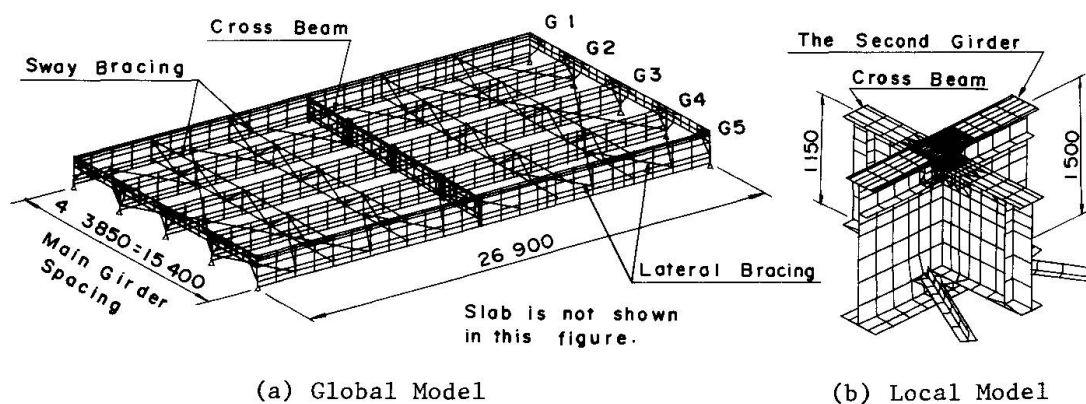
Fig. 2 Analysis Model

Finite Element Method was used to analyze stress distribution and its value. Phase-1 analysis was made on coarse three dimensional model shown in Fig. 2(a) to assess the global stress flow. A 20-ton-truck load, designated as T-20 loading in design specification [1](Fig. 3), was placed in the longitudinal

direction, two in the transverse direction so that those cause the most severe stress distribution at the place of concern. To make a detail investigation of stress distribution, Phase-2 analysis was made on a partial three dimensional model shown in Fig. 2(b) by applying the sectional force given by the Phase-1 analysis.

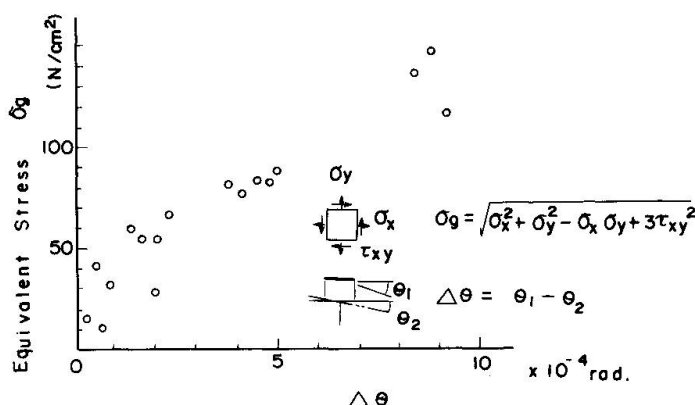
Fig. 4 Relation between  $\sigma_g$  and  $\Delta\theta$

From Phase-1 analysis, it was concluded there is a close correlation between the equivalent stress at the connection plate and the rotational difference between the slab and the cross beam as shown in Fig. 4.
