Artikel: Repair of chloride-contaminated concrete walls in a tunnel
Autor: Andersen, Ole Viggo / Thomsen, Jens Vejlbj / Sørensen, Egon A.
DOI: <https://doi.org/10.5169/seals-44287>

Repair of Chloride-Contaminated Concrete Walls in a Tunnel

The tunnel is situated in the northern suburbs of Copenhagen, and leads the southbound road traffic on Bernstorffsvej under and into Lyngbyvej - the motorway which is the main road link between Copenhagen and Elsinore.

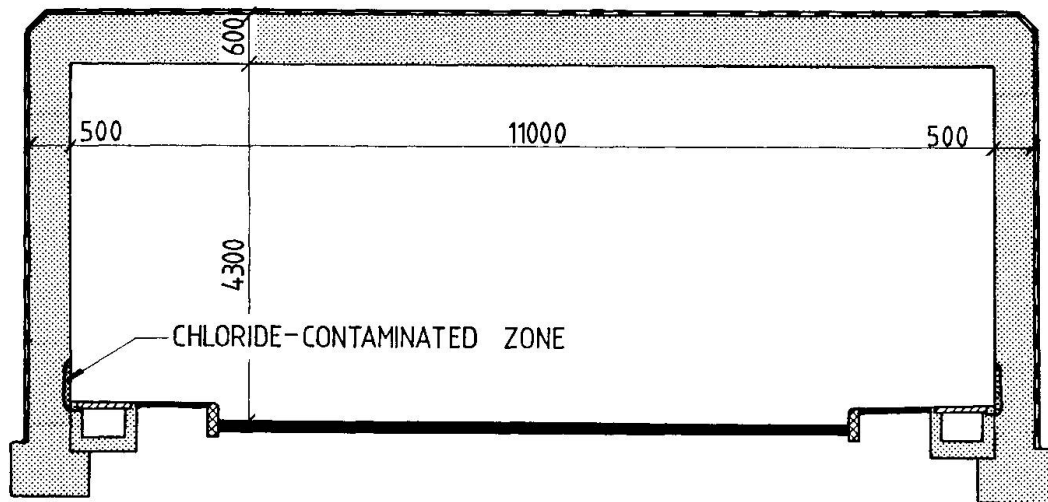
Fig. 1 Cross Section of Tunnel

The tunnel was built in 1969 and is about 180 m long and 11 m wide, including two 1.75 m wide emergency and service footways and a 7.5 m wide dual traffic lane for one-way traffic. The reinforced concrete cast-in-situ walls are 0.5 m thick, shown in Fig. 1.
