Artikel: Vibration fatigue of steel bridges of the bullet train system

Autor: Sakamoto, Kenji / Miki, Chitoshi / Ichikawa, Atushi

Vibration Fatigue of Steel Bridges of the Bullet Train System

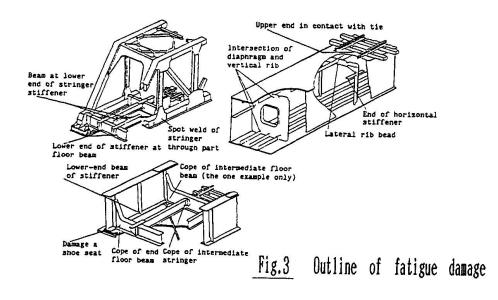
damage have been observed as shown in fig.3. No fatigue damage due to low fatigue strength has not observed in main members where fatigue was assessed in the design stage. However, fatigue cracks which are the result of secondary stresses and displacement induced stresses are often discovered in such various structural elements as girder webs, stringer webs, floor beam webs, side walks, connections of attached facilities and diaphragms. One of these fatigue crackings which occurs relatively frequently and whose cause has not been made much clear is a fatigue crack which occurs on a web plate at the lower end of a siffener (hereinafter referred to as the "lower end of a stiffener"). This fatigue cracks is in parallel with the lower flange.

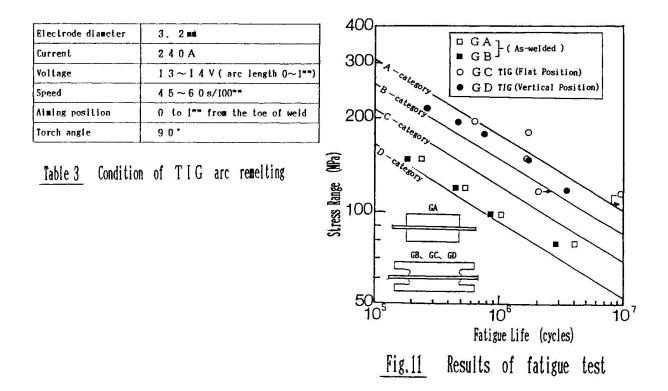
Repair of the Lower end of a stiffener by TIG arc remelting is required to be conducted, while ensuring that the form of the toe of a fillet weld will be smooth and that penetration will be deep enough to fuse slight fatigue cracks which occur at the toe and is visually undiscoverable. The appearance of the bead under various application conditions and the amount of fusion in the boxing-welded portion were investigated. As a result, it was found that under the conditions as shown in Table 3 fusion was about 2mm in the case of stand-up position and the shape of the bead was in good condition. It was also found that confirmation of the position of a crack is necessary in carrying out the work because there is the possibility of a gap occurring between the position of the maximum fusion by the TIG dressing and the position of a crack.

As a countermeasure against these fatigue cracks, it is most effective to stop local horizontal vibrations of lower flange which cause fatique cracks. In some truss bridge stringers, fatique cracks were removed by applying of arc air gouging and rewelded and then an additional plates were installed by highstrength bolts (Fig. 10). In some cases a sway bracing was also Another possible measure is to increase the fatigue strength of the detail. As it is costly to add plates to a slight fatigue crack, it was necessary to consider an economic method for raising fatigue strength. It is advisable to improve the fatigue strength of the toe of a fillet weld and prevent occurrence of additional crack in a part where occurrence of a fatigue crack is not confirmed as a preventive measure. Application of TIG (Tungsten Inert Gas) arc remelting has considered as an effective and economic method for repairing a fatigue crack at the toe of a fillet weld and improving fatigue strength.
