**Artikel:** Vibration fatigue of steel bridges of the bullet train system  
**Autor:** Sakamoto, Kenji / Miki, Chitoshi / Ichikawa, Atushi  
**DOI:** <https://doi.org/10.5169/seals-45713>

## **Vibration Fatigue of Steel Bridges of the Bullet Train System**

### **SUMMARY**

Fatigue cracks caused by out-of-plane vibration were observed in steel bridges of the Tokaido Shinkansen. Crack growth behaviour, measured cyclic stresses, evaluation of fatigue damage, and retrofitting methods are described.

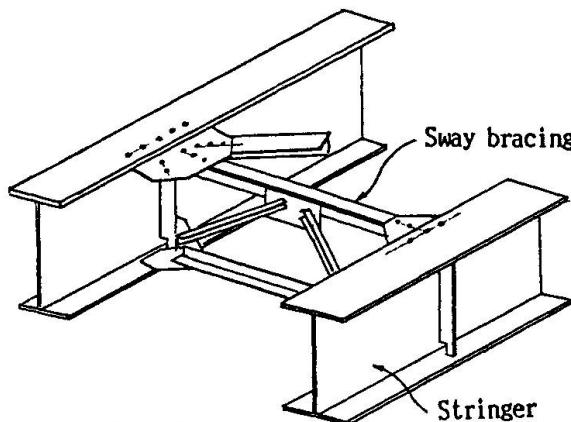
Fig.5 Sway bracing

The stringer of a truss bridge was selected for cyclic stress study. This truss bridge has a standard floor system of the Tokaido Shinkansen whose span is 60 m, and the span of stringers is about 10 m. Measurement was made by comparison concerning whether there are sway bracings (Fig.5) and differences in train speeds. Dynamic strain measurement was conducted by placing strain gauges to the back and surface of the web plate at the lower end of the welded portion. The strain gauges were located 5 to 10 mm away from the lower end of weld toes (Fig. 6) stress records were processed as follows.

As a countermeasure against these fatigue cracks, it is most effective to stop local horizontal vibrations of lower flange which cause fatigue cracks. In some truss bridge stringers, fatigue cracks were removed by applying of arc air gouging and rewelded and then an additional plates were installed by high-strength bolts (Fig. 10). In some cases a sway bracing was also added. Another possible measure is to increase the fatigue strength of the detail. As it is costly to add plates to a slight fatigue crack, it was necessary to consider an economic method for raising fatigue strength. It is advisable to improve the fatigue strength of the toe of a fillet weld and prevent occurrence of additional crack in a part where occurrence of a fatigue crack is not confirmed as a preventive measure. Application of TIG (Tungsten Inert Gas) arc remelting has considered as an effective and economic method for repairing a fatigue crack at the toe of a fillet weld and improving fatigue strength.

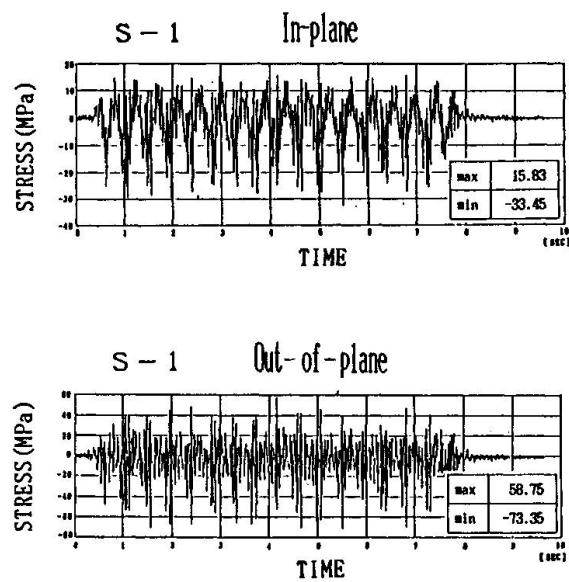
Fig.8 Stress component in In-plane and Out-of-plane of web

Stresses in S-1 is the largest measured value in this structure and its stress waveform exhibits a resonating behavior. However, S-2, the stress waveform of a low-speed train ( $v=178$  km/h) does not produce as large stress as S-1 ( $v=203$  km/h). Therefore, horizontal vibration of the lower flange was induced only by the passage of high speed trains. In order to examine this resonating behavior, a stress was separated into the in-plane component and the out-of-plane component as shown in Fig.8. Its results indicate that the stress at the lower end of the stiffener without sway bracing detail is mainly caused by out-of-plane distortion of the web plate. From this, it seems possible to say that the source of a predominating stress which occurs at the lower end of a stiffener is horizontal vibrations of the lower flange.
