Vibration Fatigue of Steel Bridges of the Bullet Train System

Kenji SAKAMOTO

Fatigue cracks caused by out-of-plane vibration were observed in steel bridges of the Tokaido Shinkansen. Crack growth behaviour, measured cyclic stresses, evaluation of fatigue damage, and retrofitting methods are described.

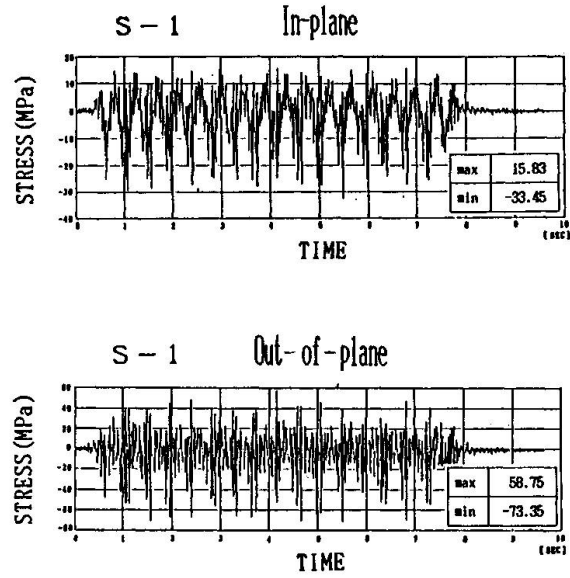
Fig.8 Stress component in In-plane and Out-of-plane of web

Stresses in S-1 is the largest measured value in this structure and its stress waveform exhibits a resonating behavior. However, S-2, the stress waveform of a low-speed train ($v=178$ km/h) does not produce as large stress as S-1 ($v=203$ km/h). Therefore, horizontal vibration of the lower flange was induced only by the passage of high speed trains. In order to examine this resonating behavior, a stress was separated into the in-plane component and the out-of-plane component as shown in Fig. 8. Its results indicate that the stress at the lower end of the stiffener without sway bracing detail is mainly caused by out-of-plane distortion of the web plate. From this, it seems possible to say that the source of a predominating stress which occurs at the lower end of a stiffener is horizontal vibrations of the lower flange.
