# Vibration Fatigue of Steel Bridges of the Bullet Train System

Fatigue cracks caused by out-of-plane vibration were observed in steel bridges of the Tokaido Shinkansen. Crack growth behaviour, measured cyclic stresses, evaluation of fatigue damage, and retrofitting methods are described.

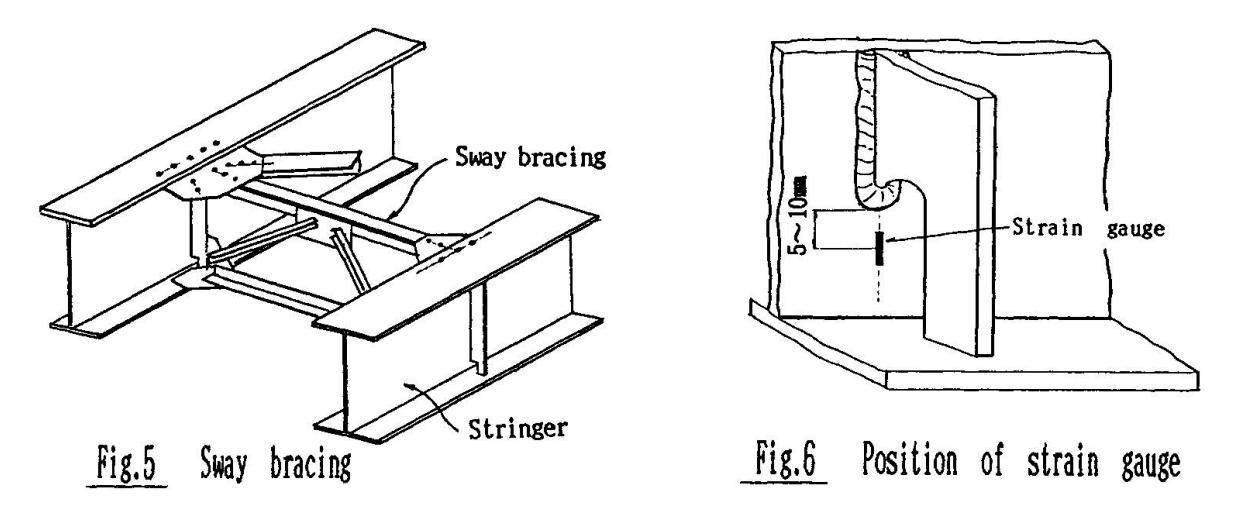
The stringer of a truss bridge was selected for cyclic stress study. This truss bridges has a standard floor system of the Tokaido Shinkansen whose span is 60 m, and the span of stringers is about 10 m. Measurement was made by comparison concerning whether there are sway bracings (Fig.5) and differences in train speeds. Dynamic strain measurement was conducted by placing strain gauges to the back and surface of the web plate at the lower end of the welded portion. The strain gauges were located 5 to 10 mm away from the lower end of weld toes (Fig. 6) stress records were processed as follows.

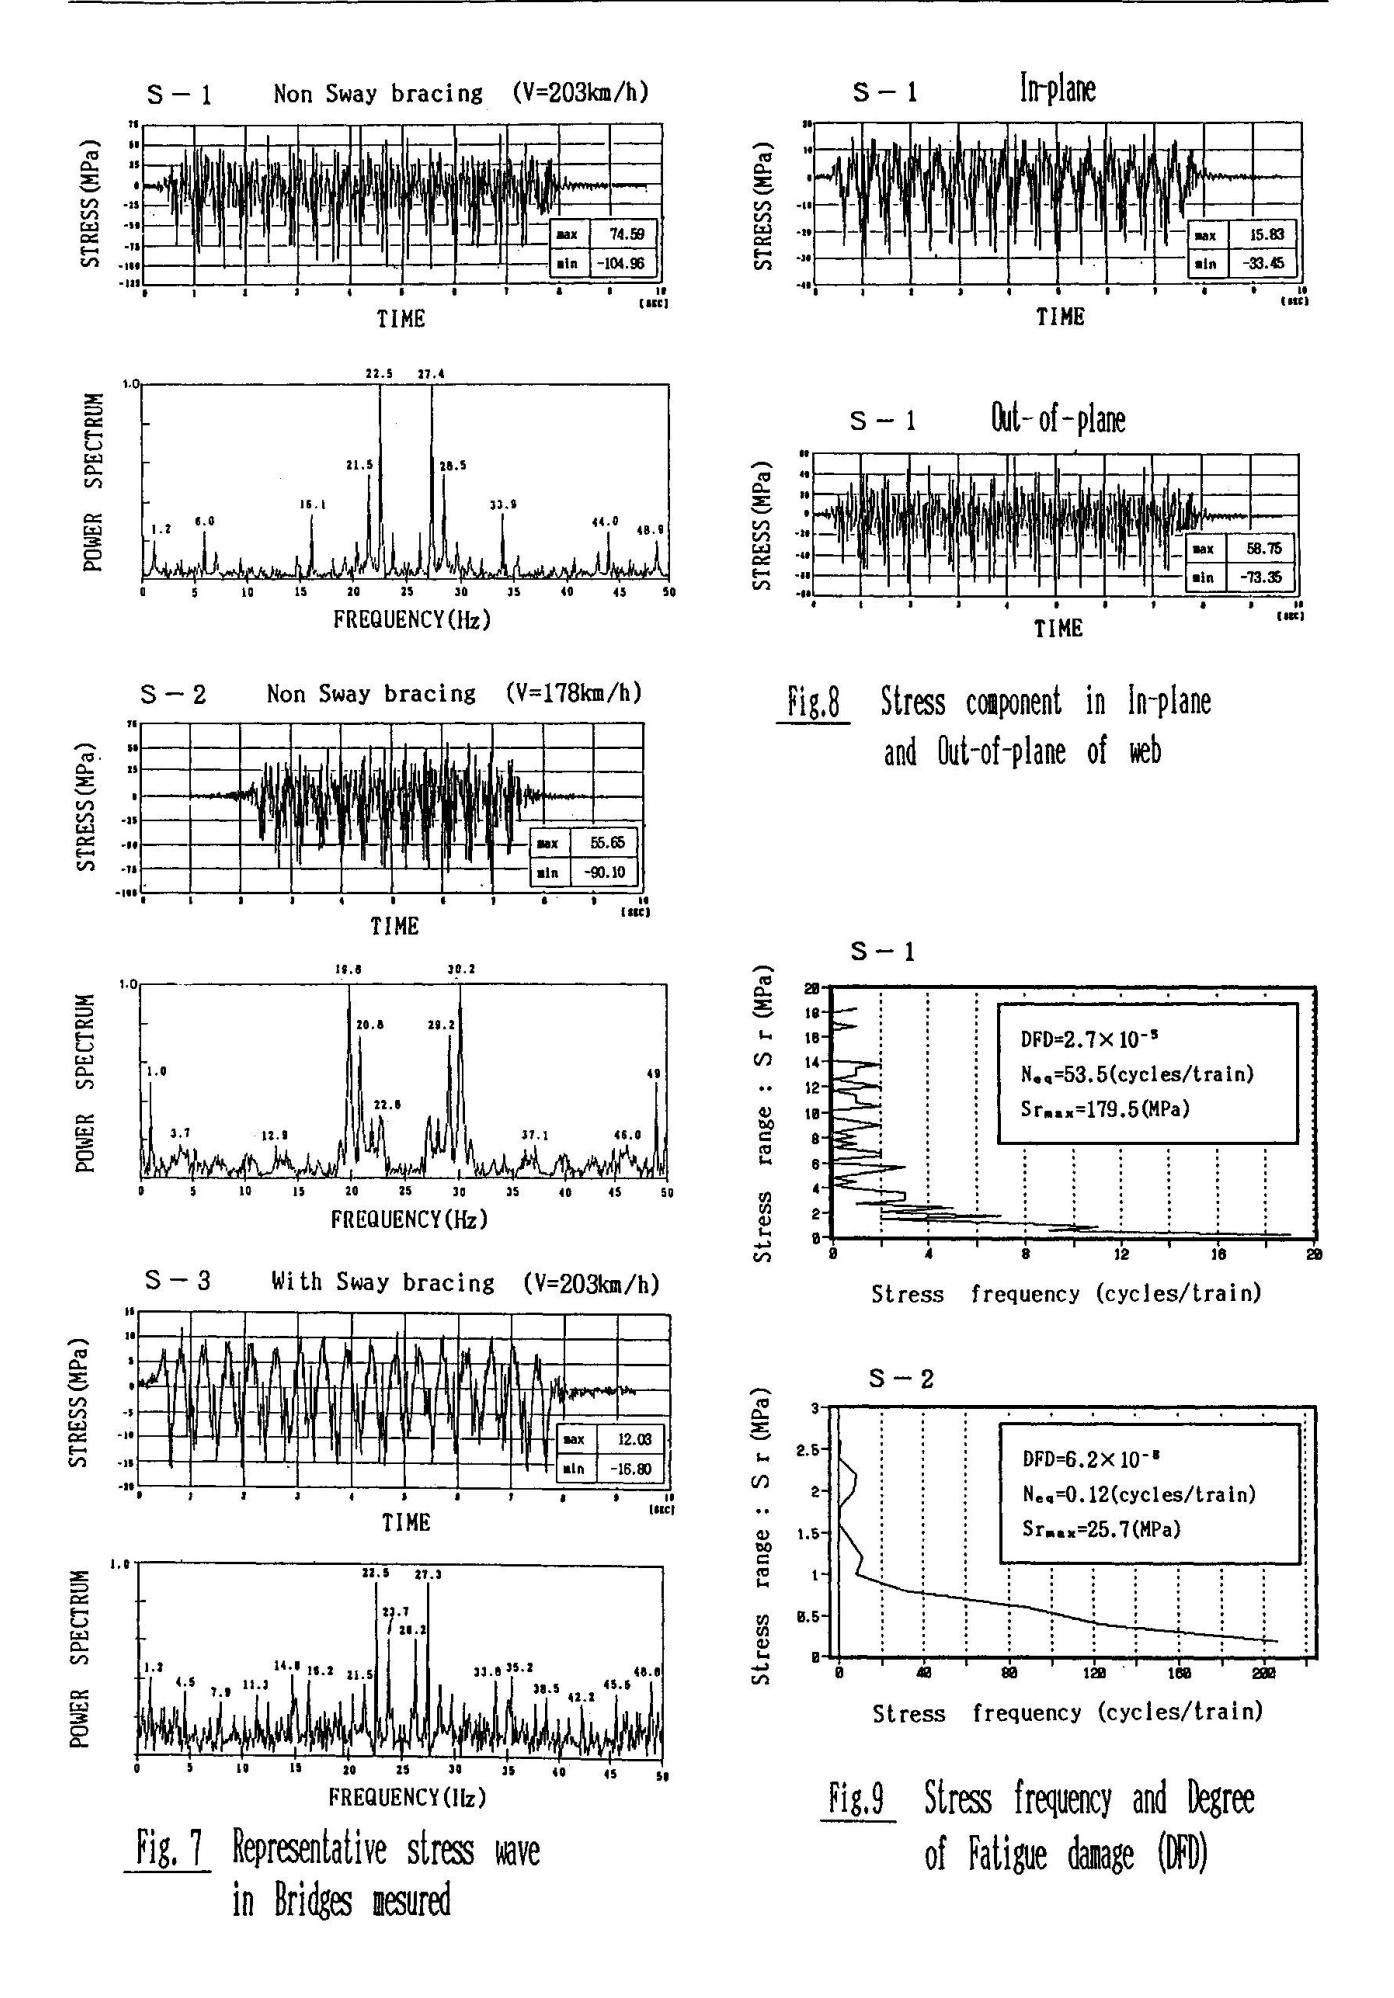
Fig.7 shows a typical stress records on the stringer web and the results of frequency analysis. S-1 and S-2 are stress records at same point of stiffener end detail without sway bracing when a train passed away at a speed of 203 km/h and 178 km/h respectively. S-3 is a stress by train passing at a speed of 203 km/h at a position to which sway bracing is connected. Train speeds were obtained, using a strain gauge fitted to the track. Major results of this test can be summarized as follows; As obviously shown by the comparison between S-1 and S-3, at the detail where sway bracing exists, stress amplitude is smaller than where sway bracing does not exists, and the high-frequency component is also smaller. This is considered to be due to horizontal vibrations of the lower flange. Stresses in S-1 is the largest measured value in this structure and its stress waveform exhibits a resonating behavior. However, S-2, the stress waveform of a low-speed train (v=178 km/h) does not produce as large stress as S-1 (v=203 km/h). Therefore, horizontal vibration of the lower flange was induced only by the passage of high speed trains. In order to examine this resonating behavior, a stress was separated into the in-plane component and the out-of-plane component as shown in Fig.8. Its results indicate that the stress at the lower end of the stiffener without sway bracing detail is mainly caused by out-of-plane distorsion of the web plate. From this, it seems possible to say that the source of a predominating stress which occurs at the lower end of a stiffener is horizontal vibrations of the lower flange. Fig.9 shows the stress histgram and the degree of fatigue damage of each stress component. The results suggest that fatigue cracks occurred in several years under S-1 stress history. However, S-2 shows not so high degree of damage.
