Artikel: Vibration fatigue of steel bridges of the bullet train system

Autor: Sakamoto, Kenji / Miki, Chitoshi / Ichikawa, Atushi

Vibration Fatigue of Steel Bridges of the Bullet Train System

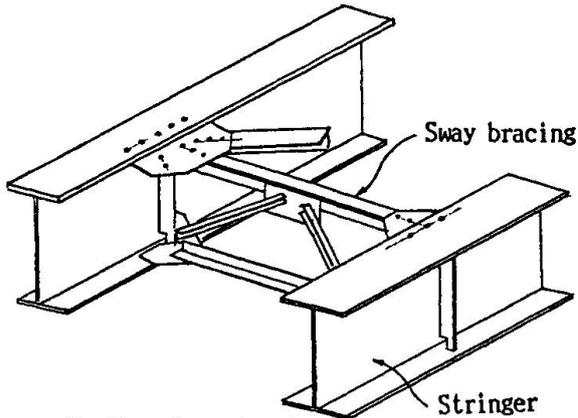
Fig.5 Sway bracing

The stringer of a truss bridge was selected for cyclic stress study. This truss bridges has a standard floor system of the Tokaido Shinkansen whose span is 60 m, and the span of stringers is about 10 m. Measurement was made by comparison concerning whether there are sway bracings (Fig.5) and differences in train speeds. Dynamic strain measurement was conducted by placing strain gauges to the back and surface of the web plate at the lower end of the welded portion. The strain gauges were located 5 to 10 mm away from the lower end of weld toes (Fig. 6) stress records were processed as follows.

As a countermeasure against these fatigue cracks, it is most effective to stop local horizontal vibrations of lower flange which cause fatigue cracks. In some truss bridge stringers, fatigue cracks were removed by applying of arc air gouging and rewelded and then an additional plates were installed by high-strength bolts (Fig. 10). In some cases a sway bracing was also added. Another possible measure is to increase the fatigue strength of the detail. As it is costly to add plates to a slight fatigue crack, it was necessary to consider an economic method for raising fatigue strength. It is advisable to improve the fatigue strength of the toe of a fillet weld and prevent occurrence of additional crack in a part where occurrence of a fatigue crack is not confirmed as a preventive measure. Application of TIG (Tungsten Inert Gas) arc remelting has considered as an effective and economic method for repairing a fatigue crack at the toe of a fillet weld and improving fatigue strength.

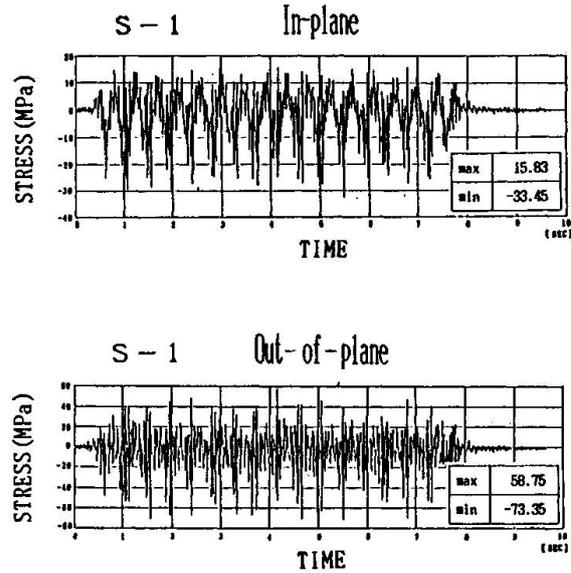
Fig. 8 Stress component in In-plane and Out-of-plane of web

Stresses in S-1 is the largest measured value in this structure and its stress waveform exhibits a resonating behavior. However, S-2, the stress waveform of a low-speed train ($v=178$ km/h) does not produce as large stress as S-1 ($v=203$ km/h). Therefore, horizontal vibration of the lower flange was induced only by the passage of high speed trains. In order to examine this resonating behavior, a stress was separated into the in-plane component and the out-of-plane component as shown in Fig.8. Its results indicate that the stress at the lower end of the stiffener without sway bracing detail is mainly caused by out-of-plane distortion of the web plate. From this, it seems possible to say that the source of a predominating stress which occurs at the lower end of a stiffener is horizontal vibrations of the lower flange.
