Artikel: Vibration fatigue of steel bridges of the bullet train system
Autor: Sakamoto, Kenji / Miki, Chitoshi / Ichikawa, Atushi
DOI: <https://doi.org/10.5169/seals-45713>

Vibration Fatigue of Steel Bridges of the Bullet Train System

Fatigue cracks caused by out-of-plane vibration were observed in steel bridges of the Tokaido Shinkansen. Crack growth behaviour, measured cyclic stresses, evaluation of fatigue damage, and retrofitting methods are described.

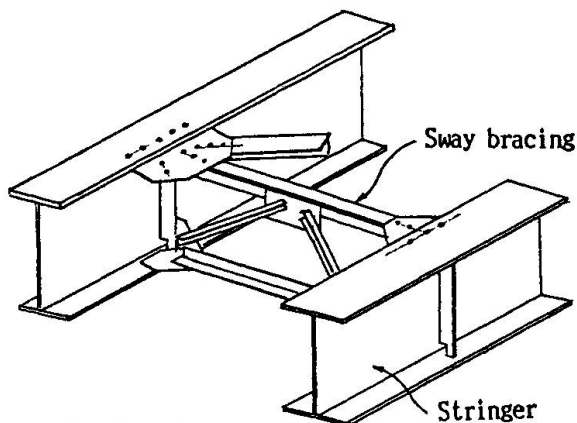
Fig.5 Sway bracing

The stringer of a truss bridge was selected for cyclic stress study. This truss bridges has a standard floor system of the Tokaido Shinkansen whose span is 60 m, and the span of stringers is about 10 m. Measurement was made by comparison concerning whether there are sway bracings (Fig.5) and differences in train speeds. Dynamic strain measurement was conducted by placing strain gauges to the back and surface of the web plate at the lower end of the welded portion. The strain gauges were located 5 to 10 mm away from the lower end of weld toes (Fig. 6) stress records were processed as follows.

As a countermeasure against these fatigue cracks, it is most effective to stop local horizontal vibrations of lower flange which cause fatigue cracks. In some truss bridge stringers, fatigue cracks were removed by applying of arc air gouging and rewelded and then an additional plates were installed by high-strength bolts (Fig. 10). In some cases a sway bracing was also added. Another possible measure is to increase the fatigue strength of the detail. As it is costly to add plates to a slight fatigue crack, it was necessary to consider an economic method for raising fatigue strength. It is advisable to improve the fatigue strength of the toe of a fillet weld and prevent occurrence of additional crack in a part where occurrence of a fatigue crack is not confirmed as a preventive measure. Application of TIG (Tungsten Inert Gas) arc remelting has considered as an effective and economic method for repairing a fatigue crack at the toe of a fillet weld and improving fatigue strength.

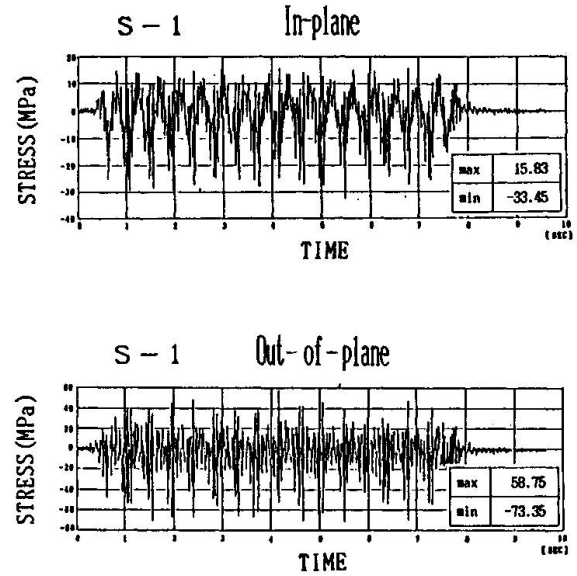
Fig. 8 Stress component in In-plane and Out-of-plane of web

Stresses in S-1 is the largest measured value in this structure and its stress waveform exhibits a resonating behavior. However, S-2, the stress waveform of a low-speed train ($v=178$ km/h) does not produce as large stress as S-1 ($v=203$ km/h). Therefore, horizontal vibration of the lower flange was induced only by the passage of high speed trains. In order to examine this resonating behavior, a stress was separated into the in-plane component and the out-of-plane component as shown in Fig.8. Its results indicate that the stress at the lower end of the stiffener without sway bracing detail is mainly caused by out-of-plane distortion of the web plate. From this, it seems possible to say that the source of a predominating stress which occurs at the lower end of a stiffener is horizontal vibrations of the lower flange.
