Zeitschrift: IABSE reports = Rapports AIPC = IVBH Berichte

Artikel: Fatigue crack detection and repair of steel bridge structures

Autor: Fisher, John W. / Menzemer, Craig C. / Yen, Ben T.

Fatigue Crack Detection and Repair of Steel Bridge Structures

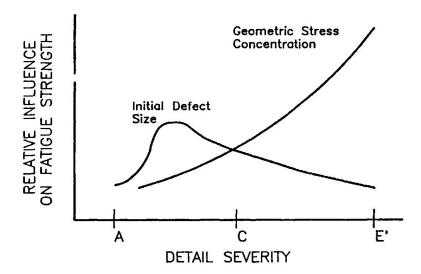
Fig. 1 Relationship Between Fatigue Strength, Detail Type and Defects

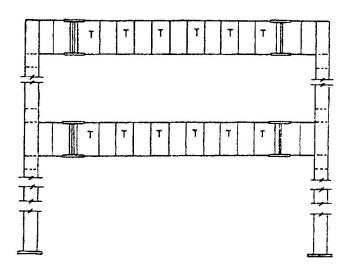
Fig. 2 Typical Bent Elevation

The Central Artery carries traffic through Boston, Massachusetts and surrounding communities. A viaduct structure, located in the Artery's northern area, consists of bilevel rigid steel frame bents which support a two girder floorbeam stringer system on each level. Columns of the rigid bents have box section while transverse beams have either box or I sections (Fig. 2). I-beam

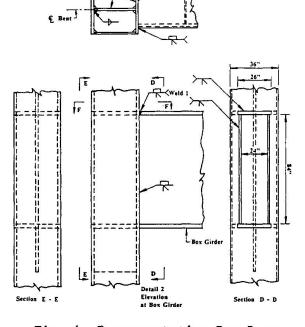
to column connections contain closure plates fillet welded to the edges of the I section and column flanges (Fig. 3). Webs of the I beams are groove welded to the columns while beam flanges (both box and I) and box beam webs of the lower portion of the bents are connected via full penetration groove welds

Fig. 4 Representative Box Beam to Column Connection

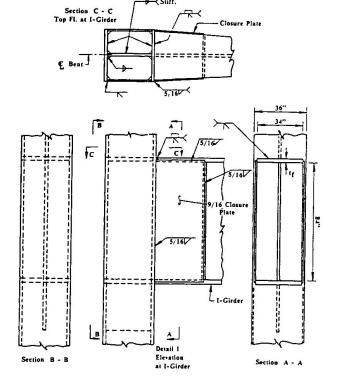
Fig. 3 Representative I-Beam to Column Connection

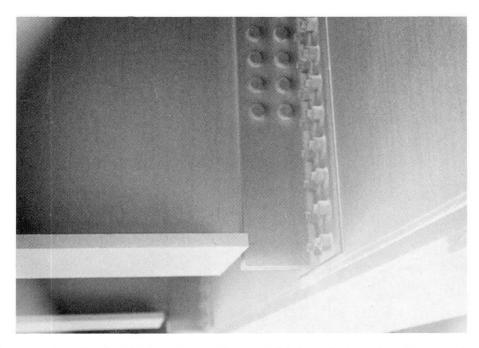
Figure 7 shows cracks which extended several inches along the bottom end of the angle fillet, between the girder web and the transverse beam of the bents. The cracks were found only at locations where the longitudinal girder web was bolted full depth to the connection angles. Other locations where the girder web was not bolted full depth exhibited no evidence of cracking (Fig. 8).

Fig. 8 Longitudinal Girder Not Bolted Full Depth to the Connection Angles

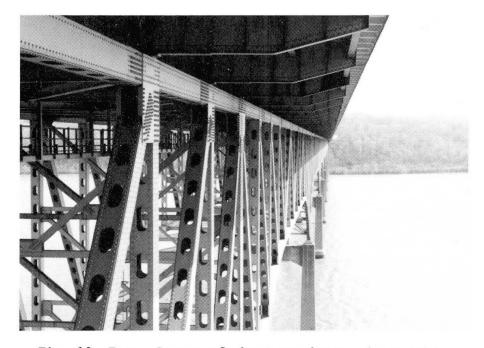
Fig. 12 Truss System of the Susquehanna River Bridge

I-95 crosses the Susquehanna River in Maryland. The structure is a multiple span deck truss bridge whose members are either built-up riveted construction or rolled structural shapes. Transverse floorbeams and longitudinal stringers of the floor system are composite with the reinforced concrete deck. All of the floorbeams are supported by the top chord of the main deck trusses (Fig. 12). Suspended truss spans contain pin and hanger assemblies which consist of riveted box sections [2].
