**Zeitschrift:** IABSE reports = Rapports AIPC = IVBH Berichte  
**Band:** 59 (1990)

**Artikel:** Fatigue crack detection and repair of steel bridge structures  
**Autor:** Fisher, John W. / Menzemer, Craig C. / Yen, Ben T.  
**DOI:** <https://doi.org/10.5169/seals-45726>

## **Fatigue Crack Detection and Repair of Steel Bridge Structures**

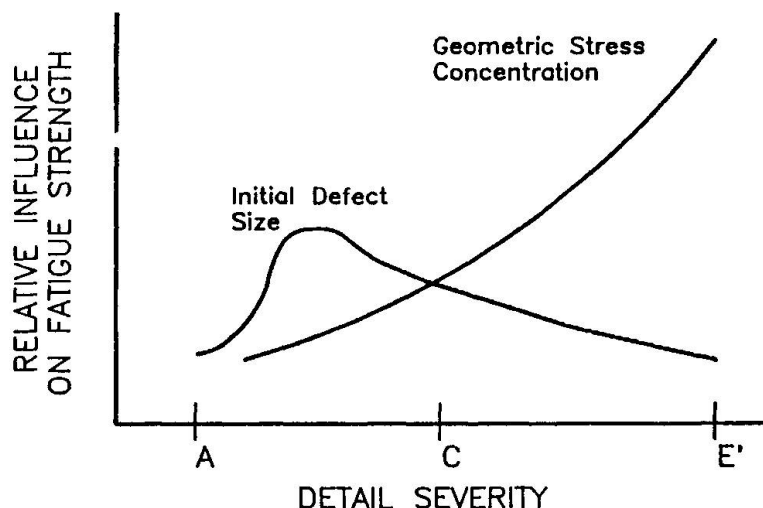
Fig. 1 Relationship Between Fatigue Strength, Detail Type and Defects

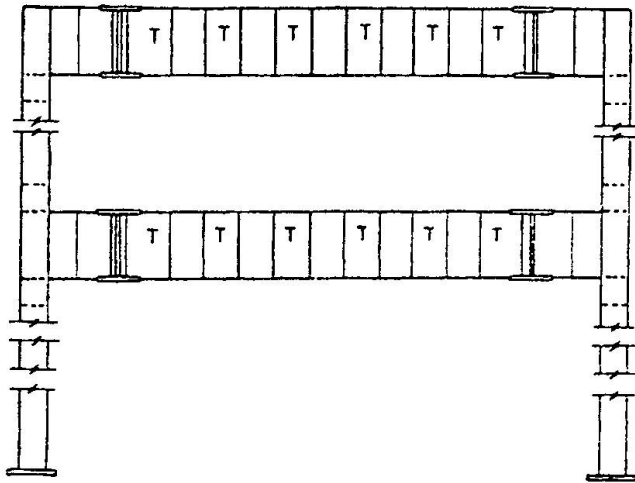
The Central Artery carries traffic through Boston, Massachusetts and surrounding communities. A viaduct structure, located in the Artery's northern area, consists of bilevel rigid steel frame bents which support a two girder floor-beam stringer system on each level. Columns of the rigid bents have box section while transverse beams have either box or I sections (Fig. 2). I-beam

Fig. 2 Typical Bent Elevation

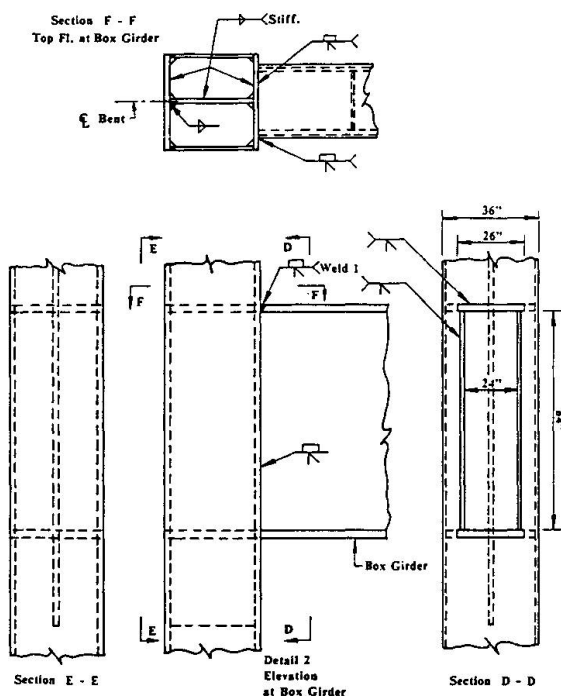
to column connections contain closure plates fillet welded to the edges of the I section and column flanges (Fig. 3). Webs of the I beams are groove welded to the columns while beam flanges (both box and I) and box beam webs of the lower portion of the bents are connected via full penetration groove welds with back-up bars (Fig. 4).

Fig. 4 Representative Box Beam to Column Connection

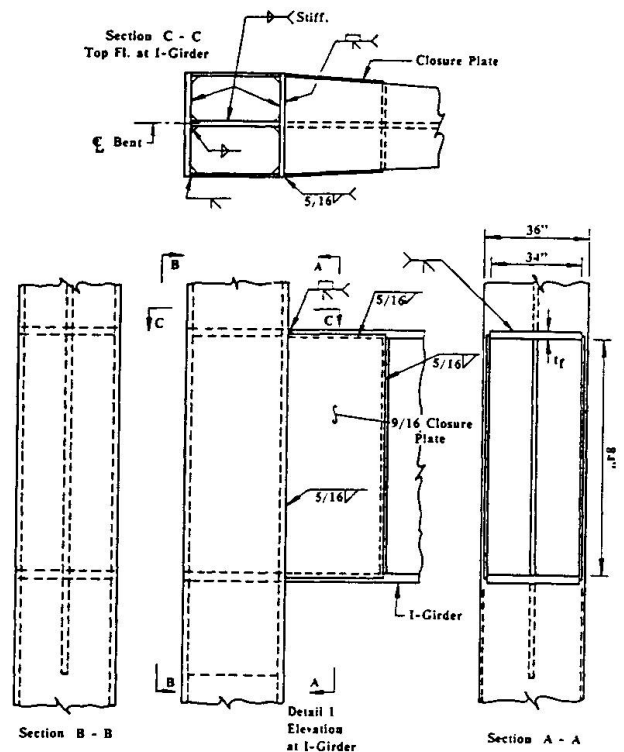
Fig. 3 Representative I-Beam to Column Connection

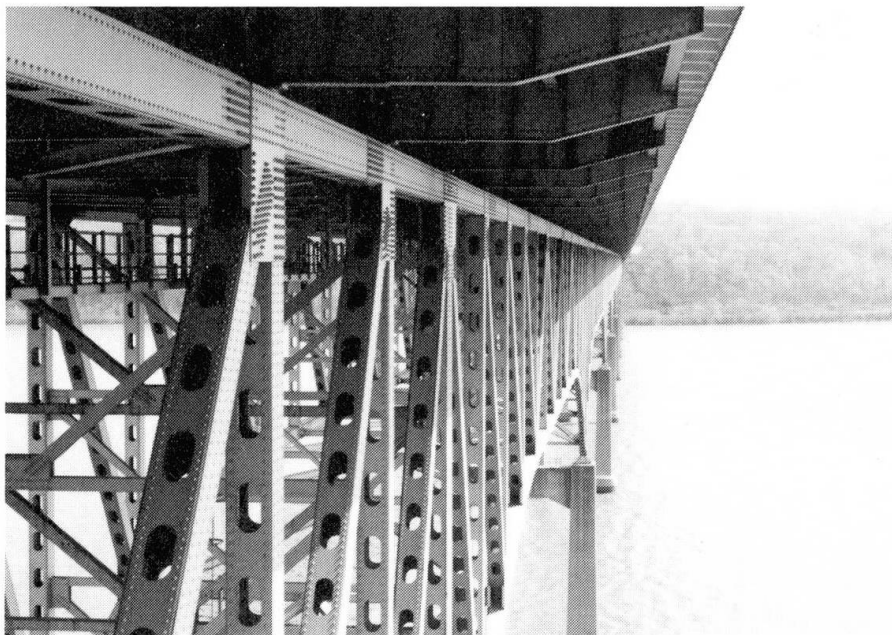
I-95 crosses the Susquehanna River in Maryland. The structure is a multiple span deck truss bridge whose members are either built-up riveted construction or rolled structural shapes. Transverse floorbeams and longitudinal stringers of the floor system are composite with the reinforced concrete deck. All of the floorbeams are supported by the top chord of the main deck trusses (Fig. 12). Suspended truss spans contain pin and hanger assemblies which consist of riveted box sections [2].

Fig. 12 Truss System of the Susquehanna River Bridge
