Zeitschrift: IABSE reports = Rapports AIPC = IVBH Berichte
Band: 59 (1990)

Artikel: Fatigue crack detection and repair of steel bridge structures
Autor: Fisher, John W. / Menzemer, Craig C. / Yen, Ben T.
DOI: <https://doi.org/10.5169/seals-45726>

Fatigue Crack Detection and Repair of Steel Bridge Structures

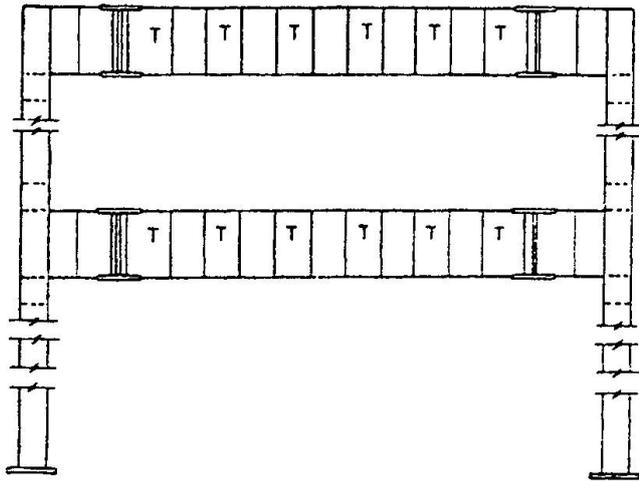
Fig. 2 Typical Bent Elevation

The Central Artery carries traffic through Boston, Massachusetts and surrounding communities. A viaduct structure, located in the Artery's northern area, consists of bilevel rigid steel frame bents which support a two girder floor-beam stringer system on each level. Columns of the rigid bents have box section while transverse beams have either box or I sections (Fig. 2). I-beam

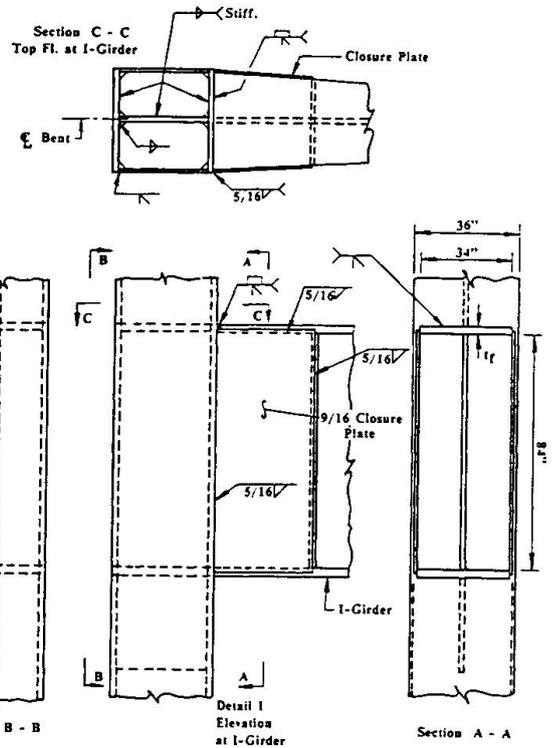
Fig. 3 Representative I-Beam to Column Connection

to column connections contain closure plates fillet welded to the edges of the I section and column flanges (Fig. 3). Webs of the I beams are groove welded to the columns while beam flanges (both box and I) and box beam webs of the lower portion of the bents are connected via full penetration groove welds with back-up bars (Fig. 4).

Inspection of the rigid frame bents revealed cracks in the fillet welds at several corner joints where transverse I-beam closure plates were jointed to the bent column flange. Grinding the fillet weld throat in the cracked corner region of the closure plates exposed the crack which had extended into the

groove weld connecting the top flange of transverse beam to the column. Further grinding exposed the crack which extended from the back-up bar halfway through the groove weld thickness. Other bents revealed cracks at the web cope closure plates of the transverse box beam (Fig. 9). Grinding the fillet weld throat into the beam flange exposed cracks extending from the back-up bar into the groove weld thickness.

Transfer of the live load forces from the beam top flange to the bent column had to be assured for an effective retrofit of the beam column connection of the bent. Short sections of wide flange shapes were modified by partial removal of the web and were bolted to the top flange of the lower beam and webs of the column (Fig. 11). If the fatigue cracks in the groove welds continued to propagate and eventually led to fracture of the top beam flange to column connection, the live load forces would be transferred via the bolted splice. In addition, the reinforcement provided more resistance to the longitudinal forces.

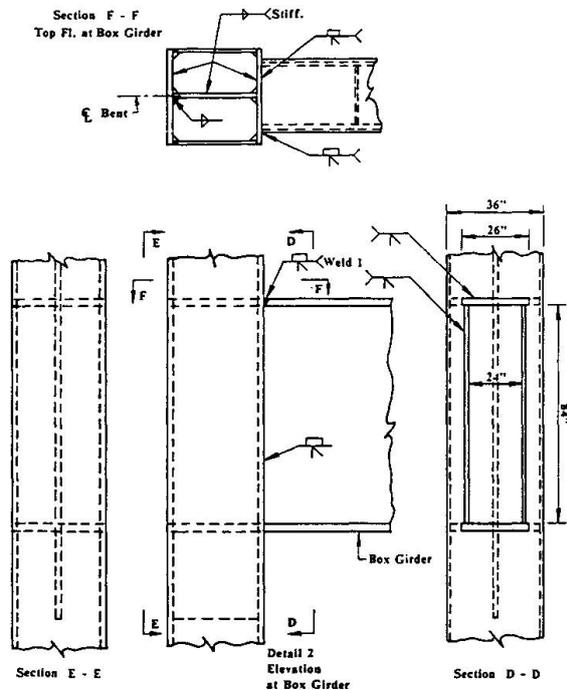
Fig. 4 Representative Box Beam to Column Connection

Beam flanges of the upper portion of the bent are continuous into the column. Cope openings in the box beam webs at the beam column connection points are covered with small plates which are fillet welded to the box beam webs [2].

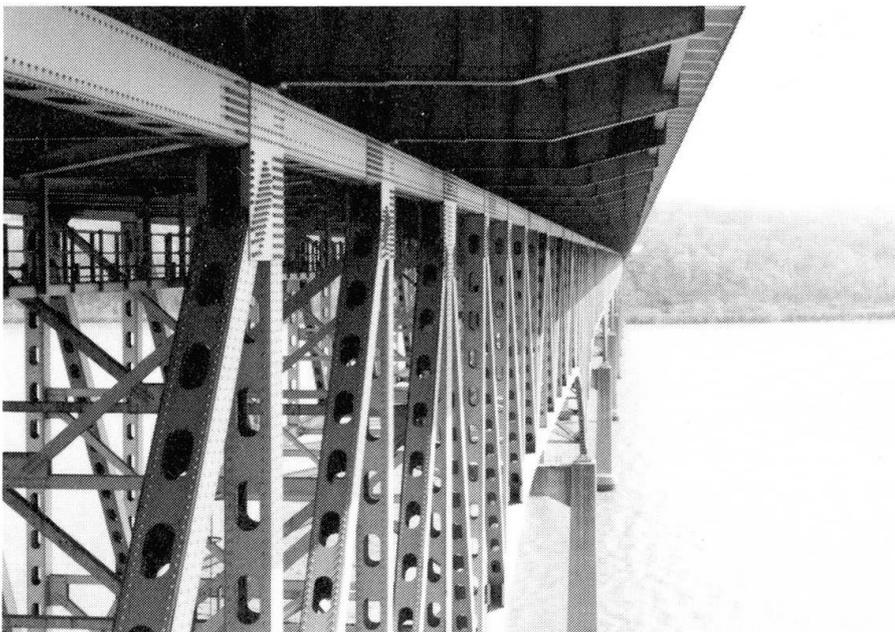
Fig. 12 Truss System of the Susquehanna River Bridge

I-95 crosses the Susquehanna River in Maryland. The structure is a multiple span deck truss bridge whose members are either built-up riveted construction or rolled structural shapes. Transverse floorbeams and longitudinal stringers of the floor system are composite with the reinforced concrete deck. All of the floorbeams are supported by the top chord of the main deck trusses (Fig. 12). Suspended truss spans contain pin and hanger assemblies which consist of riveted box sections [2].
