Zeitschrift:	IABSE reports = Rapports AIPC = IVBH Berichte
Band:	70 (1993)
Artikel:	Structural assessment of St. Mark's Basilica, Venice
Autor:	Rossi, Pier Paolo / Ventrucci, Franco / Vio, Ettore
DOI:	https://doi.org/10.5169/seals-53298

Evaluation structurale de la Basilique de St. Marc, Venise Tragfähigkeitsbeurteilung der Basilika von San Marco, Venedig

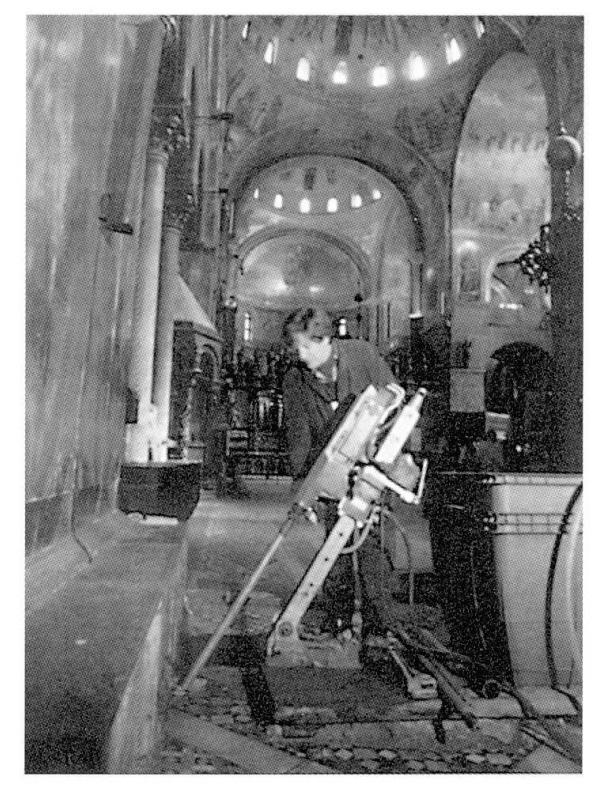
Fig. 3 - Drilling equipment for coring the foundation masonry

An in-depth investigation was also carried out to analyze the geometric and structural characteristics of the foundation masonry of the perimeter walls and of the pillars. Several small boreholes (diameter 62 mm) were cored by using a light diamond saw and the lateral surface of the boreholes was surveyed by means of a colour video camera. Fig. 3 shows the drilling equipment installed at the base of a pillar for coring the foundation masonry. More than 50 subvertical boreholes were drilled to investigate the structural characteristics of the foundation masonries. In order to obtain qualitative information concerning the mechanical characteristics of the masonry structures, a sonic-log survey was carried out as well as cross-hole measurements by using two parallel boreholes. As a result of the coring and video camera survey, the typical structural scheme of the foundation masonry was determined (Fig. 4). At a depth of about 70-90 cm from floor level, a stone basement made with large blocks of sandstone is present with a thickness of about 2 m. Underneath this stone basement there is a wood plate (10 cm thick) which is about 3.0 m below the floor. This wood plate rests on short wooden piles which are very poorly preserved.

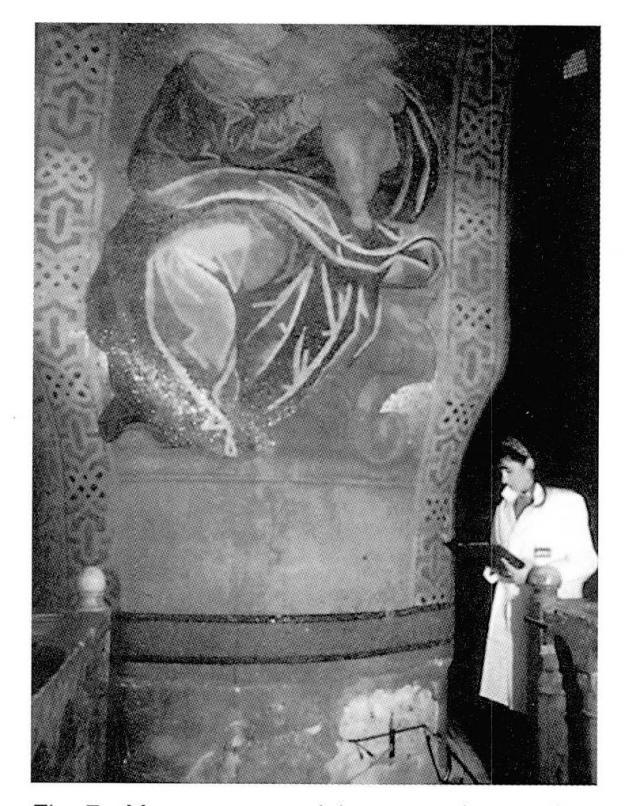
Fig. 7 - Measurement of the state of stress in a pillar by means of the flat-jack technique

lars. For this purpose the well-known flat-jack test was used. This non-destructive test, developed by ISMES about 15 years ago, is based on the release of the state of stress by making a small slot in a mortar layer and then reloading by means of a thin flat-jack inserted into the slot. This test is very simple and reliable, as proven by calibration tests carried out in the laboratory. More than 80 flat-jack tests were carried out (about 65 on the pillars and 20 on the perimeter walls). Fig. 7 shows the view of a flat-jack test on a pillar.

The stress values measured on the pillars are shown in fig. 8. A certain heterogeneity of the state of stress in the pillars can be observed, which is related not only to the position and size of the pillars but also to the type and extent of the consolidation works which some pillars have undergone in the past. High stress values (up to 1.1 MPa) were measured in some pillars. Furthermore, in the above-mentioned pillar 2 (the south-east pillar of the St. John's Dome), a state of stress of 0.95 MPa was measured. This value was considered very high in relation to the results obtained by sonic tomography, coring and video camera survey.
