Artikel: Structural assessment of St. Mark's Basilica, Venice

Autor: Rossi, Pier Paolo / Ventrucci, Franco / Vio, Ettore

Structural Assessment of St. Mark's Basilica, Venice

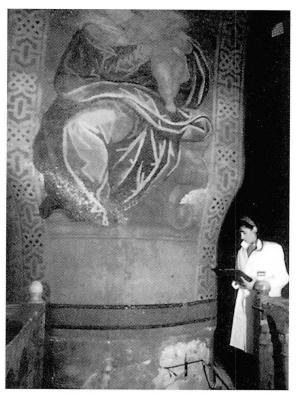
The combined analysis of the results obtained by flat-jack test, sonic tomography, coring and video camera survey clearly shows that the pillar n. 2 (sout-east pillar of St. John's Dome) has to withstand very severe loading conditions in comparison with the poor mechanical characteristics of the masonry. For this reason, it was decided to carry out a more detailed investigation in the lower part of the pillar after removing the marble lining. At first a detailed

Fig. 7 - Measurement of the state of stress in a pillar by means of the flat-jack technique

crack pattern survey was carried out which showed the presence of several vertical small cracks, especially near the corners. Sonic tomography was performed at three sections of the pillar at different heights from the floor and the results obtained confirmed the low velocity values presented in fig. 5. In several points of the pillar, the state of stress was measured by flat-jack test and an average value of 0.85 MPa was found. Then, in two points, the deformability characteristics were determined by two parallel flat-jacks. The typical stress-strain curve of the masonry is shown in fig. 9, where axial and transversal strain values are presented as functions of axial stress. The average value of the measured state of stress is also indicated. It can be observed that the masonry presents a linear behaviour up to a stress level of about 0.8 MPa with a value of Young's modulus of about 2.000 MPa. For higher stress levels, up to 1.2 MPa, Young's modulus decrea-

ses to a value of about 900 MPa and for the stress range between 1.2 and 1.5 MPa the modulus is lower than 300 MPa. It can be observed that the average state of stress measured in the pillar exceeds the limit between elastic and plastic behaviour. This supplementary investigation clearly confirmed that the static conditions of the pillar are not satisfactory and for this reason it was decided to carry out urgent consolidation works which are now in the design phase.
