Artikel: Structural assessment of St. Mark's Basilica, Venice

Autor: Rossi, Pier Paolo / Ventrucci, Franco / Vio, Ettore

Structural Assessment of St. Mark's Basilica, Venice

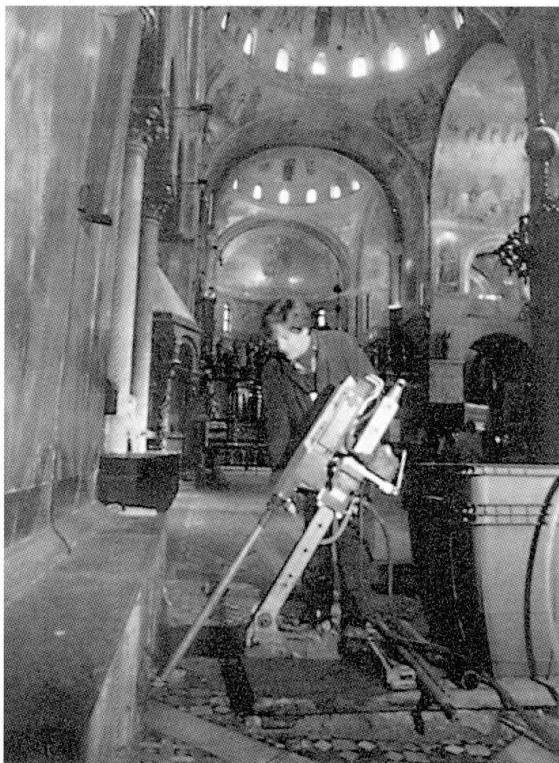
An in-depth investigation was also carried out to analyze the geometric and structural characteristics of the foundation masonry of the perimeter walls and of the pillars. Several small boreholes (diameter 62 mm) were cored by using a light diamond saw and the lateral surface of the boreholes was surveyed by means of a colour video camera. Fig. 3 shows the drilling equipment installed at the base of a pillar for coring the foundation masonry. More than 50 subvertical boreholes were drilled to investigate the structural characteristics of the foundation masonries. In order to obtain qualitative information concerning the mechanical characteristics of the masonry structures, a sonic-log survey was carried out as well as cross-hole measurements by using two parallel boreholes. As a result of the coring and video camera survey, the typical structural scheme of the foundation masonry was determined (Fig. 4). At a depth of about 70-90 cm from floor level, a stone basement made with large blocks of sandstone is present with a thickness of about 2 m. Underneath this stone basement there is a wood plate (10 cm thick) which is about 3.0 m below the floor. This wood plate rests on short wooden piles which are very poorly preserved.

Fig. 3 - Drilling equipment for coring the foundation masonry

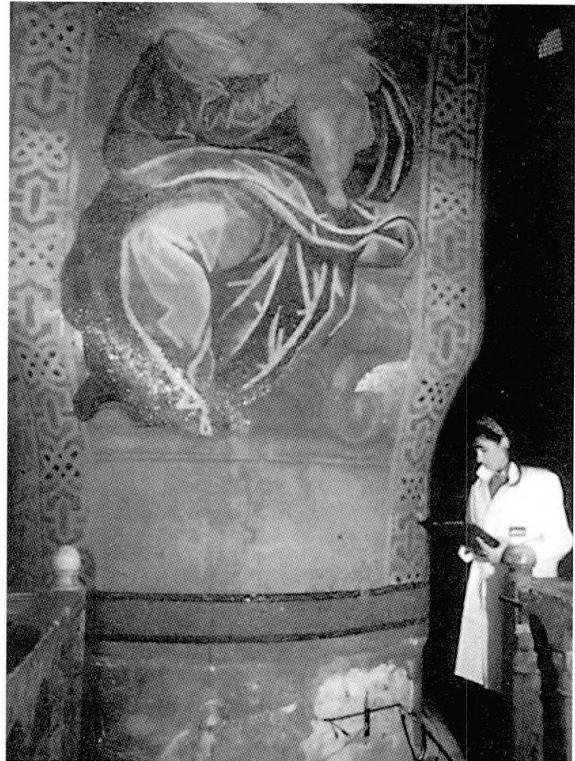
For the evaluation of the static conditions of the Basilica it seemed advisable to measure the actual state of stress on the main supporting structures with special attention to the pillars. For this purpose the well-known flat-jack test was used. This non-destructive test, developed by ISMES about 15 years ago, is based on the release of the state of stress by making a small slot in a mortar layer and then reloading by means of a thin flat-jack inserted into the slot. This test is very simple and reliable, as proven by calibration tests carried out in the laboratory. More than 80 flat-jack tests were carried out (about 65 on the pillars and 20 on the perimeter walls). Fig. 7 shows the view of a flat-jack test on a pillar.

Fig. 7 - Measurement of the state of stress in a pillar by means of the flat-jack technique
