Artikel: Structural assessment of St. Mark's Basilica, Venice

Autor: Rossi, Pier Paolo / Ventrucci, Franco / Vio, Ettore

Structural Assessment of St. Mark's Basilica, Venice
Evaluation structurale de la Basilique de St. Marc, Venise
Tragfähigkeitsbeurteilung der Basilika von San Marco, Venedig

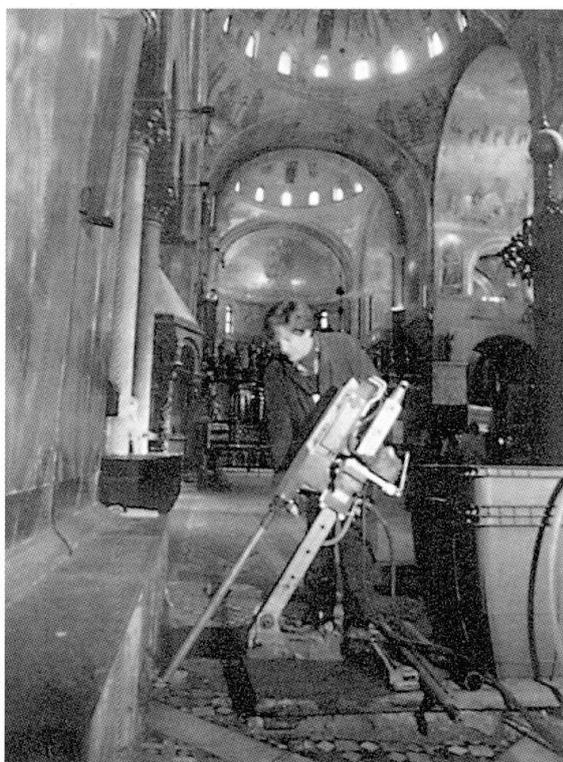
Fig. 3 - Drilling equipment for coring the foundation masonry

An in-depth investigation was also carried out to analyze the geometric and structural characteristics of the foundation masonry of the perimeter walls and of the pillars. Several small boreholes (diameter 62 mm) were cored by using a light diamond saw and the lateral surface of the boreholes was surveyed by means of a colour video camera. Fig. 3 shows the drilling equipment installed at the base of a pillar for coring the foundation masonry. More than 50 subvertical boreholes were drilled to investigate the structural characteristics of the foundation masonries. In order to obtain qualitative information concerning the mechanical characteristics of the masonry structures, a sonic-log survey was carried out as well as cross-hole measurements by using two parallel boreholes. As a result of the coring and video camera survey, the typical structural scheme of the foundation masonry was determined (Fig. 4). At a depth of about 70-90 cm from floor level, a stone basement made with large blocks of sandstone is present with a thickness of about 2 m. Underneath this stone basement there is a wood plate (10 cm thick) which is about 3.0 m below the floor. This wood plate rests on short wooden piles which are very poorly preserved.

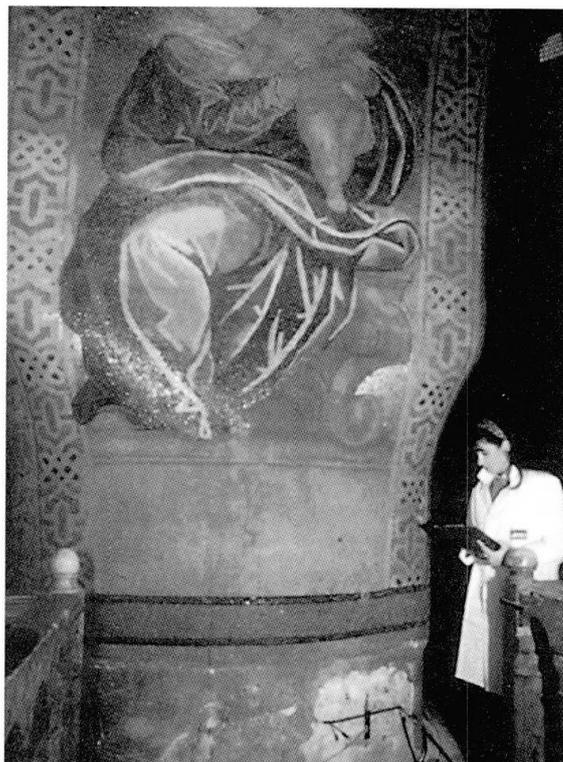
Fig. 7 - Measurement of the state of stress in a pillar by means of the flat-jack technique

For the evaluation of the static conditions of the Basilica it seemed advisable to measure the actual state of stress on the main supporting structures with special attention to the pillars. For this purpose the well-known flat-jack test was used. This non-destructive test, developed by ISMES about 15 years ago, is based on the release of the state of stress by making a small slot in a mortar layer and then reloading by means of a thin flat-jack inserted into the slot. This test is very simple and reliable, as proven by calibration tests carried out in the laboratory. More than 80 flat-jack tests were carried out (about 65 on the pillars and 20 on the perimeter walls). Fig. 7 shows the view of a flat-jack test on a pillar.

The combined analysis of the results obtained by flat-jack test, sonic tomography, coring and video camera survey clearly shows that the pillar n. 2 (south-east pillar of St. John's Dome) has to withstand very severe loading conditions in comparison with the poor mechanical characteristics of the masonry. For this reason, it was decided to carry out a more detailed investigation in the lower part of the pillar after removing the marble lining. At first a detailed

crack pattern survey was carried out which showed the presence of several vertical small cracks, especially near the corners. Sonic tomography was performed at three sections of the pillar at different heights from the floor and the results obtained confirmed the low velocity values presented in fig. 5. In several points of the pillar, the state of stress was measured by flat-jack test and an average value of 0.85 MPa was found. Then, in two points, the deformability characteristics were determined by two parallel flat-jacks. The typical stress-strain curve of the masonry is shown in fig. 9, where axial and transversal strain values are presented as functions of axial stress. The average value of the measured state of stress is also indicated. It can be observed that the masonry presents a linear behaviour up to a stress level of about 0.8 MPa with a value of Young's modulus of about 2.000 MPa. For higher stress levels, up to 1.2 MPa, Young's modulus decreases to a value of about 900 MPa and for the stress range between 1.2 and 1.5 MPa the modulus is lower than 300 MPa. It can be observed that the average state of stress measured in the pillar exceeds the limit between elastic and plastic behaviour. This supplementary investigation clearly confirmed that the static conditions of the pillar are not satisfactory and for this reason it was decided to carry out urgent consolidation works which are now in the design phase.
