Artikel: Investigation of the Roman aqueduct structure of Acqui Terme
Autor: Nascè, Vittorio / Pistone, Giuseppe / Roccati, Roberto
DOI: <https://doi.org/10.5169/seals-53299>

Investigation of the Roman Aqueduct Structure of Acqui Terme

The research concerns the remnants of a Roman aqueduct of stone block masonry at Acqui Terme in Piemonte, Italy. Its aim was to acquire exhaustive data on the mechanical behaviour of the aqueduct, to serve as a basis for assessments concerning the safety and preservation of this monument.

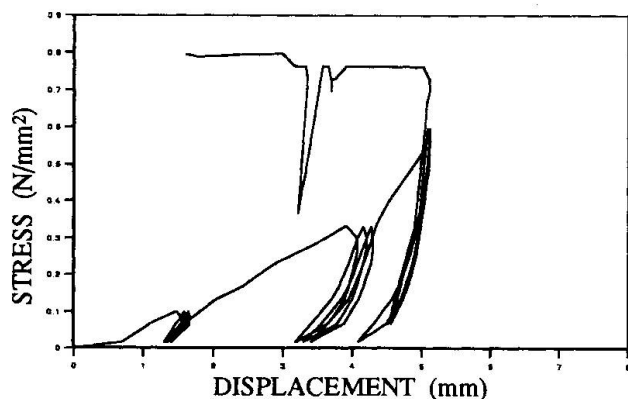
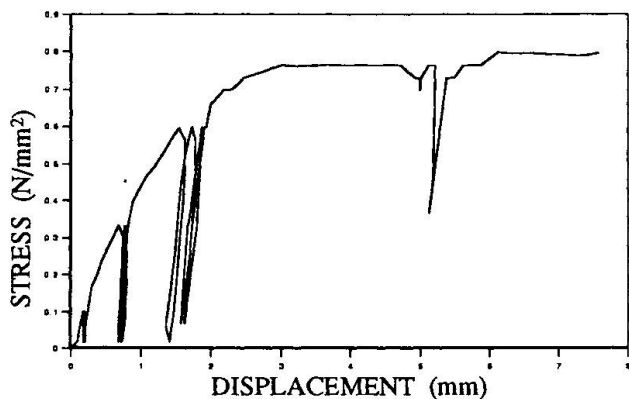
Figs. 4 - 5 - Stress-strain curve of strain gauge 4 (vertical) and 9 (horizontal) - specimen 3.

A comparison between the diagrams plotted from the readings taken by two strain gauges of about the same length on the same face of specimen No. 3 (figs. 4, 5), - a vertical and a horizontal gauge, Nos. 4 and 9, respectively - shows that the strain values are of the same order of magnitude and the horizontal one entails a transverse strain modulus about three times as high as that of the masonry at the elastic stage. Moreover, the downward portion of the curve in fig. 5 reveals a major overall settlement of the specimen under the load, this behaviour closely resembling that of specimen No. 1 already described above (fig. 6). Thus we find that the transverse strains that have been observed are greater than would be expected on the basis of the Poisson modulus of the components, and are independent - even in terms of their direction - of vertical ones in the proximity of failure. Failure involved the masonry specimen as a whole, as shown in photo 13. Strain stabilisation was especially slow at a load level corresponding to 90% of the failure load and required a waiting period of about 20 minutes, this being a confirmation of the major influence exercised by the permanence of the load on the collapse of very irregular masonry.

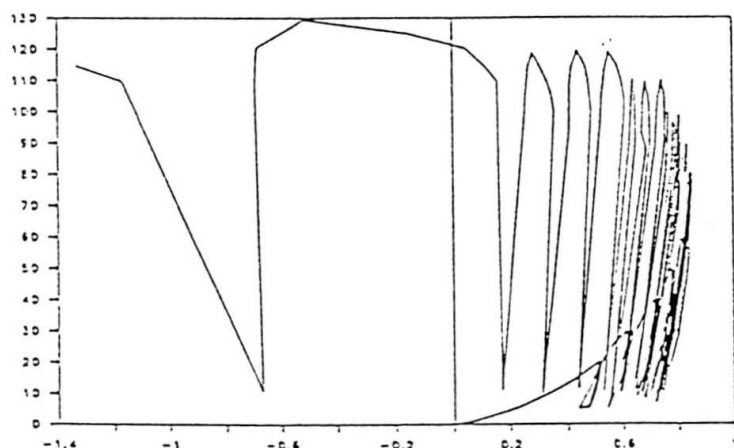
Fig. 6 - Load-displacement curve of strain gauge 5 - specimen 1.
