Artikel: Investigation of the Roman aqueduct structure of Acqui Terme
Autor: Nascè, Vittorio / Pistone, Giuseppe / Roccati, Roberto
DOI: <https://doi.org/10.5169/seals-53299>

Investigation of the Roman Aqueduct Structure of Acqui Terme

The research concerns the remnants of a Roman aqueduct of stone block masonry at Acqui Terme in Piemont, Italy. Its aim was to acquire exhaustive data on the mechanical behaviour of the aqueduct, to serve as a basis for assessments concerning the safety and preservation of this monument.

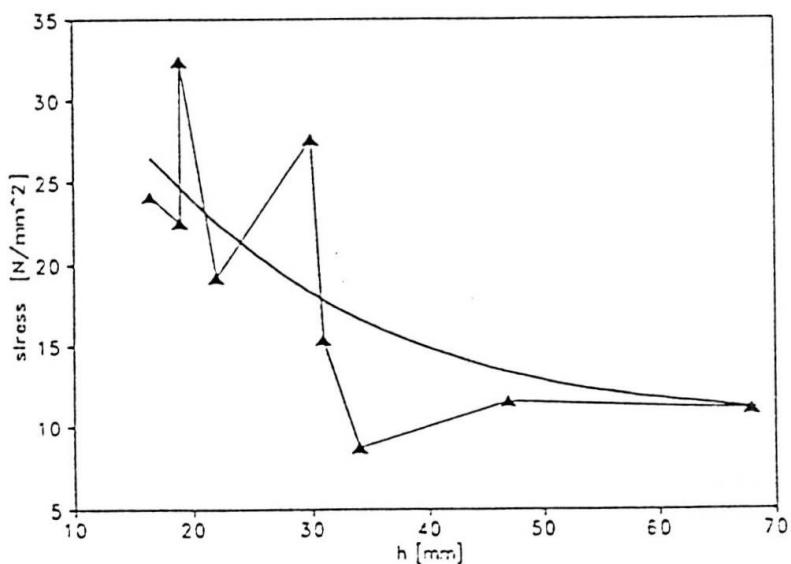
Fig. 1 - Strength as a function of the specimen height.

In the mortar, compressive strength and the elastic modulus were determined on cylinders of different heights: strength was seen to decrease with increasing specimen height (fig. 1), this being an aspect of special interest in the case being considered, on account of the sizeable discontinuities present in the mortar beds of the inner masonry, in terms of both thickness and area.

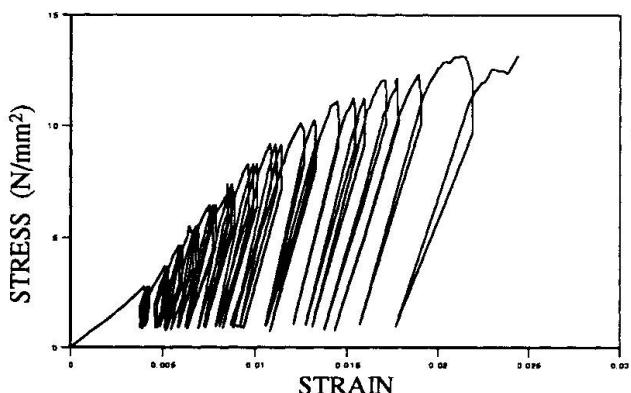
Fig. 2 - Stress-strain curve of strain gauge 7 - specimen 2.

In specimen No. 2 the compression and bending effects were much smaller, on account of a more regular composition (fig. 2), and failure occurred under a load of 1420 KN (13.1 N/mm²).

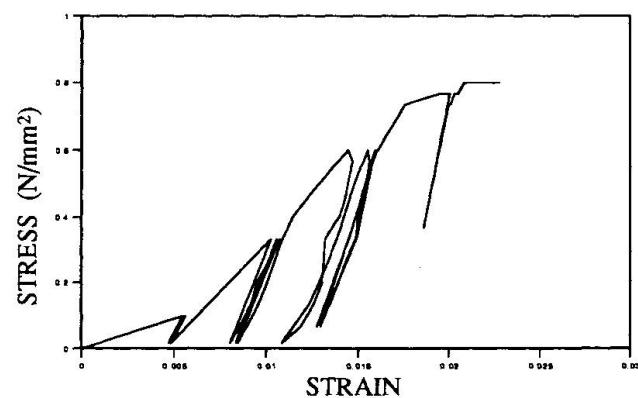
Fig. 3 - Average stress-strain curve - specimen 3.

The progressive opening of cracks did not prevent the material from exhibiting overall elastic behaviour in the individual loading cycles up to very high stress values, as confirmed by the diagram in fig. 3. This diagram illustrates a typical behaviour which was observed throughout the tests: the initial load increase, for each testing level, was accompanied by high strain values and marked residual strain, while in subsequent cycles (the load being the same) strain was lower and residual strain was virtually negligible.

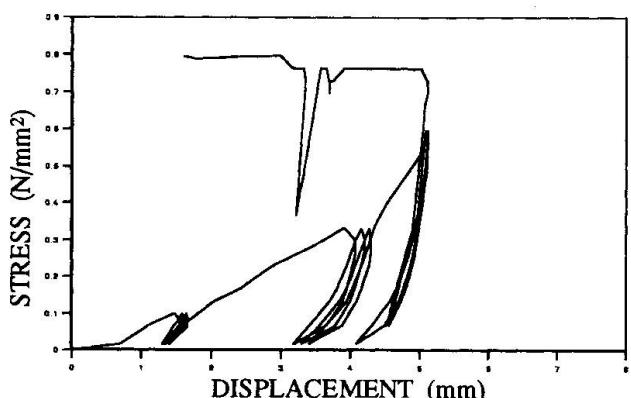
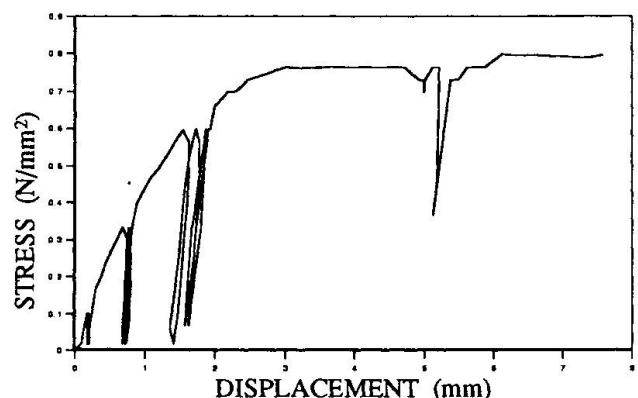
Figs. 4 - 5 - Stress-strain curve of strain gauge 4 (vertical) and 9 (horizontal) - specimen 3.

A comparison between the diagrams plotted from the readings taken by two strain gauges of about the same length on the same face of specimen No. 3 (figs. 4, 5), - a vertical and a horizontal gauge, Nos. 4 and 9, respectively - shows that the strain values are of the same order of magnitude and the horizontal one entails a transverse strain modulus about three times as high as that of the masonry at the elastic stage. Moreover, the downward portion of the curve in fig. 5 reveals a major overall settlement of the specimen under the load, this behaviour closely resembling that of specimen No. 1 already described above (fig. 6). Thus we find that the transverse strains that have been observed are greater than would be expected on the basis of the Poisson modulus of the components, and are independent - even in terms of their direction - of vertical ones in the proximity of failure. Failure involved the masonry specimen as a whole, as shown in photo 13. Strain stabilisation was especially slow at a load level corresponding to 90% of the failure load and required a waiting period of about 20 minutes, this being a confirmation of the major influence exercised by the permanence of the load on the collapse of very irregular masonry.

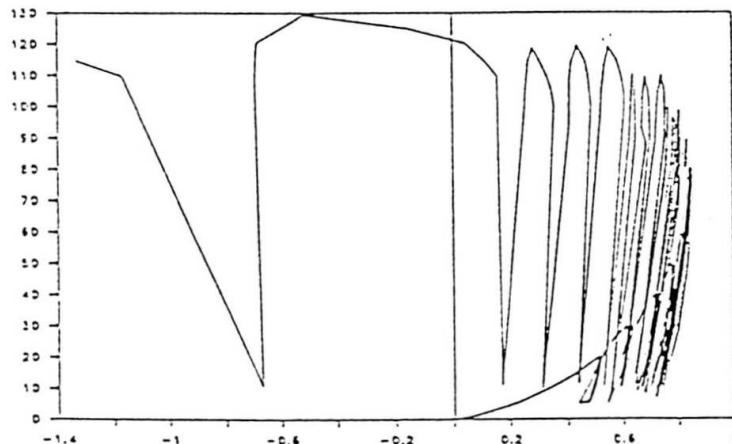
Fig. 6 - Load-displacement curve of strain gauge 5 - specimen 1.

In the case of sample No. 1, though care had been taken to apply the load to its centre of gravity, a marked compression and bending effect occurred due to the presence of a stiffer and stronger core in one of the corner area. Failure took place at 1180 KN (8.6 N/mm²), during the second loading cycle of the last triplet, at a strain value markedly higher than that observed during the previous cycle where the specimen, however, had reached a load of 1300 KN (9.4 N/mm²).
