Strengthening Landmarks for Improved Seismic Performance

Loring A. WYLLIE, Jr.

Structural Engineer
H.J. Degenkolb Assoc.
San Francisco, CA, USA

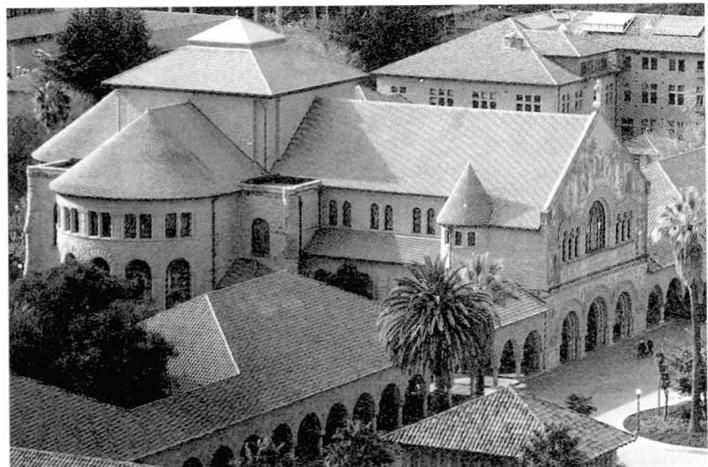
Stanford University is located about 50 km south of San Francisco. The Memorial Church was built by Jane Stanford between 1899 and 1902 as a memorial to her husband, Leland Stanford, Jr., who founded the University. It was built in the classic cruciform shape with the nave, transepts and chancel meeting in the crossing, an area bounded by four tall stone and brick arches supporting a 15 m diameter dome and four mosaics on plaster of the archangels. The Church was built of unreinforced stone masonry with wood roof and a steel supported tower above the dome of the crossing. The new Church was severely damaged in the 1906 San Francisco earthquake and was completely rebuilt with reinforced concrete walls with stone veneer except for the crossing. The steel tower was removed above the interior wood and plaster dome. Figure 3 is an overall photograph of the Church.

Figure 3. Stanford Memorial Church, Stanford University.

The damage was analyzed, the conditions determined and an analysis was completed. It was decided to strengthen the arches by filling the void in their center with some heavily reinforced concrete, to provide a diaphragm at the top of the walls above the arches consisting of a substantial reinforced concrete cap beam and steel diagonal braces. The added steel included a stiff downward cantilever to stiffen the arches against perpendicular movement. The reinforced core between the arches was also tied horizontally to the reinforced concrete walls of the four projections from the crossing to improve structural ties and the transfer of lateral forces. The wood roof diaphragms over the entire Church were strengthened with new plywood and stronger ties and connections at the concrete walls. All of this work was completed in concealed locations with no visible evidence of the repairs and strengthening. Figure 4 illustrates the strengthening scheme.

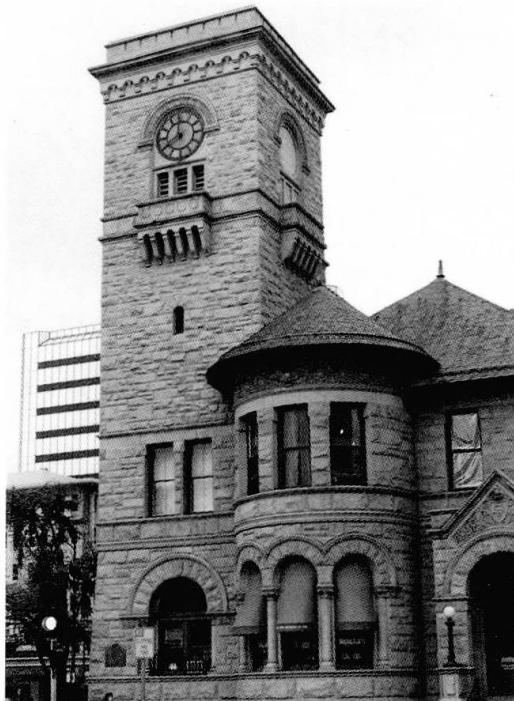
The Museum of Art in San Jose, about 70 km south of San Francisco, was built as the United States Post Office about 1890. It is a two-story plus basement structure with an 18 m high clock tower. The exterior walls are rough cut sandstone with brick backing and are bearing walls. Floor construction consists of brick arches supported by steel beams and girders spanning to cast iron columns. Figure 5 illustrates the building.

In the 1989 Loma Prieta earthquake, there was minor damage consisting of cracking in the tower near the bottom of the 1906 collapse. There was no damage in the lower floors, but in a partial Third Floor attic slab, there was significant cracking at locations where the steel framing and brick arches changed directions. At those locations, there were no continuous tension ties in the floor diaphragm to prevent spreading and resist tension forces. In the lower floors, both the steel beams and the girder-to-column connections were bolted for continuity, providing tension capacity for the floors.

Figure 5. San Jose Museum of Art, formerly the United States Post Office.

The tower and Third Floor attic have been repaired by strengthening, again funded by FEMA. The tower was strengthened by removing two wythes of brick on the interior and installing reinforced concrete applied as shotcrete. The brick was removed to keep room sizes and window recesses unchanged so original wood finishes could be reinstalled without modification. The Third Floor attic was strengthened by welding steel straps to the exposed top flanges of the steel beams in the unfinished attic to provide tensile ties in both directions of the attic slab.
