## **Strengthening Landmarks for Improved Seismic Performance**

**Loring A. WYLLIE, Jr.**

Structural Engineer  
H.J. Degenkolb Assoc.  
San Francisco, CA, USA

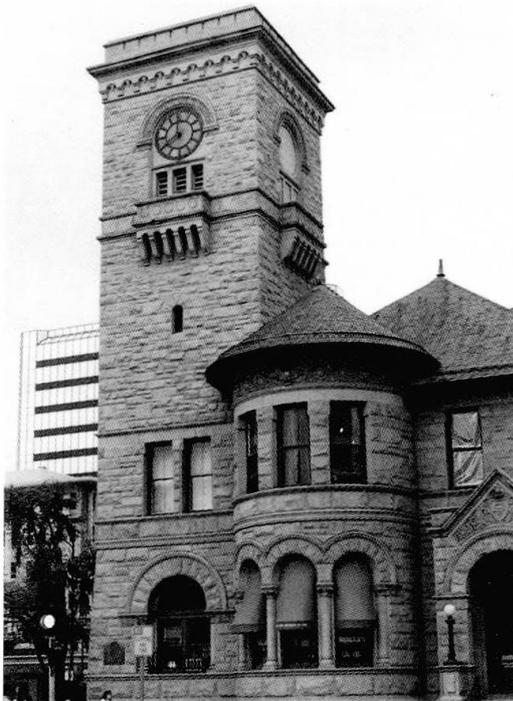
The Museum of Art in San Jose, about 70 km south of San Francisco, was built as the United States Post Office about 1890. It is a two-story plus basement structure with an 18 m high clock tower. The exterior walls are rough cut sandstone with brick backing and are bearing walls. Floor construction consists of brick arches supported by steel beams and girders spanning to cast iron columns. Figure 5 illustrates the building.

The building was extensively damaged in the 1906 San Francisco earthquake when the tower collapsed. The building was rebuilt with minor revisions to the top of the tower. In the 1989 Loma Prieta earthquake, there was minor damage consisting of cracking in the tower near the bottom of the 1906 collapse. There was no damage in the lower floors, but in a partial Third Floor attic slab, there was significant cracking at locations where the steel framing and brick arches changed directions. At those locations, there were no continuous tension ties in the floor diaphragm to prevent spreading and resist tension forces. In the lower floors, both the steel beams and the girder-to-column connections were bolted for continuity, providing tension capacity for the floors.

Figure 5. San Jose Museum of Art, formerly the United States Post Office.

The tower and Third Floor attic have been repaired by strengthening, again funded by FEMA. The tower was strengthened by removing two wythes of brick on the interior and installing reinforced concrete applied as shotcrete. The brick was removed to keep room sizes and window recesses unchanged so original wood finishes could be reinstalled without modification. The Third Floor attic was strengthened by welding steel straps to the exposed top flanges of the steel beams in the unfinished attic to provide tensile ties in both directions of the attic slab.
