**Artikel:** An engineering view of the Statue of Liberty restoration  
**Autor:** Cohen, Edward / Dinapoli, Pasquale / Vellozzi, Joseph  
**DOI:** <https://doi.org/10.5169/seals-53354>

## **An Engineering View of the Statue of Liberty Restoration**

The restoration of the Statue of Liberty was completed in 1986, in time for its centennial celebration. This paper describes the original structural system, its history, the materials and its analysis and design. Also described are the studies, surveys, investigations and analyses conducted to determine the conditions existing and the repairs and modifications necessary for the restoration of the structure. Finally, the solutions considered for the long term preservation of the Statue are discussed, the decision-making process is described and the solutions implemented are presented.

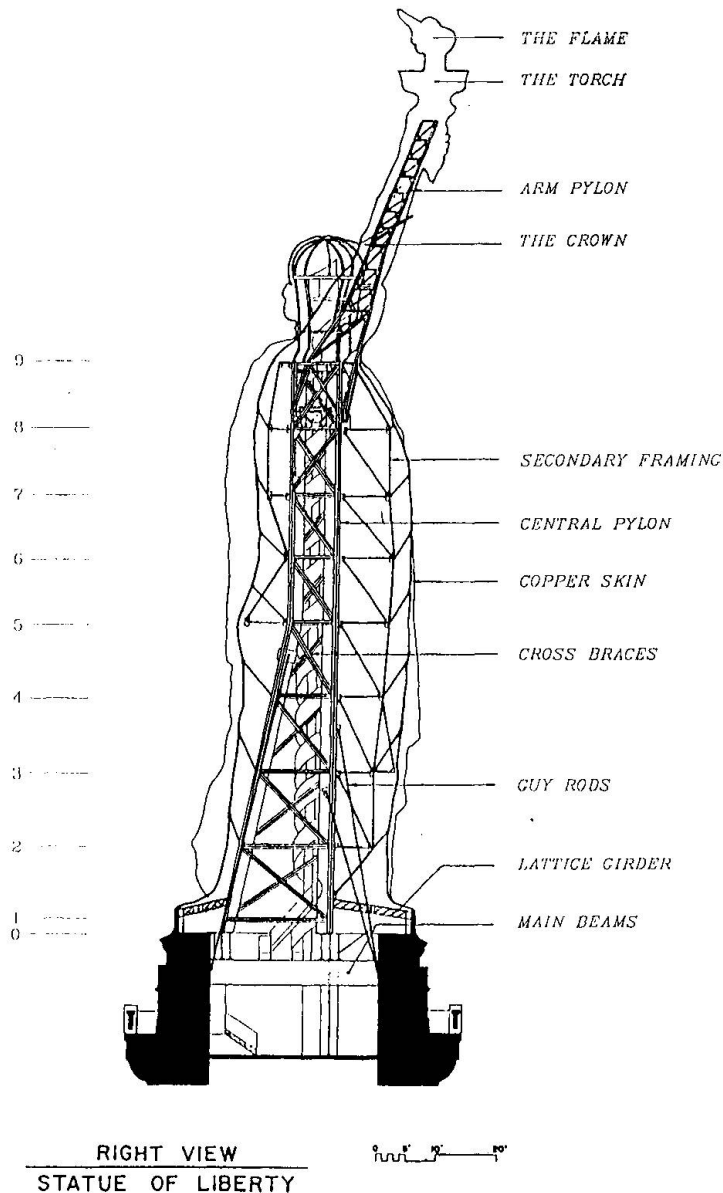
**Fig. 1** The Structure of the Statue

Eiffel's design for the structure was innovative for his time (Fig. 1). This unique system consists of a trussed central pylon and secondary framing to support the copper skin and iron armature through an assembly of sliding and articulated elements which permitted "breathing" of the Statue under thermal and wind loadings. The most ingenious aspect of his design is the concept of flat bars to connect the skin support system to the secondary framework. The steeply inclined bars are installed in compression and provide the resilience to allow adjustment to changes due to temperature and

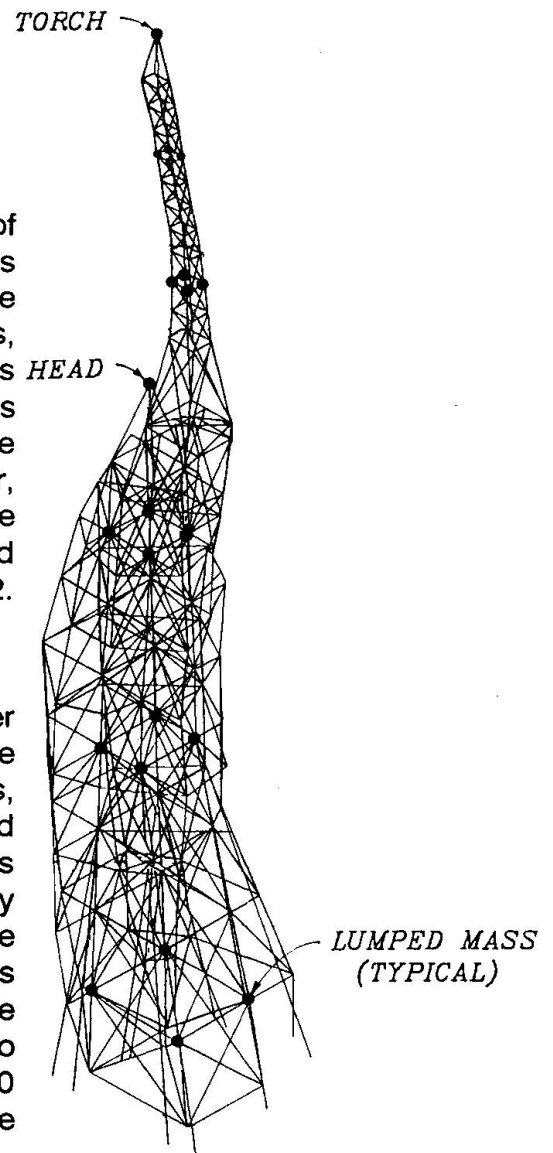
**Fig. 3 Finite Element Model**

The main pylon of the Statue, including the shoulder and the arm framing, was modelled as a three dimensional space truss. The geometric properties, including member sizes and makeup, were obtained largely from field reconnaissance surveys. Any stiffness contributed by the copper skin was conservatively omitted from the model; however, the influence of the "secondary" framework, which transfers the reactions from the skin to the main pylon, was included. The results of the dynamic analysis show that the two lowest modes, having frequencies of 1.66 hz and 1.90 hz, contribute over 95 percent to the response of the Statue under wind loads.
