**Zeitschrift:** IABSE reports = Rapports AIPC = IVBH Berichte  
**Band:** 70 (1993)  
**Rubrik:** Posters: Session 4

## **Posters - Session 4**

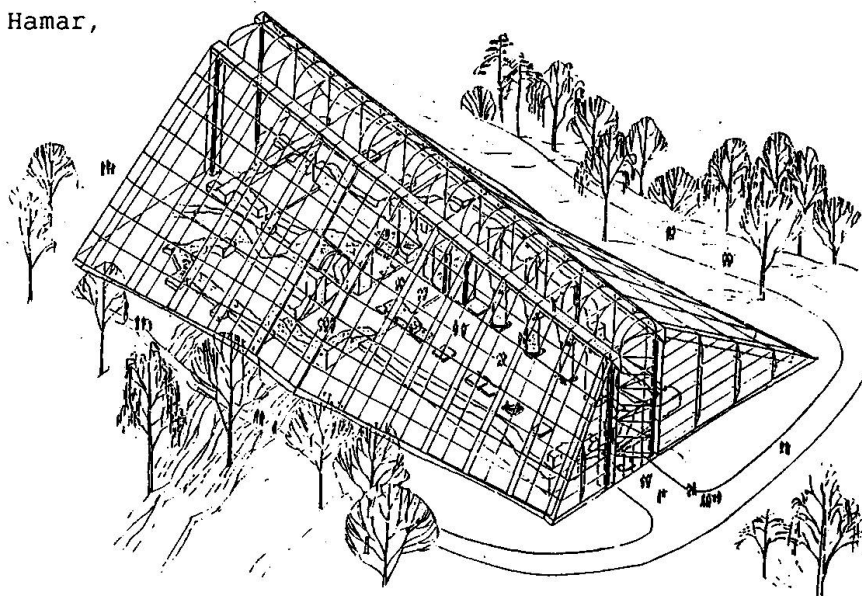
Fig. 1 Drawing of the protection building

The protection building at Hamar, designed by the architects Lund & Slaatto is an aluminium/glass building having warped, skew glass walls, see Fig. 1.

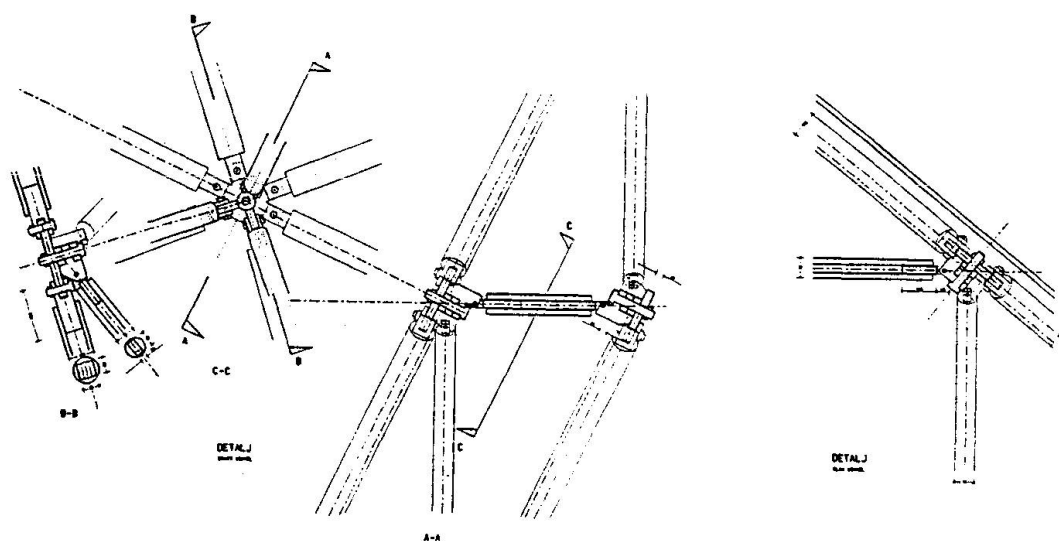
Fig. 2 Joints of the designed protection building at Hamar

For the project a new aluminium space deck system for triangular glass panels has been developed. The system can adjust itself to form a warped surface, see Fig. 2.

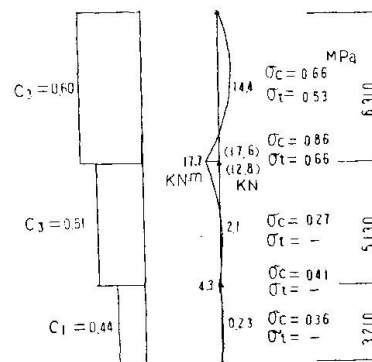
Fig 4 Bending Diagram Perpendicular to Wall

Regarding out-of-plane direction (perpendicular to masonry walls), shear forces based on the maximum response acceleration of inplane direction are adopted as the external forces to check the wall bending bearing capacity (Fig.4). By means of this calculation, at thin walls such as 380mm THK., 510mm THK. steel plates (3.2mm THK.) are installed at both sides of the wall surface to strengthen flexural capacity.

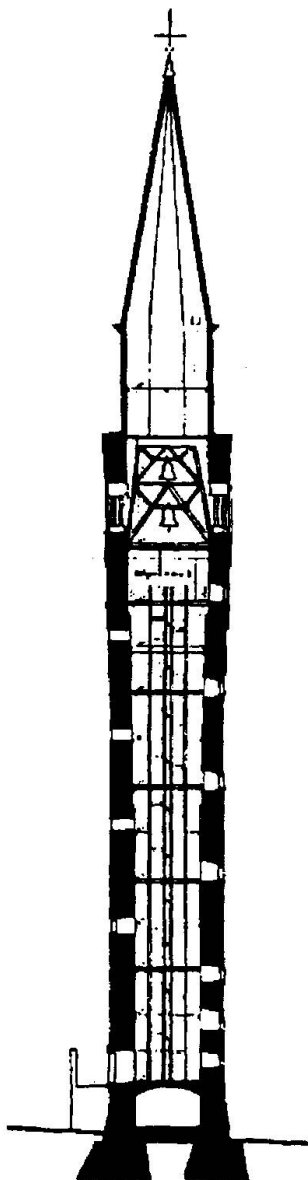
Figure 1

The described case study is the evaluation, repair and strengthening of the bell tower of the Cathedral of Pordenone, in Friuli, the Italy's region stricken by a strong earthquake in 1976. The structure, built during the last years of the 13th century, is 72 m high ( Figure 1) and dominates with its imposing mass the historical center of the town.

Some major concerns about its actual safety level were however justified by the not negligible inclination ( about 1% ) and by evident traces of past heavy damages, often caused by lightnings, which were repaired between the end of the last century and the beginning of the present one.

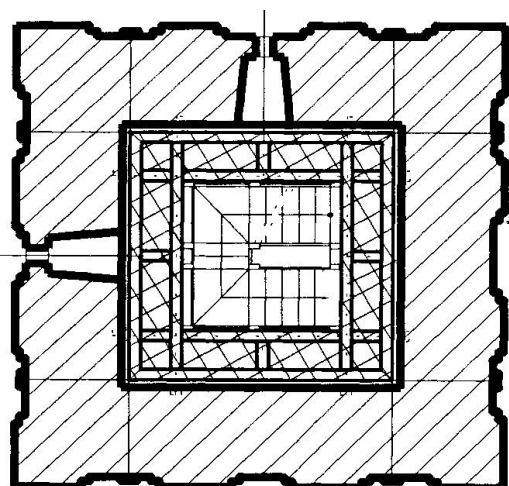
Figure 2 a: section of the tower at the level of one of the diaphragms.

Then, the inactive ties have been substituted and some new ties have been added. Finally, the confinement of the inner parts of the masonry walls have been substantially improved where an external confinement is already provided by the existing iron ties by means of five steel diaphragms in the positions indicated in Figure 1. They are included in the system of the internal stairs as shown in Figure 2 a. Their principal characteristics are shown in Figure 2 b.

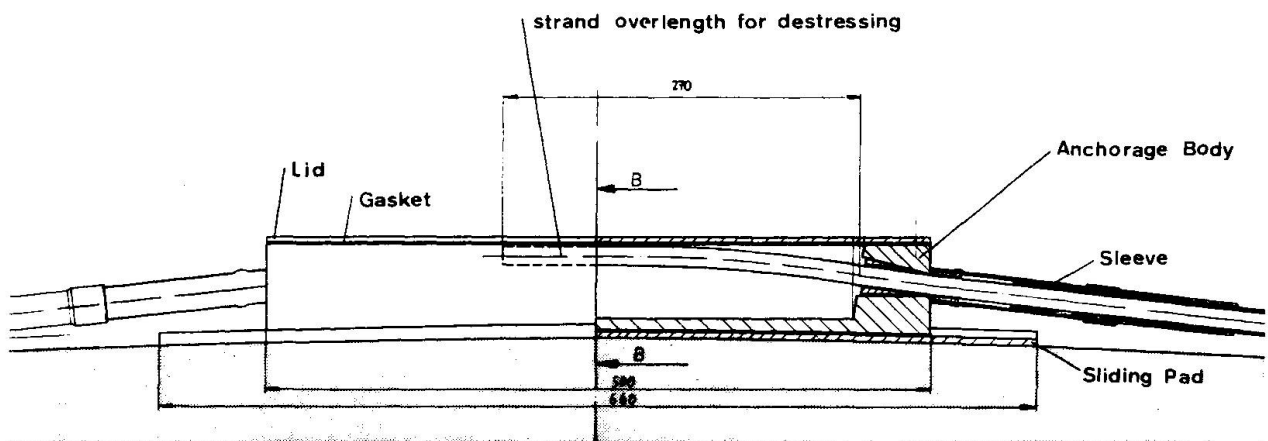
**Fig. 2: Specially Designed Monostrand Anchorage Body on Sliding Pad**

The anchorage system has minimized outside dimensions, thus causing hardly any visual impact on the structure. After stressing, the strand overlength is hidden in the anchorage body and covered by closing the lid as shown in Fig. 2.
