**Zeitschrift:** IABSE reports = Rapports AIPC = IVBH Berichte  
**Band:** 71 (1994)

**Artikel:** Experience of cupola collapse with a diameter of 237 m  
**Autor:** Rasha, Jossif / Lubarov, Boris / Jouravlev, Anatoly  
**DOI:** <https://doi.org/10.5169/seals-54158>

## **Experience of Cupola Collapse with a Diameter of 237 m**

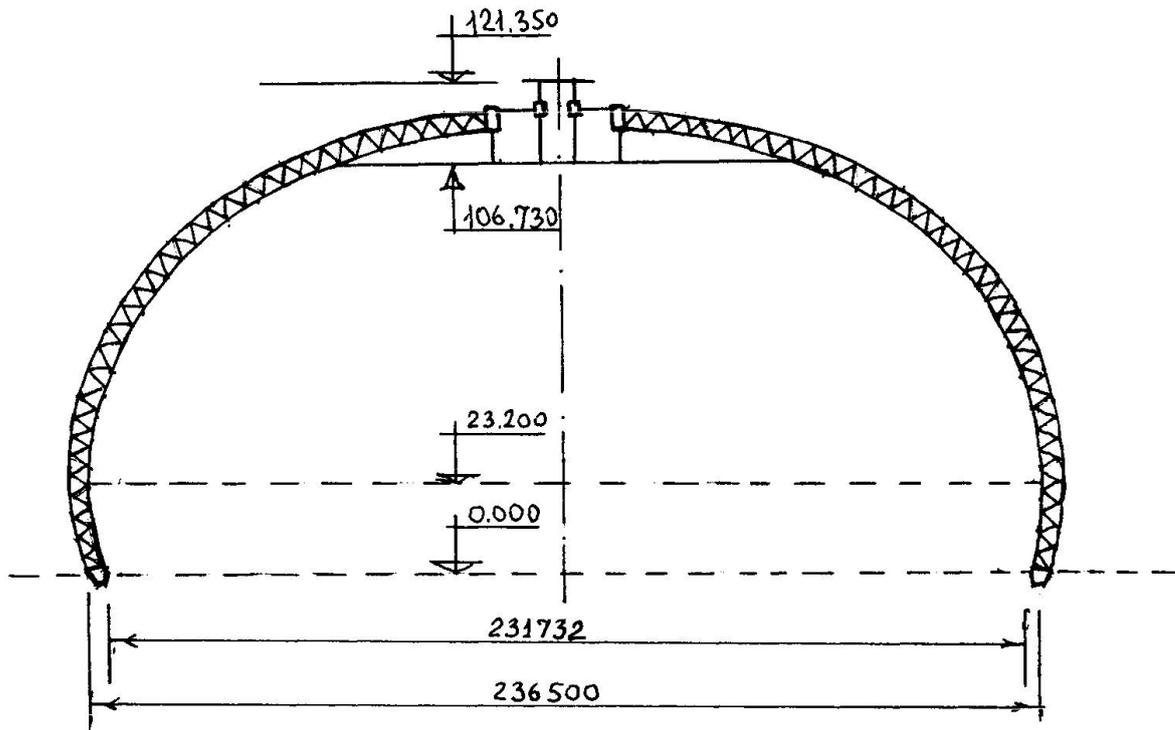
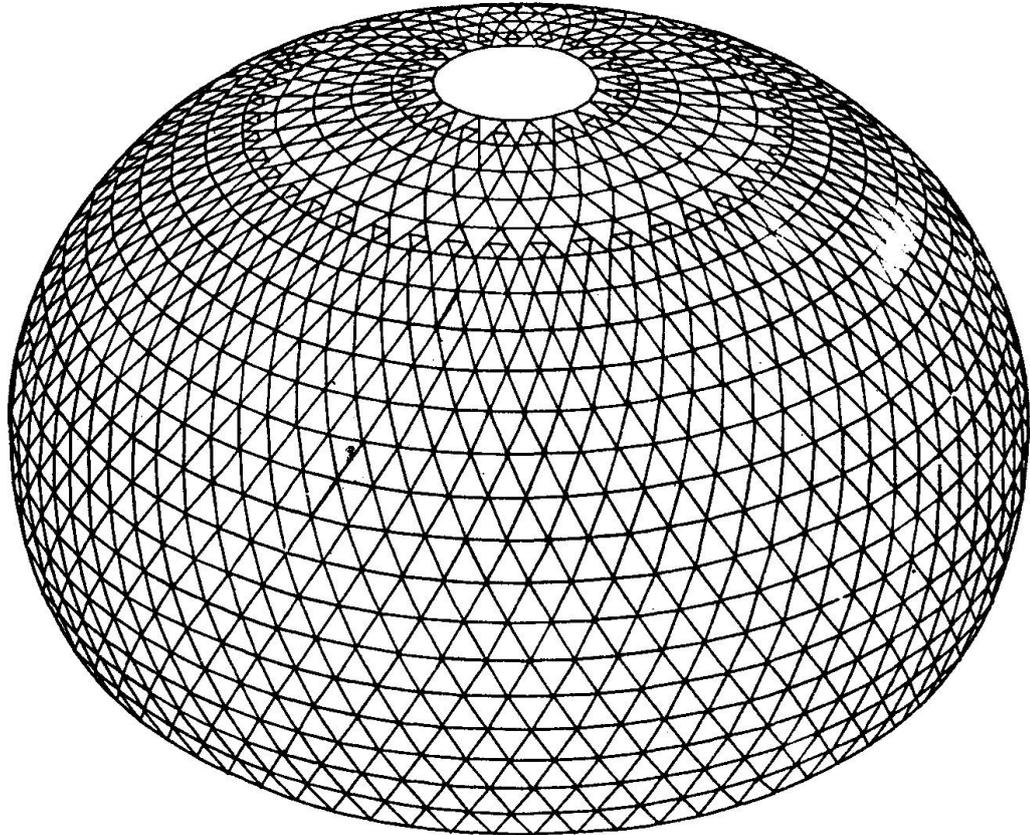
Fig. 1

Design No 1 elaborated by a team of Moscow civil engineers presented a building shaped as a flattened ellipsoid 237 m in equator diameter. The building height was 119 m. See Fig.1. The principal load-carrying structures were designed as a two-layer latticed shell at a spacing of 2.5 m between the upper and lower chords. The shell upper and lower chords were made of twin angles. The lattice between the chords was made of tubes welded to the angle flanges. A diaphragm 1,5 mm thick of weatherproof steel was welded to the upper members of the shell. The diaphragm served as roofing and made the bars stable. The heat-insulated boards of the suspended ceiling working as fire protection of the carrying structures at the same time were secured to the lower chords of the shell. The erection members were connected by high-strength bolts. The total weight of the steel structures was about 11000 tN.

In 1986 the dome collapsed. Since it was early morning, there were no victims. Before the collapse took place, the construction site underwent very rare meteorological condition. The air temperature remained  $-20^{\circ}\text{C}$  during 20 days. Then during 6 hours the temperature changed to  $+1^{\circ}\text{C}$ . Three hours after this the dome collapsed.

Let us analyse what changes happened in the stress conditions of the structures under such a sudden change of air temperature. The space 2.5 m high between the upper chord covered with cold steel sheets and the lower lagged chord turned to something like a thermos with a temperature of  $-20^{\circ}\text{C}$ . The bars of the upper cold chord warmed up faster under the outside sharp heating than the bars of the lagged lower chord - see Fig.4. The difference in temperature of the chords according to the calculations could reach  $15^{\circ}\text{C}$ . Nonuniform heating of one chord to  $1^{\circ}\text{C}$  gave the stress increment to 3 MPa in some of the bars and at  $15^{\circ}\text{C}$  this value made 45 MPa or almost 30% critical strength of the steel. Most probable the additional stresses brought mostly loaded bars to the loss of stability and caused the collapse.

1. When designing long-span structures it is necessary to use statistically treated meteorological data on the sharp changes of outdoor air temperature with determination of the temperature change speed and range and probability for 25, 50 and 100 years.
2. It is necessary to perform heat engineering and static calculations for the long-span structures for the stage of construction and operation in sharp condition of air temperature change in the building area.
3. When designing the enclosing structures it is necessary to provide for equal temperature conditions of the load carrying structures.

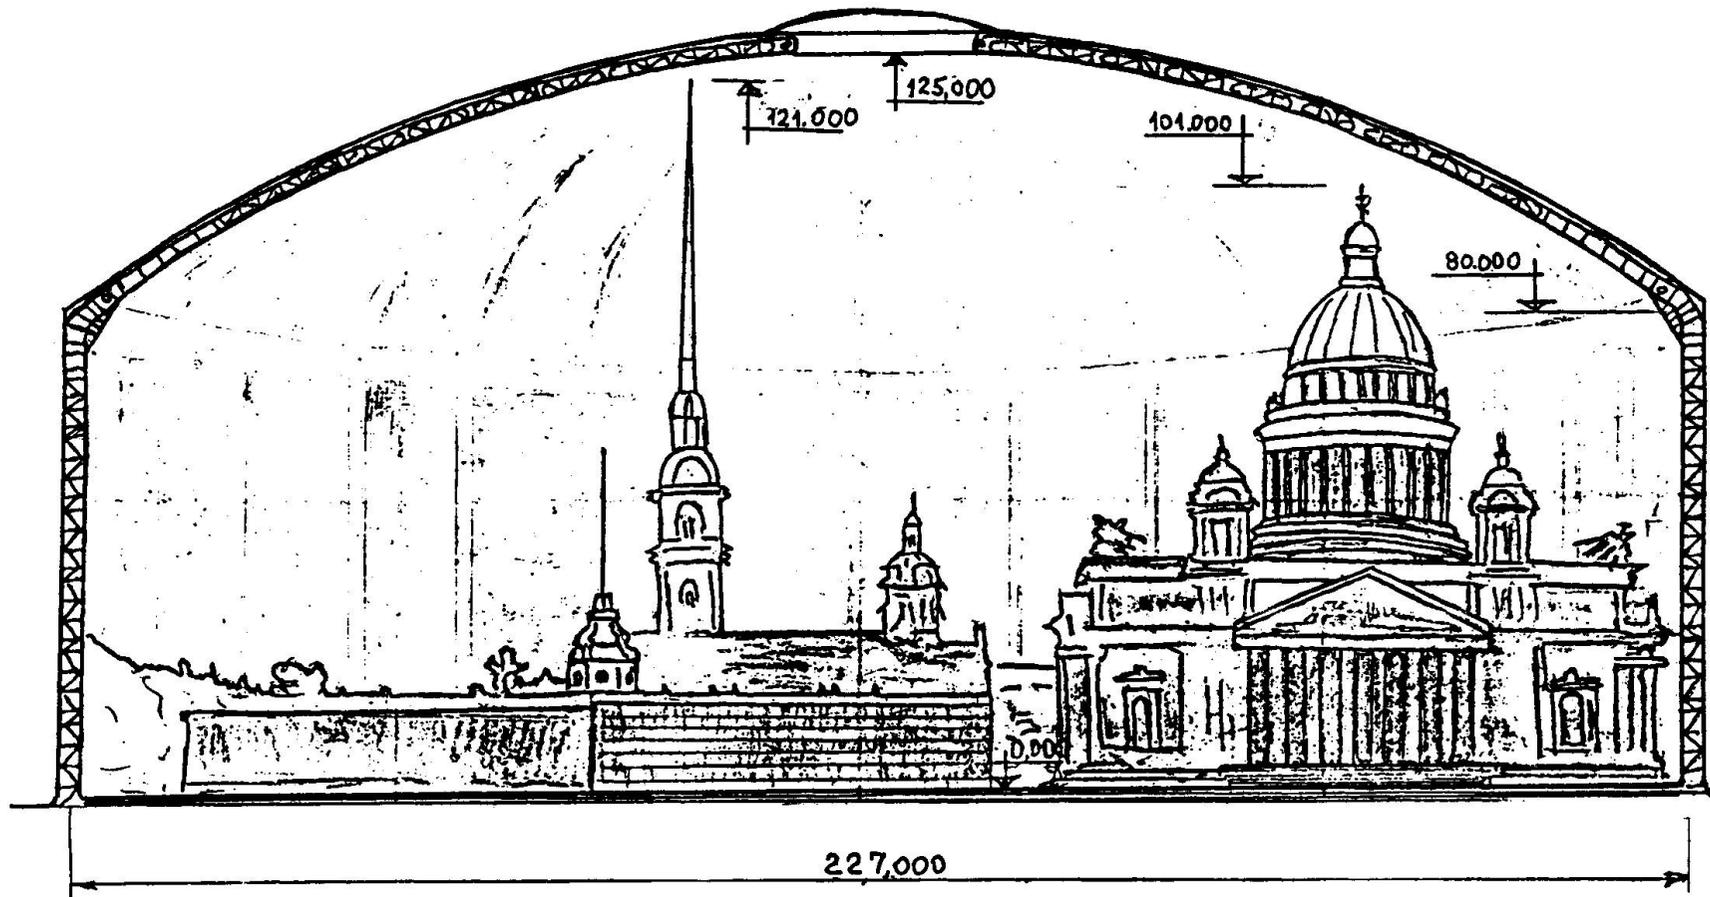
Fig 2.

Design No.2 was elaborated by a team of Leningrad (St.Petersburg) engineers. It was a structure 128 m in height made of a cylinder like part 80 m high and a hollow domelike roofing 227 m in dia with a boom of lift 47 m. See Fig.2. The cylinderlike framework was made of columns connected by cross-braces and the dome was designed as a circular ribbed structure. The total weight of the structures made about 11500 tN.
