**Zeitschrift:** IABSE reports = Rapports AIPC = IVBH Berichte  
**Band:** 73/1/73/2 (1995)

**Artikel:** Reinforced concrete framed building strengthened by prestressing  
**Autor:** Najdanovic, Dusan / Alendar, Vanja  
**DOI:** <https://doi.org/10.5169/seals-55296>

## Reinforced Concrete Framed Building Strengthened by Prestressing

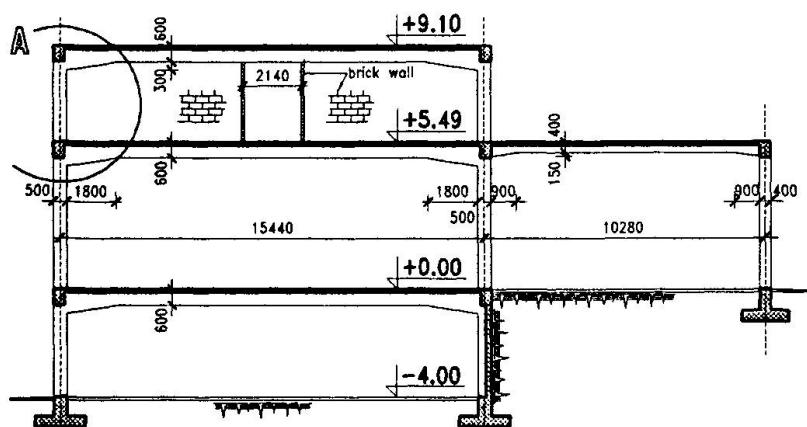
Fig. 1 Disposition of a transverse structure frame

The building is a three-story reinforced concrete frame structure with an annex, with dimensions  $73,440 \times 26,160$  mm in plan, and clear story heights  $3,400 + 4,890 + 3,061$  mm. The span of the transverse frames, mutually spaced at 5,200 mm, is 15,440 mm in the main bay and 10,280 mm in the annex, Fig. 1.

Frame beams are haunched, of rectangular cross-section, dimensions  $400 \times 600$  mm in the main bay and  $400 \times 400$  mm in the annex. Frame columns, dimensions  $400 \times 500$  mm are founded on strip foundations. Floor structure consists of semi-prefabricated solid reinforced concrete one-way slab, total thickness 120 mm.
