Survey on Fatigue Damage in Steel Railway Bridges in Thailand
Dommages par fatigue de ponts ferroviaires métalliques en Thaïlande
Ermüdungsschäden an Stahleisenbahnbrücken in Thailand

Thongpan THAVEE
Director
The State Railway of Thailand
Bangkok, Thailand

The results of the survey of fatigue damage of steel bridges of the State Railway of Thailand are presented. An investigation of the characteristic and the cause of cracks occurring in the welds of stringer necks of through girder bridges was conducted.

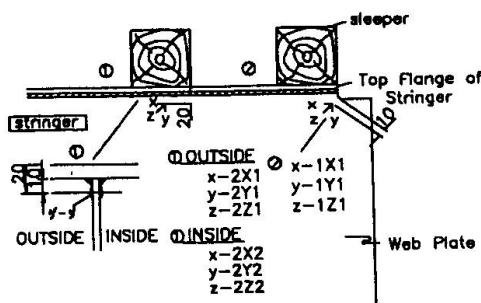
Fig.4 Position of strain gauges

Stress behaviors were examined by sticking a triaxial gauge to the positions as shown in Fig.4 with due consideration to the foregoing.

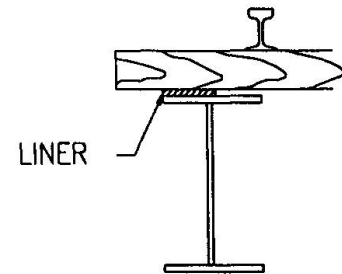
Fig.6 Liner inserted intentionally

- (1) ALSTHOM: (under present conditions: in close contact inside; 0.2 to 0.5 mm apart outside) (See Fig.5)
 - (2) ALSTHOM: (liner inserted intentionally: 2 mm apart inside; in close contact outside) (See Fig.6)
 - (3) new-HITACHI (liner inserted intentionally: 2 mm apart inside; in close contact outside)
- The axle load and spacing of ALSTHOM and new-HITACHI is shown Fig.7.

- (3) Effects of contact conditions between the sleeper and the flange
Stress acting on the neck just under the sleeper is affected greatly by the contact condition between the sleeper and the upper flange. Under present conditions, the sleeper and the flange are in contact on the inside of the stringer, but there is a gap of 0.2 to 0.5 mm in the outside. Lifting the sleeper manually makes the gap expand to 1 to 2 mm. Therefore, external force from the sleeper is absorbed by the inside of
