Survey on Fatigue Damage in Steel Railway Bridges in Thailand

Thongpan THAVEE Director The State Railway of Thailand Bangkok, Thailand

The results of the survey of fatigue damage of steel bridges of the State Railway of Thailand are presented. An investigation of the characteristic and the cause of cracks occurring in the welds of stringer necks of through girder bridges was conducted.

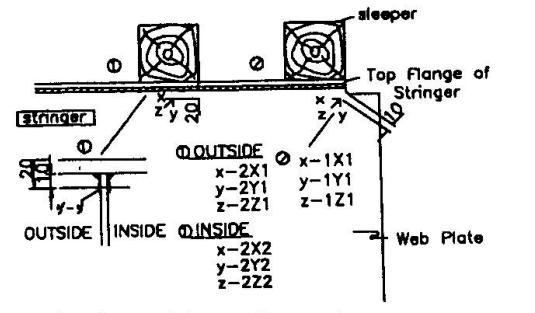
Fig.4 Position of strain gauges

Stress behaviors were examined by sticking a triaxial gauge to the positions as shown in Fig.4 with due consideration to the foregoing.

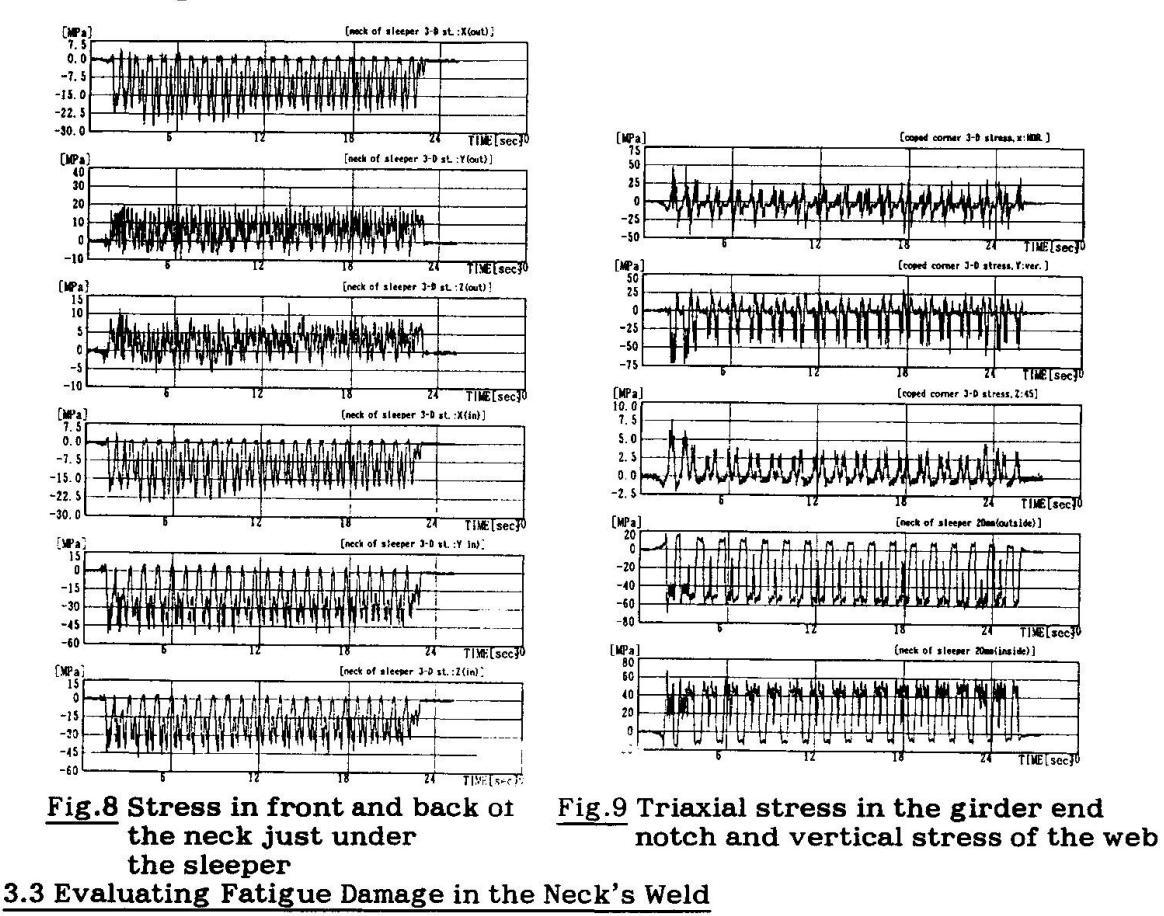
In Fig.9, the upper three waveforms show triaxial stress in the girder end notch, and the lower two waveforms show vertical stress in the front and the back of the web in the halfway of the stringer.

(3) Effects of contact conditions between the sleeper and the flange Stress acting on the neck just under the sleeper is affected greatly by the contact condition between the sleeper and the upper flange. Under present conditions, the sleeper and the flange are in contact on the inside of the stringer, but there is a gap of 0.2 to 0.5 mm in the outside. Lifting the sleeper manually makes the gap expand to 1 to 2 mm. Therefore, external force from the sleeper is absorbed by the inside of

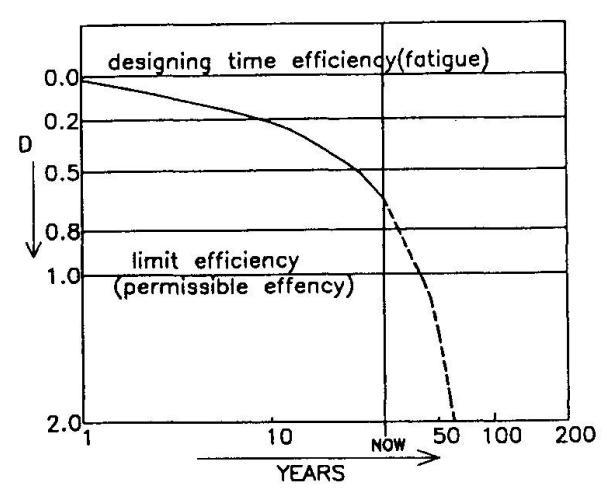
The method and standards for evaluating fatigue were based on the fatigue design guidelines of Japanese Society of Steel Construction²⁾. The result of fatigue damage evaluations is shown in Fig.10 and Fig.11.

- (1) Vertical stress of about 65 MPa is acting on the neck's weld. It was greater than the stress in the axial direction of the bridge, and was in the reverse phase in the inside and the outside of the web.
- (2) Vertical stress due to out-of-plane bending of the stringer neck was as large as 75 MPa.
- (3) Vertical stress in the notch of the stringer's end was 90 to 100 MPa and main stress was similarly great.
- (4) Fatigue crack occurrence life was calculated to be 9 years for vertical stress acting on the neck's weld. Fatigue crack occurrence life when the sleeper was in loose contact (when the sleeper was completely deviated) was calculated to be 8 years.

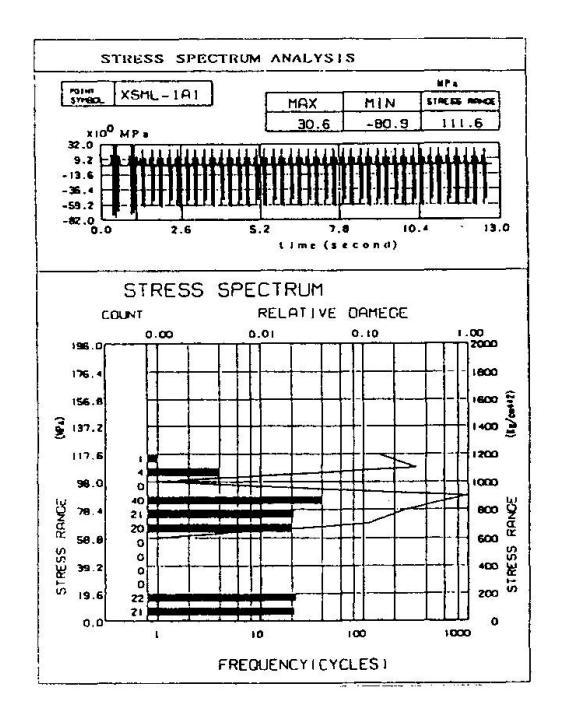
In the analysis of the waveform of stress acting on rails, based on the fact that the crack in the neck's weld was 700 mm long, the rail was assumed as a 1,000 mm span continuous beam with one sleeper lost. In that condition, axial force acting on the rail was obtained by simulation. On this basis, stress "on the railhead in the weld joint" and "bolt holes in the joint bar" was obtained. Stress acting on the bolt holes was obtained by the FEM analysis because it could not be obtained by a simple beam stress calculation. Fig.12 shows the stress waveform and stress spectrum in topflange of the rail obtained by simulation.

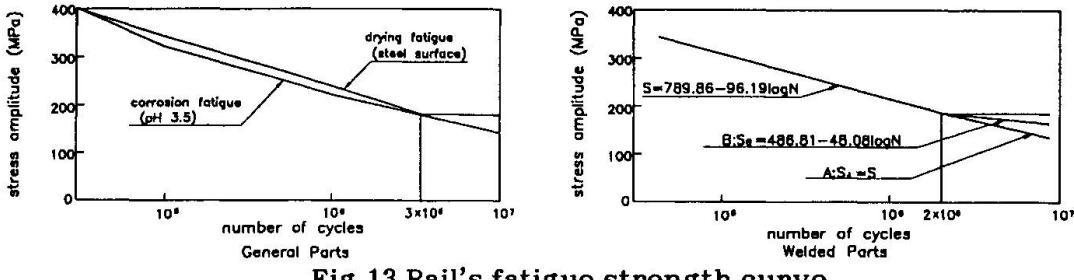
Fig.13 Rail's fatigue strength curve

The fatigue strength curve of rails used for evaluation of fatigue was the one as shown in Fig.13^{3,4)} which is usually used by former Japanese National Railways. The S-N curve used to evaluate general parts was for corrosion fatigue (pH3.5).
