**Artikel:** Survey on fatigue damage in steel railway bridges in Thailand  
**Autor:** Thavee, Thongpan / Abe, Makoto / Kobayashi, Toshio  
**DOI:** <https://doi.org/10.5169/seals-55312>

## **Survey on Fatigue Damage in Steel Railway Bridges in Thailand**

The results of the survey of fatigue damage of steel bridges of the State Railway of Thailand are presented. An investigation of the characteristic and the cause of cracks occurring in the welds of stringer necks of through girder bridges was conducted.

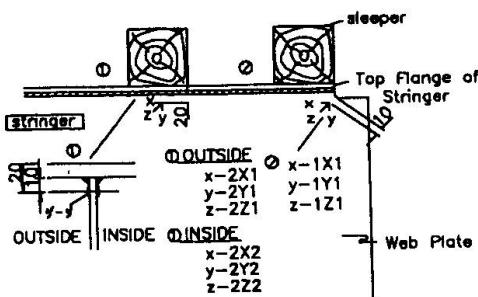
Fig.4 Position of strain gauges

Stress behaviors were examined by sticking a triaxial gauge to the positions as shown in Fig.4 with due consideration to the foregoing.

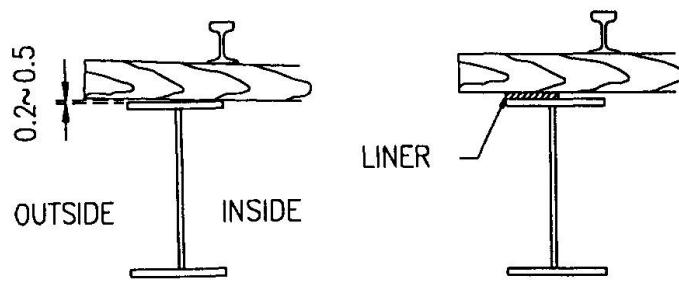
Fig.5 Present condition Fig.6 Liner inserted intentionally

- (1) ALSTHOM: (under present conditions: in close contact inside; 0.2 to 0.5 mm apart outside) (See Fig.5)
- (2) ALSTHOM: (liner inserted intentionally: 2 mm apart inside; in close contact outside) (See Fig.6)
- (3) new-HITACHI (liner inserted intentionally: 2 mm apart inside; in close contact outside)

- (3) Effects of contact conditions between the sleeper and the flange. Stress acting on the neck just under the sleeper is affected greatly by the contact condition between the sleeper and the upper flange. Under present conditions, the sleeper and the flange are in contact on the inside of the stringer, but there is a gap of 0.2 to 0.5 mm in the outside. Lifting the sleeper manually makes the gap expand to 1 to 2 mm. Therefore, external force from the sleeper is absorbed by the inside of

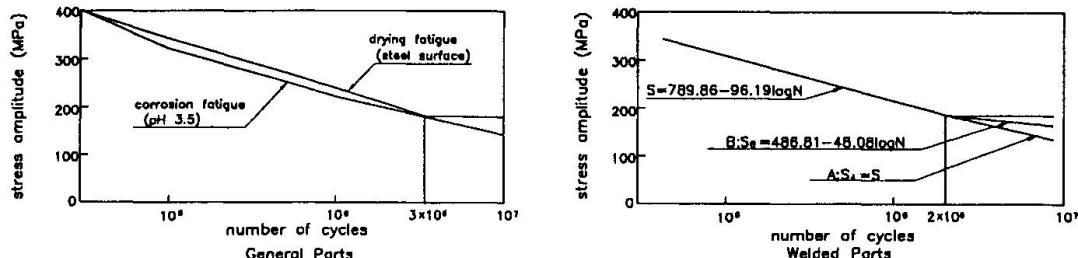
Fig.13 Rail's fatigue strength curve

The fatigue strength curve of rails used for evaluation of fatigue was the one as shown in Fig.13 <sup>3,4)</sup> which is usually used by former Japanese National Railways.
