Artikel: Correcting design deficiencies in a new five-story building
Autor: Suarez, Mario G. / McCarthy, Daniel J.
DOI: <https://doi.org/10.5169/seals-55357>

Correcting Design Deficiencies in a New Five-Story Building

A five-story office building was investigated to assess its structural integrity immediately following construction, prior to occupancy. Each floor level consisted typically of two-way post-tensioned concrete slabs, except the fourth level which was built in reinforced concrete. Significant structural deficiencies were identified. Some elements had little or no reserve against failure at normal service loads. A proposed load test was judged to be inappropriate, as it would have likely resulted in failure of structural elements. Repair and strengthening measures involving various methods and materials were engineered.

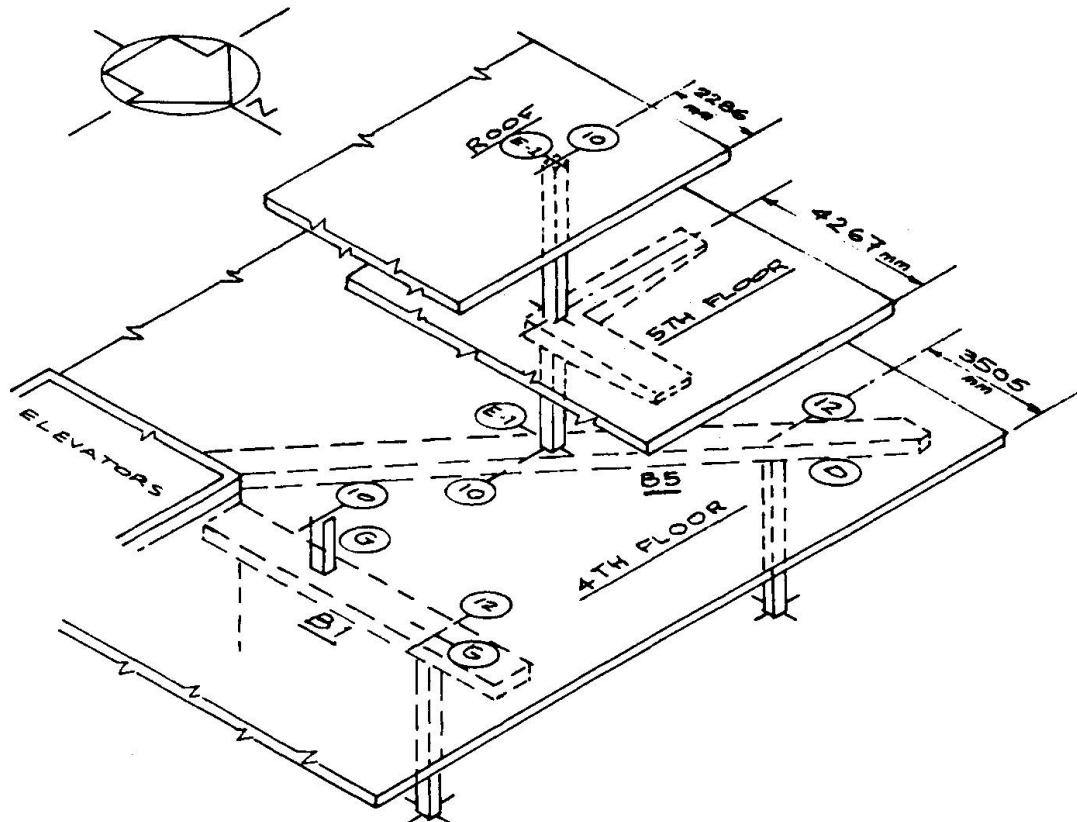
Fig. 1 represents the general structural framing of a quadrant of the original as-designed building. The roof, fifth and fourth floor slabs stepped back for architectural purposes. The third, second and first structural levels (not shown) have supporting columns around the perimeter of the building.

Fig. 1 Schematic view at corner of structure showing upper floors.

flat plates. Typically, based on US current practice, the post-tensioning strands are uniformly spaced in one direction (north-south) and banded along column lines in the orthogonal direction (east-west). Not typical of current practice was the use of relatively long cantilever overhangs of the roof and fifth level slabs, and the short beams cantilevered from the exterior columns, composite with the fifth floor slab.

The fourth level was constructed as a conventionally reinforced concrete slab and beam frame. As is seen in Fig. 1, the exterior perimeter columns supporting the roof and fifth levels did not extend below the fourth level but, instead, were supported on and transferred their loads to shallow, reinforced concrete transfer girders.
