Artikel: Deterioration and evaluation of Chien-Kou Viaduct in Taipei

Deterioration and Evaluation of Chien-Kou Viaduct in Taipei

Chien-Kou Viaduct was the first urban expressway built in Taiwan in 1983. The traffic growth increased rapidly since then. Traffic volume of the viaduct had already reached its capacity, and some damages were observed in the past years. This paper focuses on the damage assessment and the safety evaluation of the viaduct, especially, the non-destructive test for the investigation of corrosion rate of steel rebar.

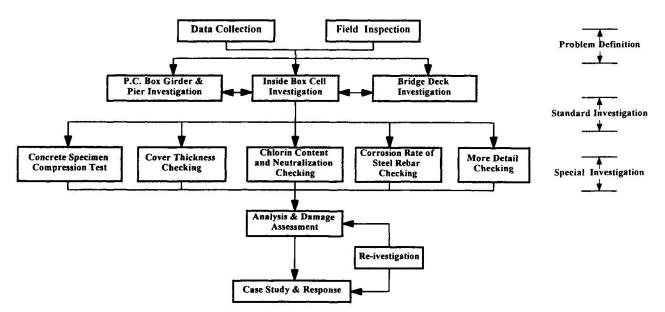
Figure 3. Inpsection of Chien Kou Viaduct

The structure of viaduct was mainly P.C. box girders and R.C. piers. The resisting capacity of the viaduct depends mainly on the strengths of concrete and reinforcement. Therefore, the inspections were focus on the damage assessment of these two materials. The checking items were damage assessment on main structure, evaluation of concrete strength and concrete deterioration, and investigation of rebar corrosion.
