**Artikel:** Strengthening of an unreinforced masonry building

**Autor:** Heintz, Jon A. / Wosser, Thomas D.

## Strengthening of an Unreinforced Masonry Building

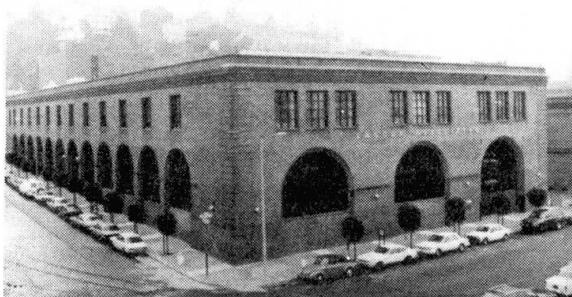
**Fig. 1** Building Exterior

50 Green Street is a two-story brick structure located north of Market Street in San Francisco's warehouse district. It occupies the entire city block between Green, Commerce, Battery, and Front Streets. The exterior facade consists of an arcade of slender piers and graceful semicircular arches along all four elevations. Ornate brick relief patterns around the arches, raised detailing in the four corners, and corbelled courses of brick at the parapet give the building a distinctive appearance.
