Repair and Consolidation of the Masonry Structure of a Building

Sevastean Ioan IANCA

The paper presents a study of a case about the damages caused by the 1977 earthquake to the structure of a building in Craiova, Romania, as well as repairing and consolidation solutions for this structure. The proposed solutions intend to restore the initial bearing capacity of the structure and its safety.

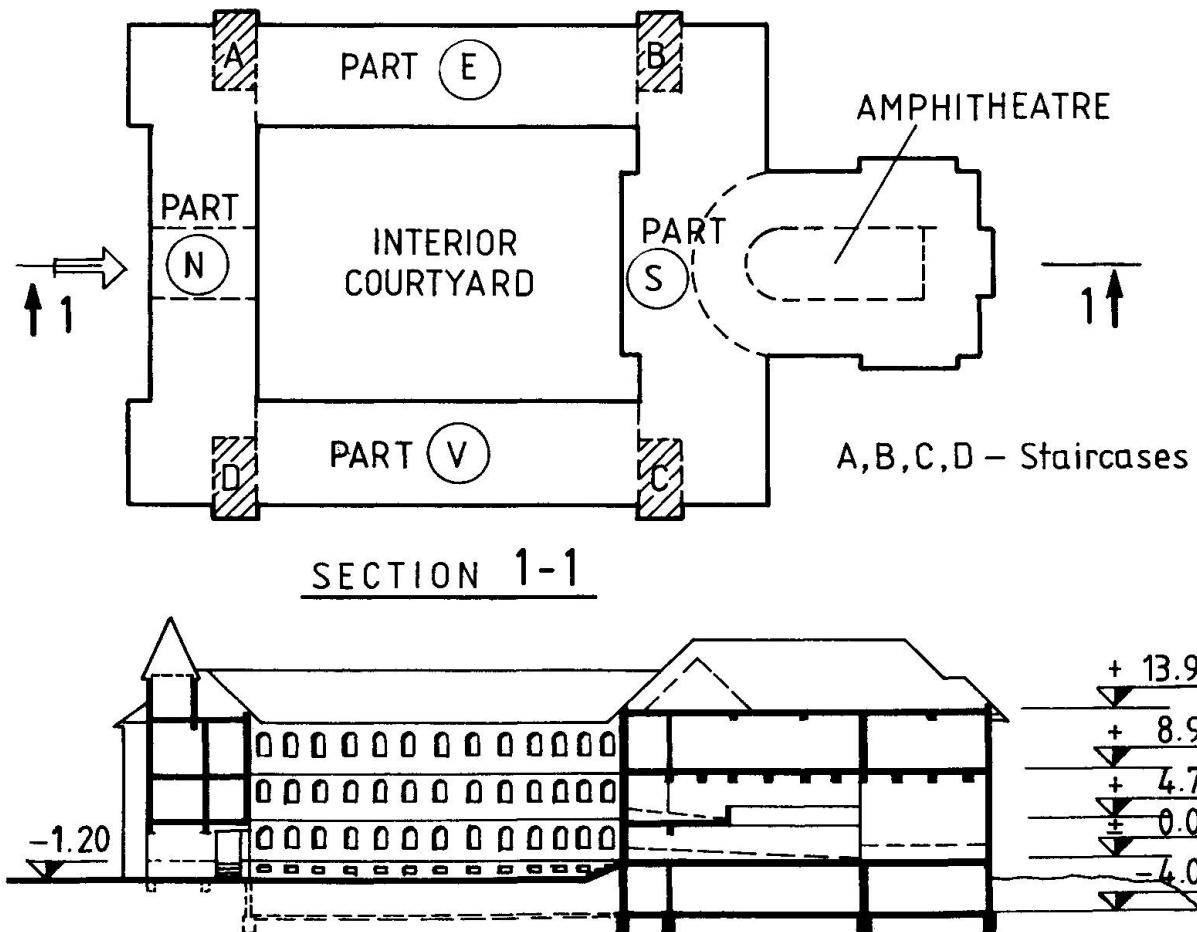
Fig. 1 The geometrical characteristics of the building

Having a quadrilateral principal plane form, with an interior courtyard, and with an amphitheatre in the South part (see Figure 1), the building is developed on three levels (ground floor and two storeys) in the North part and four levels (basement, ground floor and two storeys) in the South, East and West parts.
