Case Study of a Damaged Reinforced Concrete Bridge

Arlindo GONÇALVES

Lab. Nac. de Engenharia Civil
Lisbon, Portugal

This paper presents the results of an inspection carried out in one bridge built 50 years ago, aiming at identifying the origins of general concrete cracking. The results of the observations and tests made it possible to conclude that the cracking was due to alkali-silica reactions. Subsequently, the corrosion of the reinforcing steel caused larger cracks and concrete spalling.

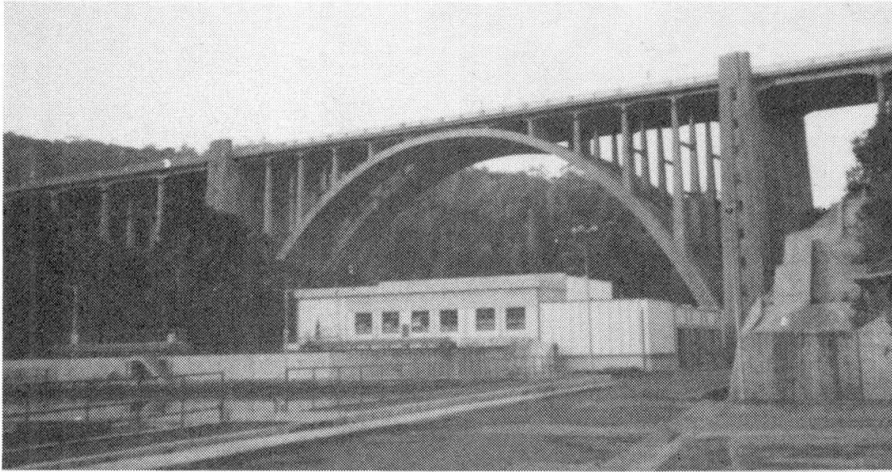
Fig. 1 General view of the bridge

The Duarte Pacheco bridge, built in the 40's, is located in the Alcântara valley, a short distance from the Tagus estuary, in Lisbon. It is made up of a central arch with a span of about 100 m, linked by two 85 m long transition portal frames to two lateral arches with a 43 m span each (Fig. 1).
