Case Study of a Damaged Reinforced Concrete Bridge

Arlindo GONÇALVES Civil Engineer Lab. Nac. de Engenharia Civil Lisbon, Portugal

This paper presents the results of an inspection carried out in one bridge built 50 years ago, aiming at identifying the origins of general concrete cracking. The results of the observations and tests made it possible to conclude that the cracking was due to alkalisilica reactions. Subsequently, the corrosion of the reinforcing steel caused larger cracks and concrete spalling.

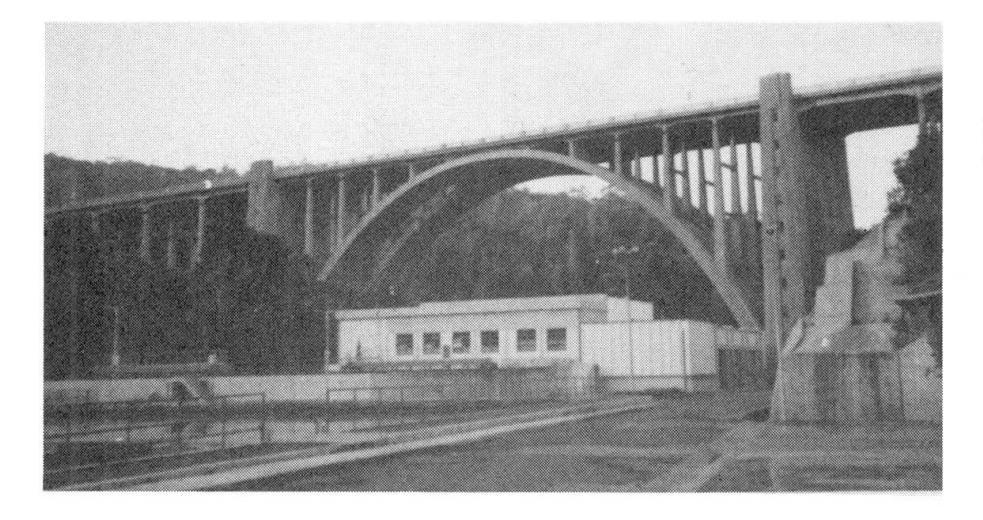
Fig. 1 General view of the bridge

The Duarte Pacheco bridge, built in the 40's, is located in the Alcântara valley, a short distance from the Tagus estuary, in Lisbon. It is made up of a central arch with a span of about 100 m, linked by two 85 m long transition portal frames to two lateral arches with a 43 m span each (Fig. 1).
