Zeitschrift: IABSE reports = Rapports AIPC = IVBH Berichte

Artikel: Case study of a damaged reinforced concrete bridge

Autor: Gonçalves, Arlindo

Case Study of a Damaged Reinforced Concrete Bridge

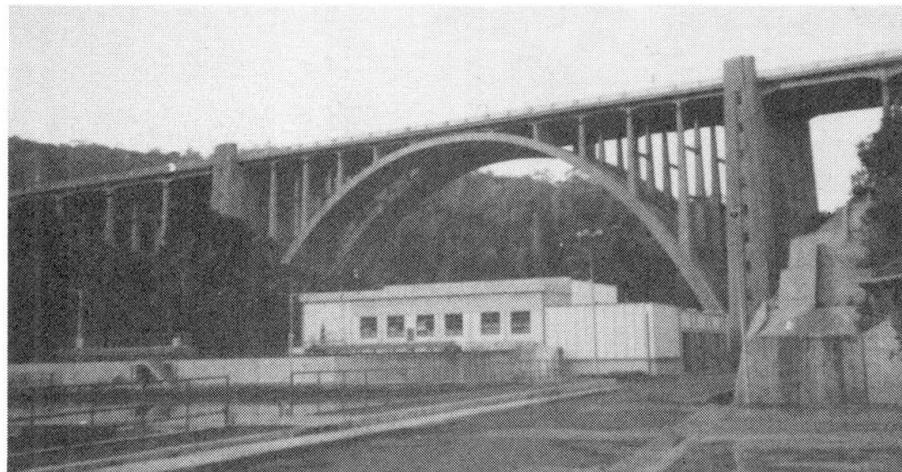
Fig. 1 General view of the bridge

The areas of greater deterioration were located in the central arch, below which the road traffic is more intense, in places more exposed to rain and sunshine. Figs. 2 and 3 show typical examples of cracking observed in concrete.
