**Zeitschrift:** IABSE reports = Rapports AIPC = IVBH Berichte  
**Band:** 73/1/73/2 (1995)

**Artikel:** Deck cracking of Shelby Creek Bridge  
**Autor:** Kuzmanovic, Bogdan O. / Sanchez, Manuel R.  
**DOI:** <https://doi.org/10.5169/seals-55240>

## Deck Cracking of Shelby Creek Bridge

### **SUMMARY**

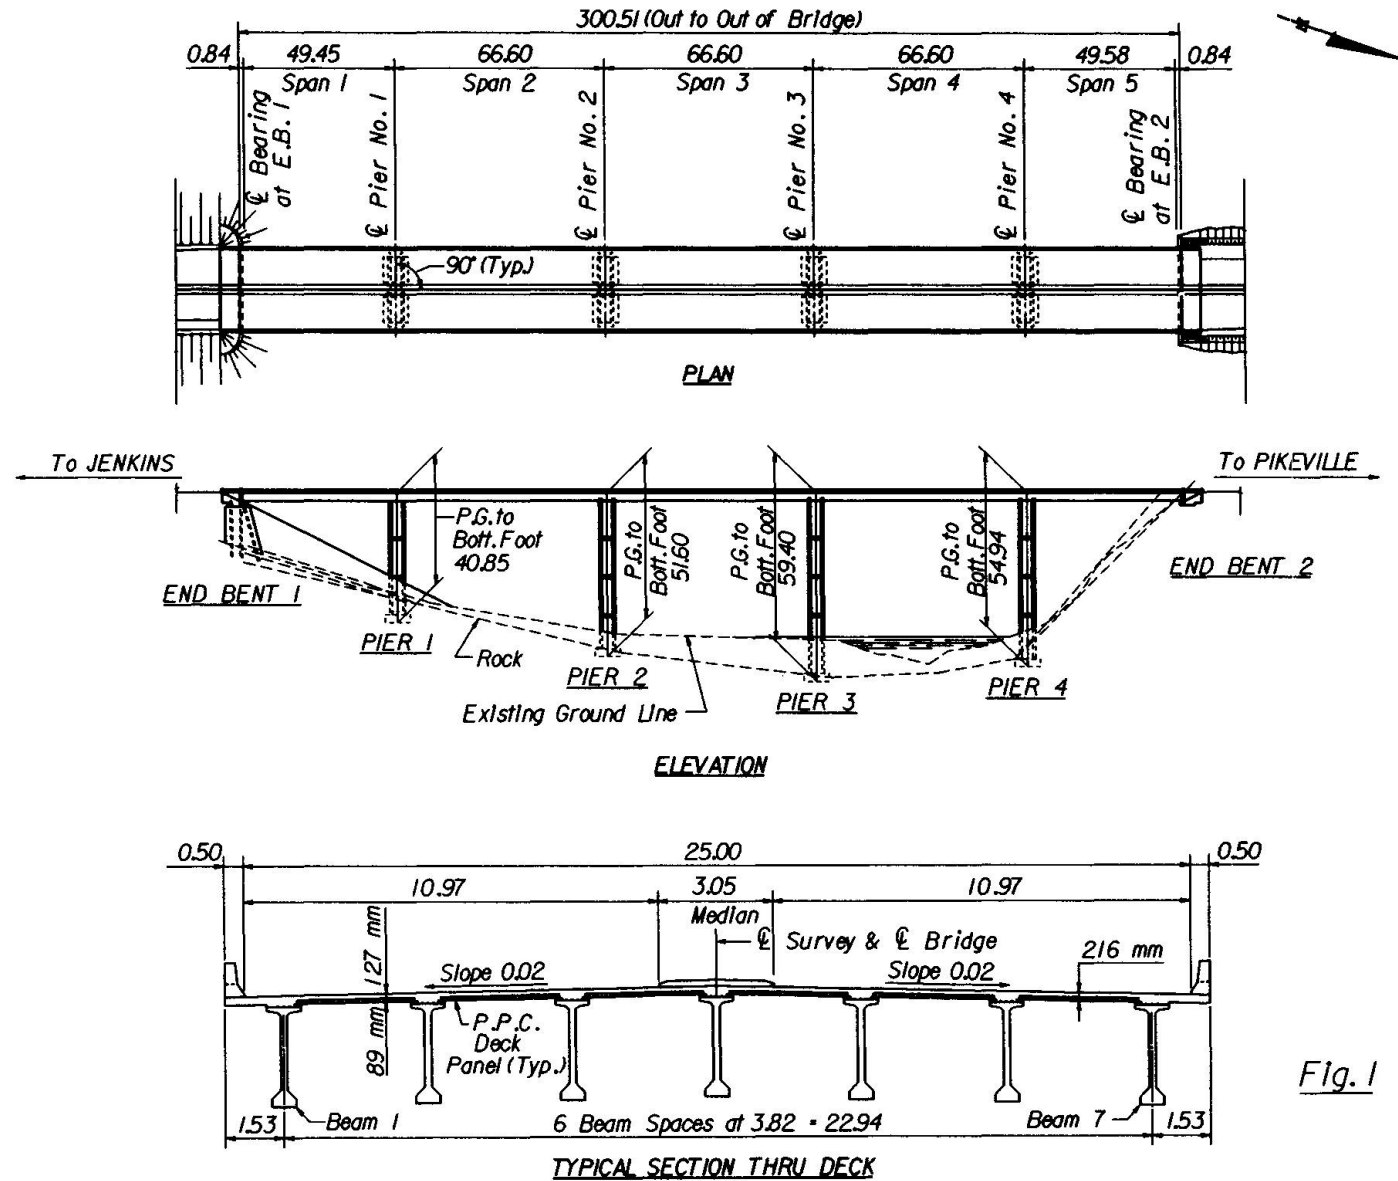
Fig. 1 Layout

Shelby Creek Bridge on US 23/US 119 in Kentucky is a four lane, five span (49.45m + 3 x 66.60m + 49.58m) beam type segmental bridge with two-way traffic as separated by a 3m wide raised median, Fig. 1. The bridge deck is 25m wide and it is composed of precast prestressed 41 MPa concrete panels (PPC) 9 cm thick used as formwork for 13cm cast-in-place reinforced 34 MPa concrete deck overlay (Fig. 4). The superstructure consists of seven precast 48 MPa lightweight concrete beams of constant depth at a spacing of 3.82m. The bridge is supported on four piers and two end-bents. The height of the piers varies from 35.74 to 50.09m. Piers are supported on spread footings on rock. Each pier consists of two twin curtain walls 0.90 x 3.66m spaced at 4.57m. They are battened together at 11.60m height intervals and post-tensioned.
