**Artikel:** Deck cracking of Shelby Creek Bridge

**Autor:** Kuzmanovic, Bogdan O. / Sanchez, Manuel R.

## Deck Cracking of Shelby Creek Bridge

Early cracking of a cast-in-place reinforced concrete overlay of a sandwich concrete deck of Shelby Creek Bridge is investigated. Independent numerical checking proved that the bridge design was correct. Shrinkage cracking was enhanced by several factors. This enhancement was due to the special features of the bridge.

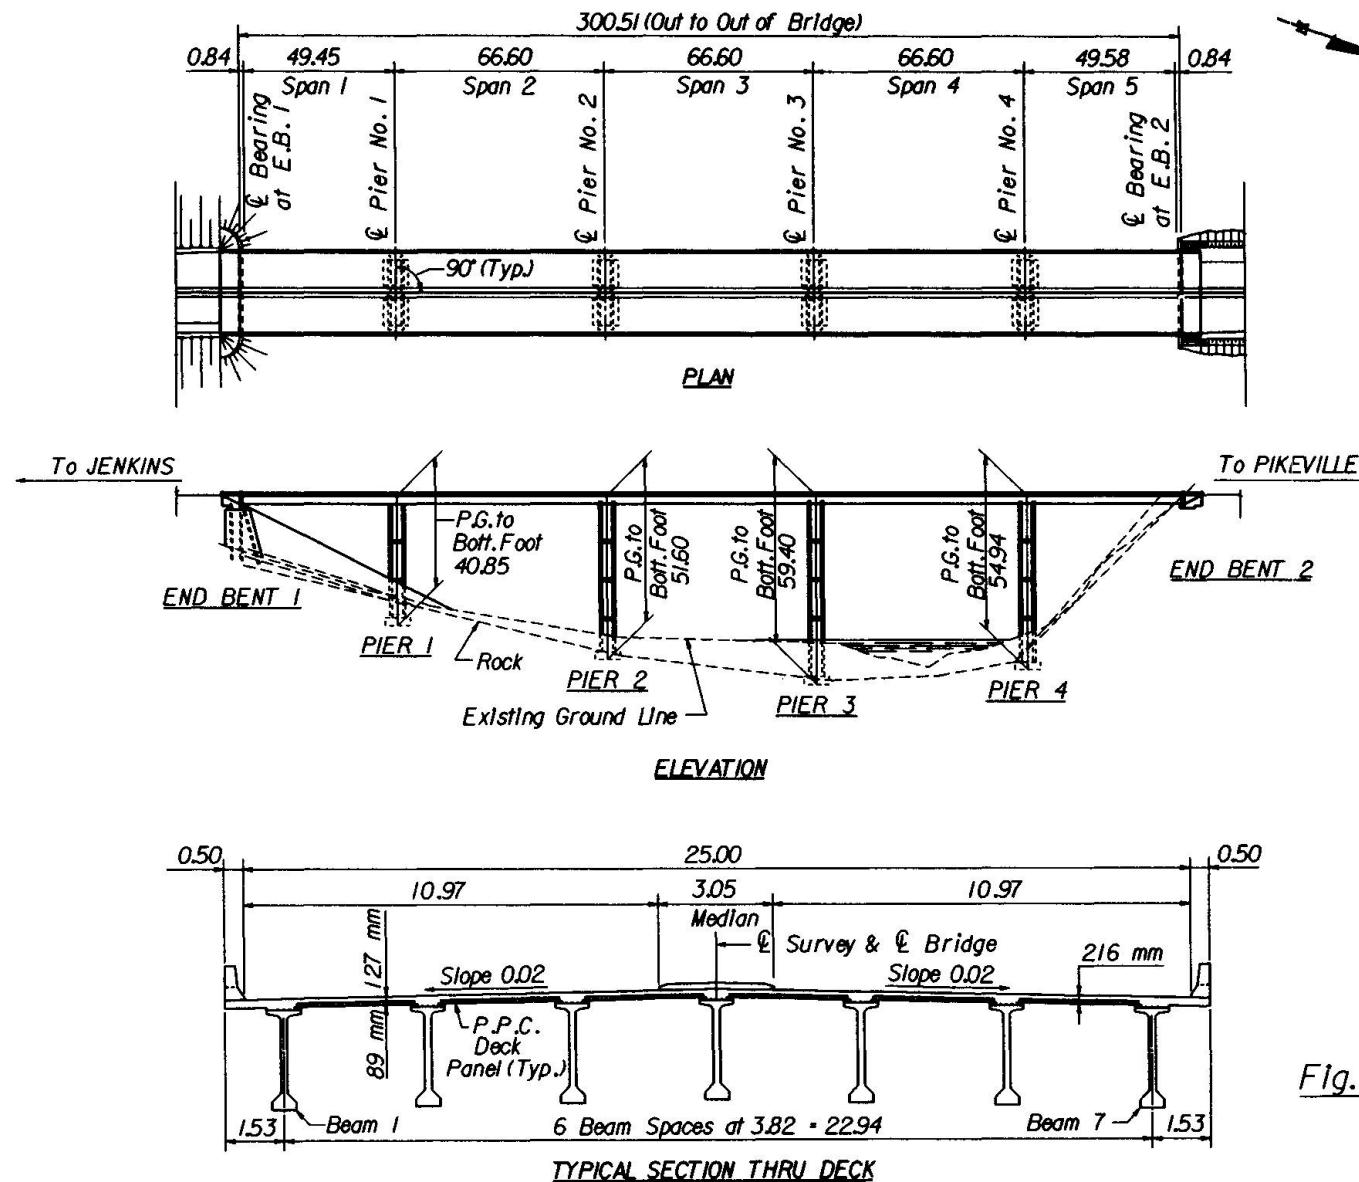
Fig. 2 Cracks at Pier 4

(curtain walls) Fig. 2 and 2) in the spans, away from piers, Fig. 3. Common to all cracks is more intense cracking in the exterior lanes of both traffic directions, than in the other two interior lanes, i.e., between the second and third beam of both bridge side faces. Next, cracks are more pronounced at piers 3 and 4 than piers 1 and 2, and the longitudinal cracks in spans are mainly developed along one or both sides of top flanges of both first interior beams.

**Cracks at Piers.** In Fig. 2, the typical pattern of enhanced cracks at pier 4 are shown. Both external lanes are almost centered on the first interior beams, and the longitudinal cracks are developed on both sides of beam's top flange. Transverse cracks crisscross them in the deck within the two pier curtain walls (diaphragms) in a way almost symmetrical to the pier centerline. Longitudinal beams and transverse diaphragms (curtain walls) produce deck panels 3.82 by 4.57m exposed to two dimensional restraints for any overlay displacement, including one due to the shrinkage. Due to this two-dimensional restraining effect, the corresponding stresses, developed in deck, produce tensile principle stresses at variable angles with bridge axis, i.e. the corresponding cracks in the overlay are semicircular.
