Zeitschrift: IABSE reports = Rapports AIPC = IVBH Berichte
Band: 73/1/73/2 (1995)

Rubrik: Session C3: General repair of buildings

General Repair of Buildings

Extending the Lifespan of the Architectural Heritage

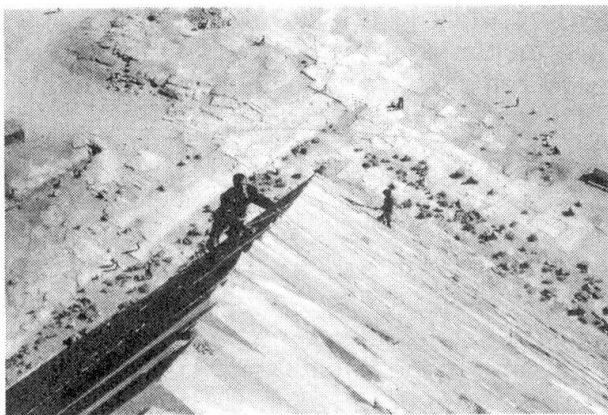
Fig. 1: The ascent of Chephren's Pyramid

On 17 November 1994, a scientific mission made an ascent of Chephren's Pyramid (Figure 1) to evaluate the role of temperature and wind in the decay of the stone and to assess the stability of some blocks that have been shifted by earthquakes in the past (Figure 2). On the one hand the survey contributed new and important elements for deeper understanding of the construction of the pyramid and, on the other, showed that, apart from the problem of weathering, no radical structural interventions were necessary, it being sufficient to add some supports in the same limestone to ensure the stability of blocks at risk.

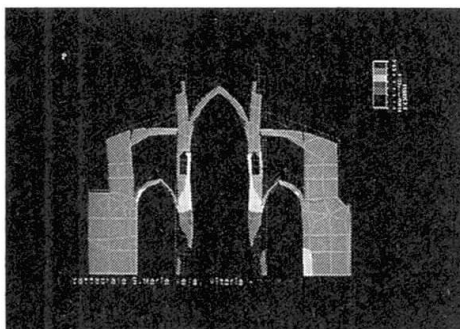
Fig. 5: Stresses and deformations where the buttresses were built before the vault

A general elastic finite element model was used to clarify first the scarce spatial cooperation in this kind of structures and, subsequently, the influence of the sequence of construction on the resulting stresses and deformations (Figures 5 and 6): the results obtained were found to correspond well with the actual state of the building (Figure 3). However, it was also necessary to carry out a non-linear analysis, taking into account the influence of the weakest zones, such as the triforium, and reductions in the resistant sections of the columns in order to define present safety levels in terms of ductility. The diagram in Figure 7 shows the equilibrium conditions in the middle section of the column, where the line "r" represents the resistant moment-curvature relationship and the line "a" is the external moment, taking account of the second order effects; the point "E" represents the equilibrium situation and the related curvature χ is very close to the actual curvature measured. ΔM_μ indicates the moment increment necessary to reach collapse, thus giving a very low real safety margin, especially taking into account possible errors in the evaluation of the limit deformations.

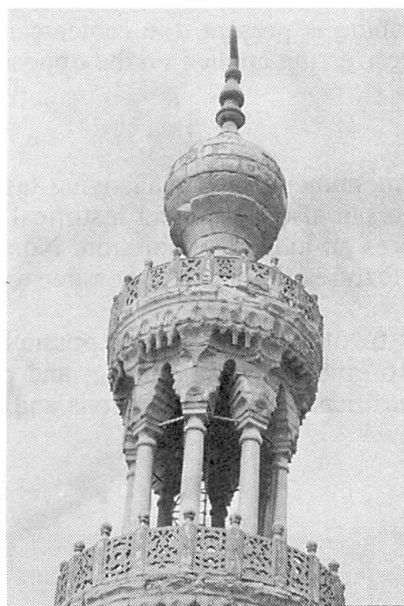
General measures to mitigate the effects of disasters can prevent much of the loss involving ancient monuments. Earthquakes are the most prevalent phenomena for which preventive measures can substantially reduce damage and avoid collapses. The damage to monuments in Cairo caused by the earthquake of 12 October '92 offers an interesting example. Many minarets collapsed not only because the masonry was of poor quality but also on account of the intrinsic weakness of the structural behaviour, especially in the upper parts where slender columns cannot withstand both flexural and twisting actions (Figures 13 and 14). The connection between the minaret and the main part of the mosque is another weak zone, as is shown both by mathematical

Fig. 13: Slender columns in some minarets

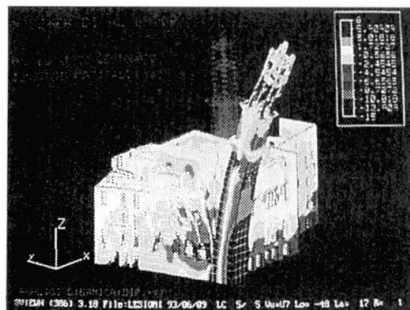
models (Figure 15) and direct observations, although the spontaneous cracks (Figure 16) automatically mitigate the seismic effects.

Fig. 15: Concentration of stresses and deformations revealed in a mathematic model

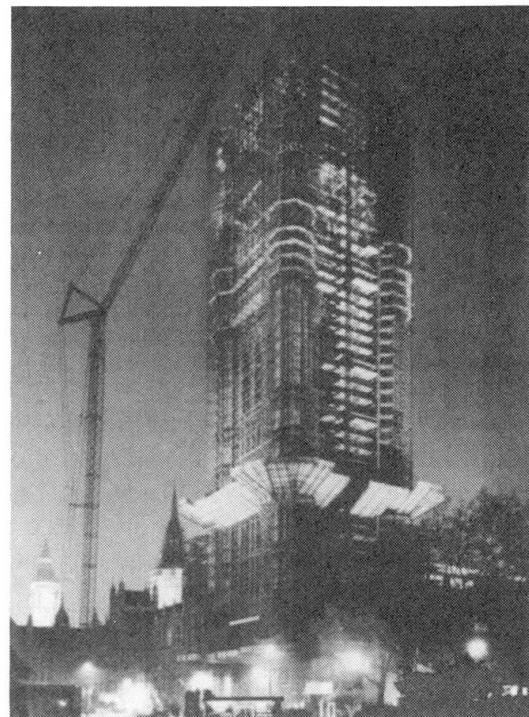
6.1.1 The access scaffolding for the 119m high Victoria Tower, which weighed 1000T and used 110km of scaffold tube, was founded on bored piles and supported over the adjacent roofs of the Palace on Bailey bridge towers and trusses. In view of the prominence and importance of the site, it was designed to the wind loading and other standards of a permanent structure. At upper levels the scaffold was tied back into the masonry using stainless steel drill anchors which were later made good with stone plugs and the positions were recorded for future use.

Fig.4 Victoria Tower Scaffold

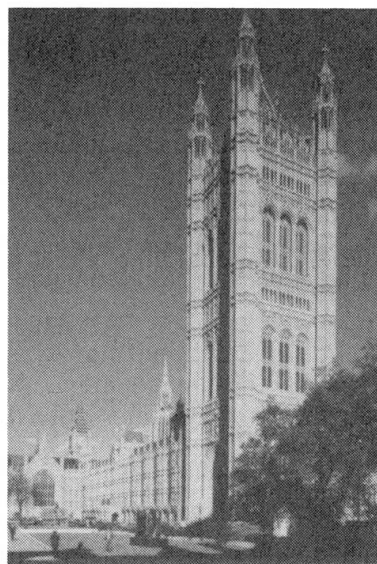
6.2.1 The Victoria Tower is roofed with large cast iron tiles on a trussed framework of cast and wrought iron. This is surmounted by a 28m high flag mast supported by ornate ironwork. Originally the tiles had a zinc anti-corrosion treatment which had failed very quickly in the acid Victorian city air and had been overcoated with a patent treatment. Research showed that many layers of lead based paint had also been applied over the years.

Fig.5 Restoration Complete

6.2.2 The aim was to put the roof in repair and provide a protective treatment which would last some 40 years. The accumulated layers of dirt and paint were removed back to bare metal by air abrasive blasting. Lead precautions included a full working enclosure, protective suits with air supply, air sampling outside the enclosure, disposal of the spent grit and dirt under controlled conditions and a decontamination unit for workmen. Broken cast iron tiles and jointing rolls were repaired by stitching, cold cast welding and off-site welding in an oven with controlled heating and cooling. Some new iron tiles, rolls and missing decorative features were cast, and after reassembly the roof surface was shot blasted and hot zinc sprayed. Pitting in the metal surface was stopped with an epoxy filler, followed by a sealing coat and finally a colour finish of vinyl co-polymer paint.

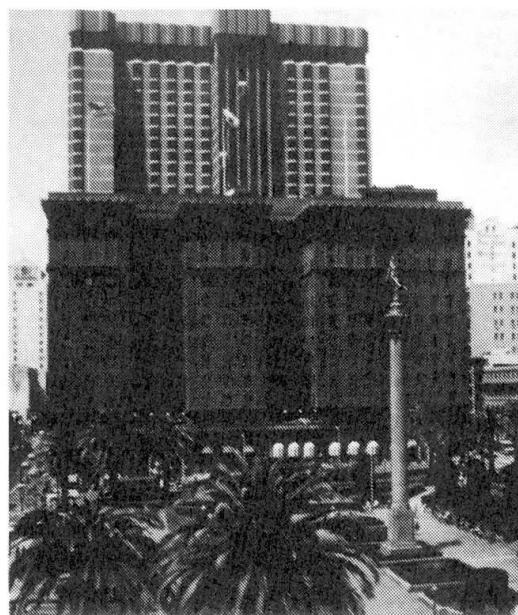
Figure 1 - St. Francis Hotel

In 1987, a condition survey of the entire sandstone facade was made from swing stages, and the condition of over 30,000 stones was recorded. The condition of each stone was recorded on scaled building elevations prepared using rectified photography. During the survey, loose pieces of stone were removed and stainless

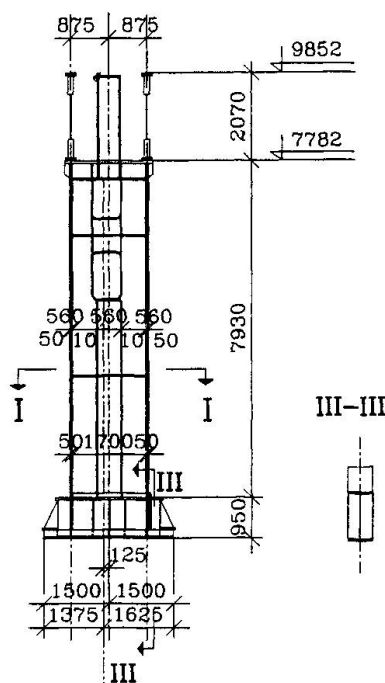
Fig. 2 Strengthened main column

The partial strengthening of main columns F8-F27 as well as the strengthening of column bases (transformation into box section) of main columns D9-D17, E8-E17 were carried out (Fig. 2). The additional longitudinal web stiffeners were welded in all columns. The amount of the additional steel material for the main columns is 44,4 t (i.e. 4,1% more steel in columns).

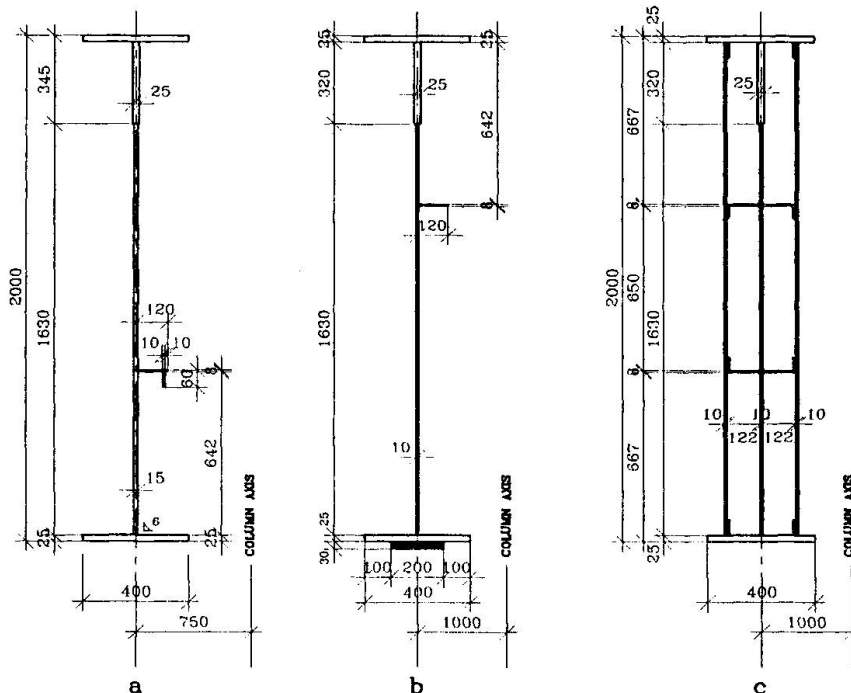
Fig. 3 Strengthened crane girders

The numerous different types (31) of the crane girders (total number 502), were applied in the original building. Thus the crane girders were classified in three types, concerning the strengthening works. The type "a" represented the crane girders (411 pieces) where the additional elements were put in for the longitudinal web stiffeners; the crane girders of type "b" required the additional plate to be welded on the bottom flange; the transformation of plate girder into box girder was applied to the crane girders (81 pieces) of type "c" (Fig. 3). The expansion joints of crane girders were strengthened as well. The additional steel material for the strengthening of crane girders amounts 256,1 t (i.e. 10,0% more steel in crane girders).

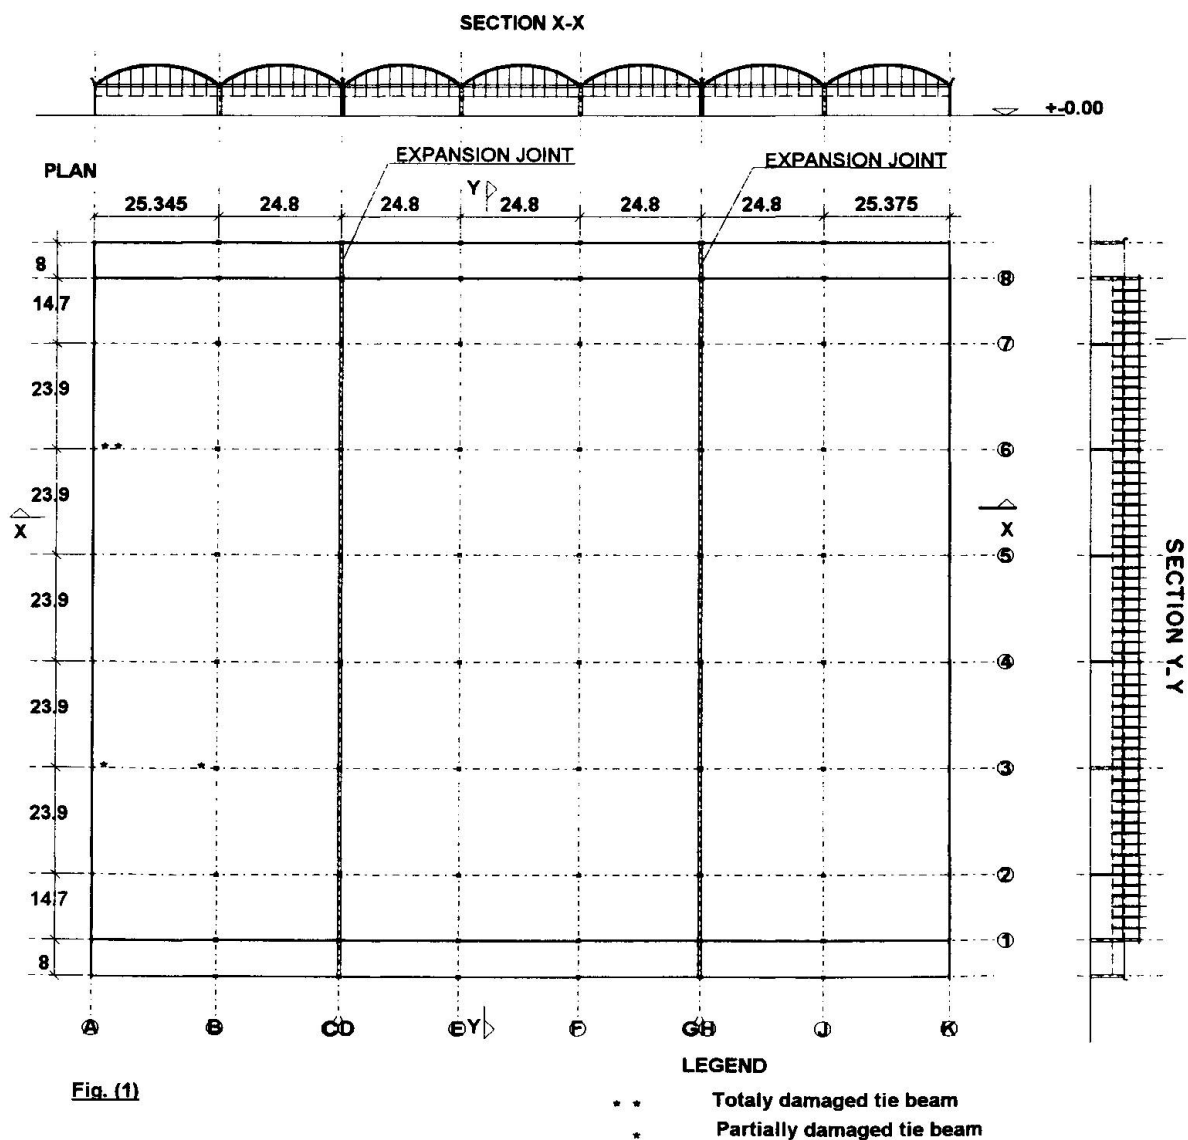
A prestressed concrete shell 164.9 x 173.9 m. for a spinning mill that was constructed and later repaired by "The Misr Concrete Development Co.". The roof consisted of concrete shell 7 to 25 cm. thickness supported on truss diaphragms with post tensioned tie beams in the longitudinal direction and on valley beams in the short direction. There was also a concrete flat plate slab hanging from the shell roof by high tensile steel bars. The shell was supported on 64 columns hinged up and down as link members and 16 fixed columns on axes 7 and 8. The mill foundations were supported on piles. Fig.(1).

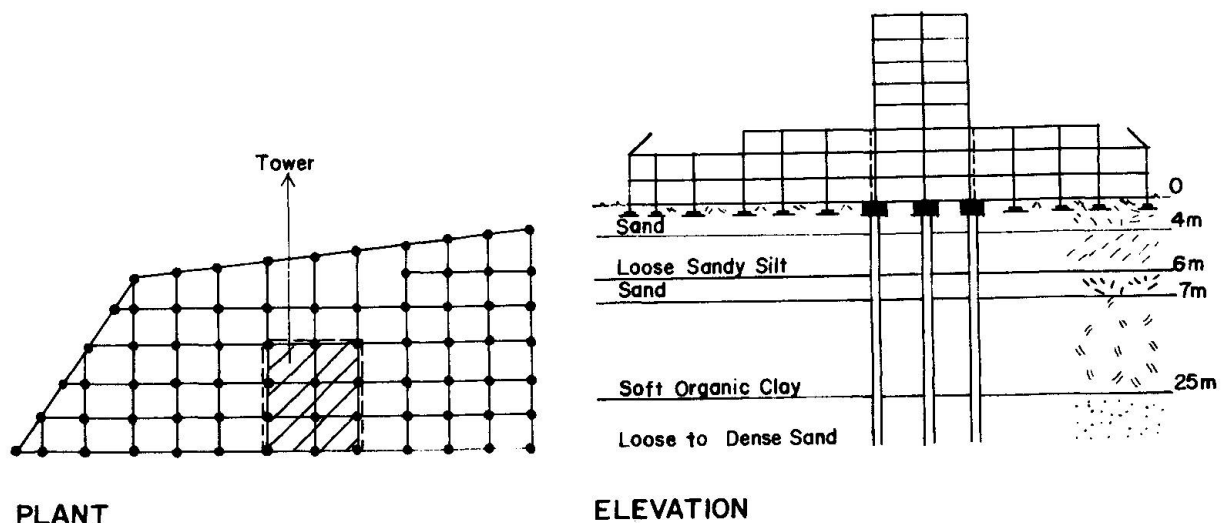
One building that is a medical center in Recife, Brazil, started having cracks due to foundation settlement soon after the end of its construction. It was a reinforced concrete structure with two types of foundation. The central block is an eight floors tower having deep foundation of steel piles near 40 m long. The outer block has three floors in spread foundation at the depth of 0.85 m with columns spaced 6m per 5m and takes 90 % of the ground area. The blocks are separated by a joint but the beams of the lower block were set on consols at the columns of the tower. Figure 1 shows the general lay-out.

Fig. 1 Lay-out of the structure and foundation conditions

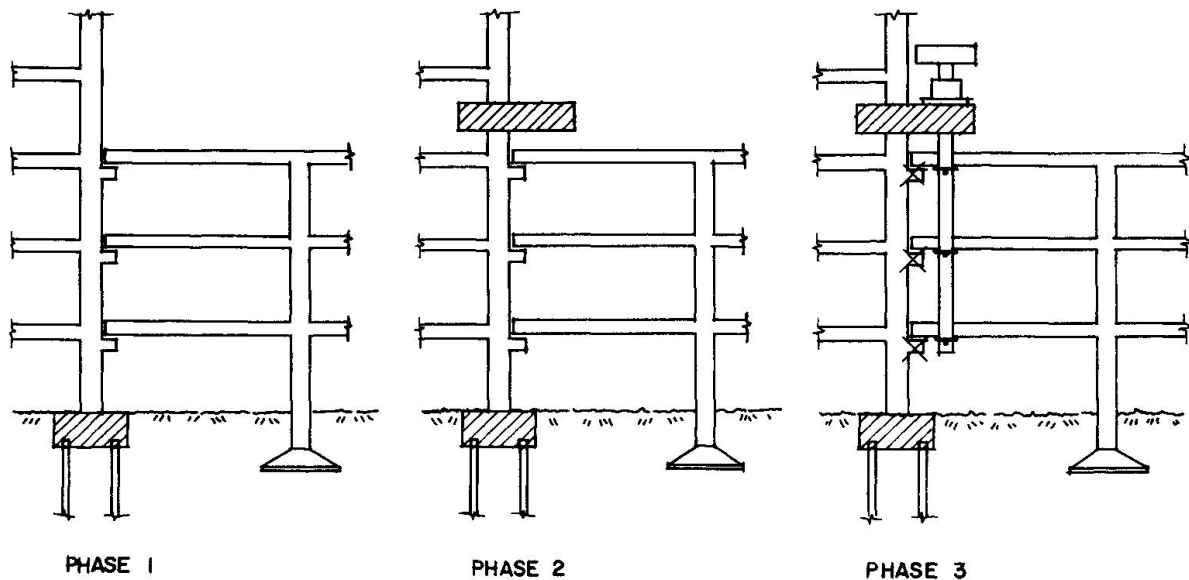
Fig 2 Construction sequence of the solution

The basic conception of the temporary solution is to compensate the settlement due to consolidation of the 18 m thick layer of soft organic clay. The solution implies on some procedures as to predict and measure settlement regularly, to loose the outer block from the tower where it is supported replacing the original fix supports of the beams by moveable ones and to descend the lower structure from time to time, according to the settlement occurred in the meantime. Figure 2 shows the succeeding phases of construction that was followed. Phase 1 is the initial situation. Phase 2 is the construction of consols in turn of the tower's columns at the 4th floor, above the roof level of the lower block. Phase 3 is the placement of moveable ties hung from these tower's consols, resting over sand jacks and supporting the three level's beams of the outer block. After the load transfer, the primitive consols are cut off giving way to the descent of the beams.

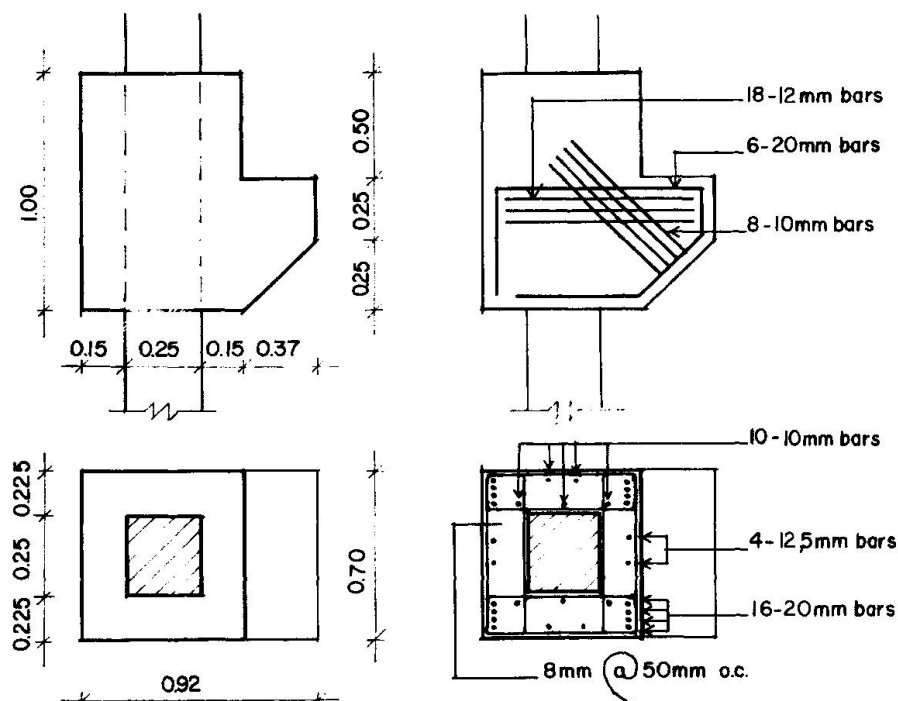
Fig. 3 Dimension and reinforcement of the consol

The principal effect of the solution is on the reinforced concrete frame of the tower. The structure system should be able to resist to the new load distribution with safety. The maximum tie load is 266 kN. Loads are applied symmetrically to the frame at the 4th floor, when originally they are distributed along the lower floors. The structure was calculated to this new stage of loading and found adequate to support it. The new consols in turn of the tower's columns were designed using the provisions in the Reinforced Concrete Brazilian Code (1) to $f_{ck} = 15$ MPa. Epoxy was used to bond the external encasement and the surrounding concrete. A summary of the detail is given in Figure 3.

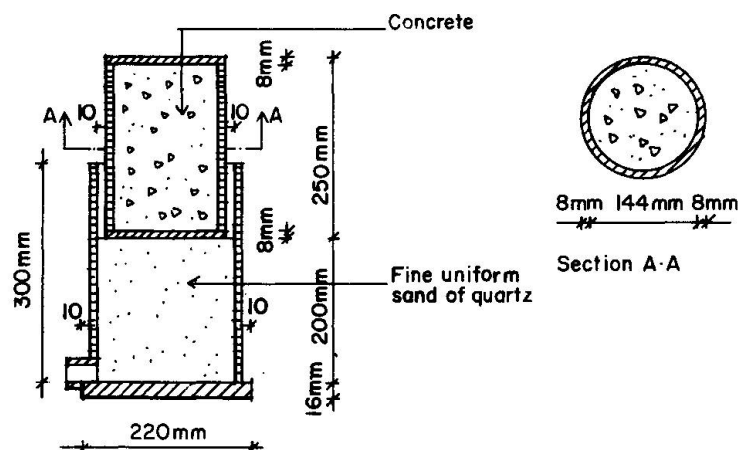
Fig. 4 Detail of the sand jack

Figure 4 gives detail of the sand jack. Its 160 mm diameter piston should get out an extension of 150 mm which is the settlement predicted to be compensated along time. The cylinder below has an internal diameter of 180 mm. It is filled in by fine sand of quartz with uniform grain-size and pre-loaded to 350 kN. This load is higher than the maximum one to be transmitted by the tie system. The device has two little holes at the bottom. The sand takes out smoothly using a thin steel pointer through them. Two lateral defletometers measured the descent up to the value of the settlement to be compensated. Laboratory tests permitted to define the procedures to assure an even lowering of the piston. The field operations proved to be the sand jack a practical, simple and safe device to lower the conceived system.

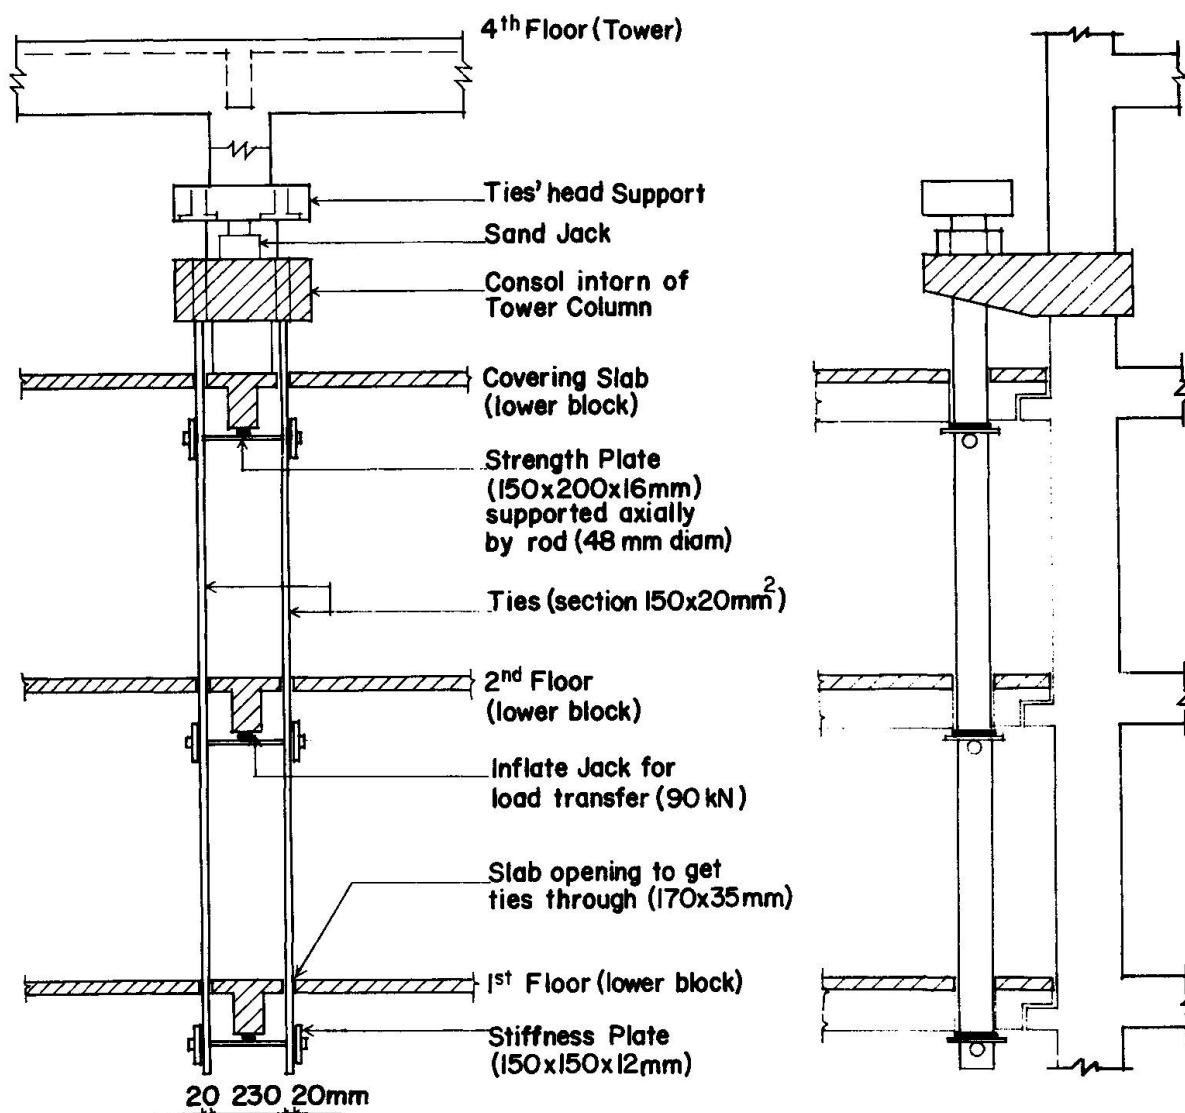
Fig. 5 Tie device to compensate settlement

The system is shown in Figure 5. All parts of it as splice, hook, bolt, welding, connection, etc. were tested to failure. The system's details should facilitate the anticipated construction sequence, including provisions for its erection and descent, installation through openings made at the existing structure, change of the sand jacks, space to operate them and the placement of inflate jacks to support the beams. Finally, load test made at each installed tie system determined the load transferred by each beam using strain gages fixed on the ties.

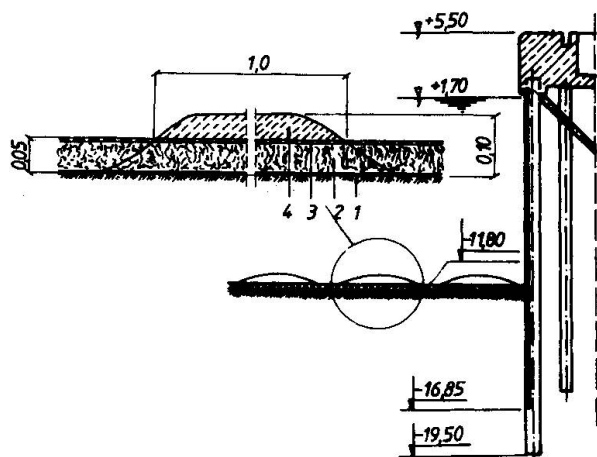
Fig. 1 Bottom protection using geotextiles [2]: 1-woven textile, 2-geomembrane with sand, 3-reinforcing geotextile, 4-mortar

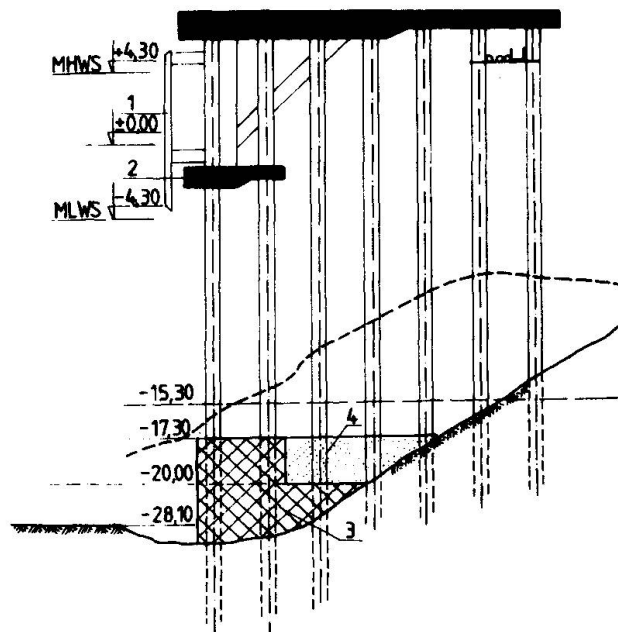
Fig. 2 Strengthening of an existing jetty through a submerged retaining wall [5] 1-main fender, 2-concrete fender tray, 3-concrete retaining wall, 4-soil refill

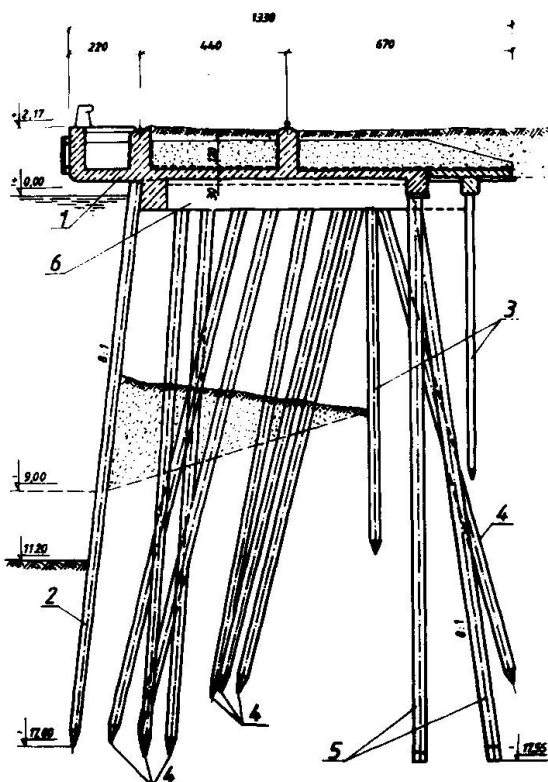
Fig. 3 Reconstruction of the Ore Terminal berthing structure in Gdańsk [3]: 1-new reinforced concrete slab, 2-concrete sheet wall, 3-existing timber sheet wall, 4-existing timber piles, 5-concrete piles, 6-existing concrete slab with reduced thickness

The first solution (Fig.3) [3] was adopted for the reconstruction of the Ore Terminal in the Harbour of Gdańsk. In the first phase the existing structure was equipped with a new crane connected with the construction of a new crane truck; in the second phase the construction of a new coping slab supported by the old structure and new prefabricated reinforced concrete sheet wall was made. The reconstruction allowed to increase the depth at the structure from 8.0 to 11.5 m and to load it by two crane tracks, one railway track and surcharge of 30 kN/m².

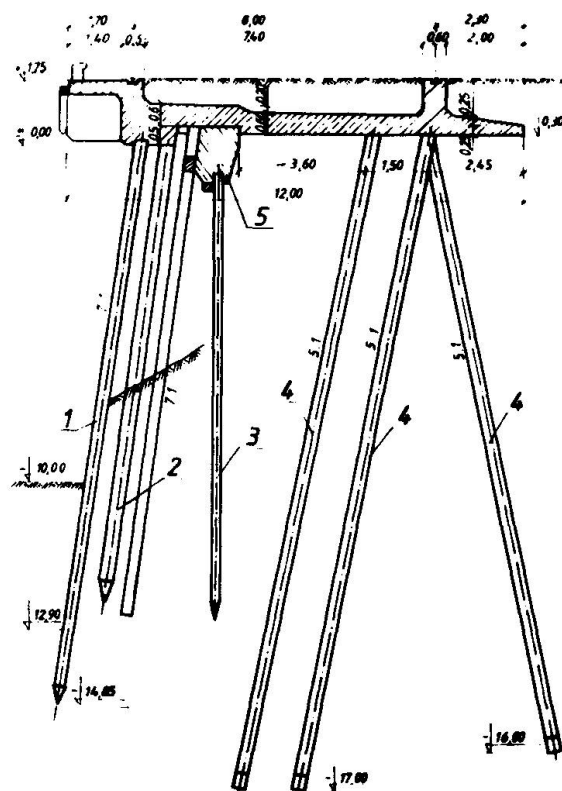
Fig. 4 Strengthening of the berthing structure of the Vistula Terminal in Gdańsk [3]: 1-concrete sheet wall, 2-existing timber piles, 3-existing timber sheet wall, 4-concrete piles, 5-existing concrete coping beam

In the second case, concerning the berthing structure of the Vistula Terminal in Gdańsk (Fig.4) [3], the existing structure consisting of anchored timber sheet wall was used to decrease the influence of earth pressure and to support partially the new coping slab. An increase of the depth of 4.0 m was reached while the loadings from cranes through constructed crane tracks were allowed.

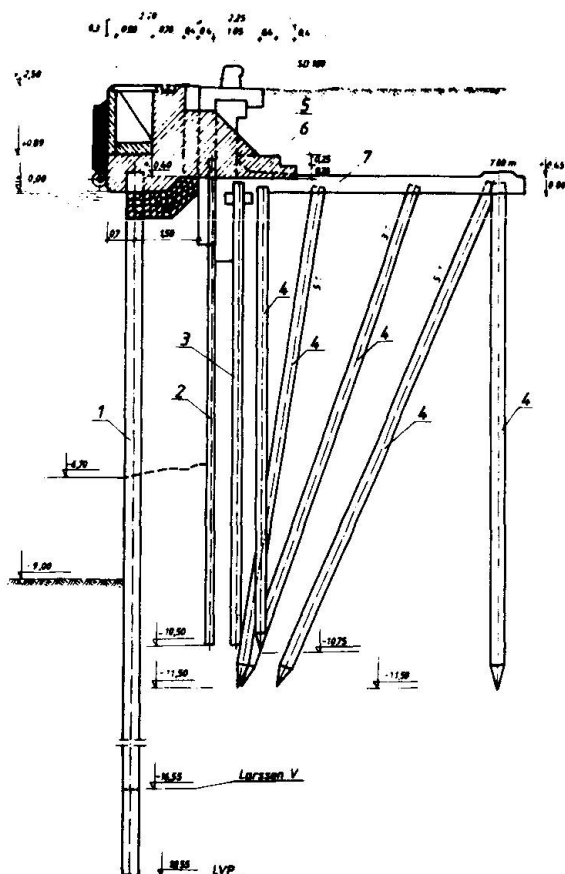
Fig.5 Strengthening of the Swedish Quay in Gdynia [3]: 1-steel sheet wall Larssen V strengthende with box type piles LVP, 2-existing timber sheet wall, 3-steel sheet wall, 4-timber piles, 5-longitudinal anchoring beam, 6-transverse anchoring beams, 7-existing cover plate

The third solution (Fig.5) [3] was introduced for the strengthening of the Swedish Quay in the Harbour of Gdynia. The reconstruction (increase of depth, new installations, new cranes) was made by driving in the front at a distance of 1.5 m a steel sheet wall of Larssen V type, strengthened by box piles LVP. The space between the existing and new sheet pile wall was filled by compacted sand while the new upper structure was used to connect and anchor the new structure with the old one.

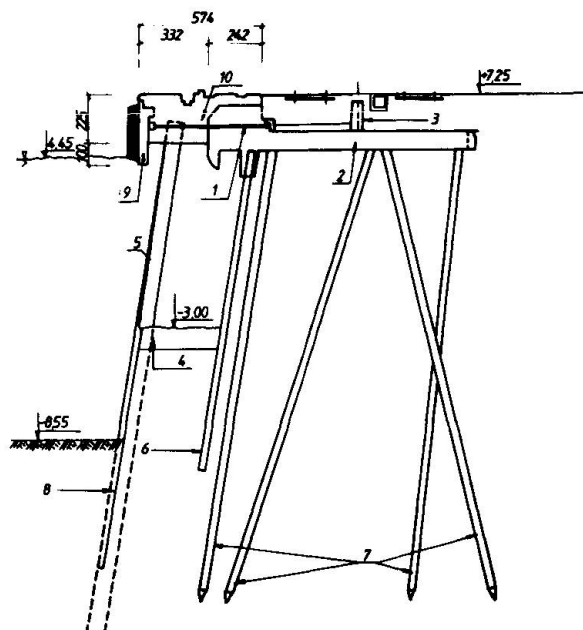
Fig.6 Cross-section of the strengthened berthing structure [4]: 1-prestressed anchor, 2-existing cover plate, 3-new crane-rail beam, 4-concrete, 5-H-piles, 6-existing BZ-sheet piling, 7-existing concrete piles, 8-Z-sheets, 9-prefabricated element, 10-new head beam.

The last case (Fig.6) [4] concerns a structure consisting of a new inclined sheet piling wall, driven in front of the existing structure and attached to the remainder of the old structure by prestressed anchors. The bottom at the previous seabed level is secured by an underwater concrete plug. The strengthening of the existing berthing structure allows on the increase of the depth from -7.0 m to -12.5 m. The front wall is a combined HZ-steel wall in which the Z-sheets are driven from the level -3.5 m to -14.5 m.
